Residual properties in damaged laminated composites through nondestructive testing: A review

Residual Properties in Damaged Laminated Composites through Nondestructive Testing: A Review

Abstract: The development of damage tolerance strategies in the design of composite structures constitutes a major challenge for the widespread application of composite materials. Damage tolerance approaches require a proper combination of material behavior description and nondestructive techniques. In contrast to metals, strength degradation approaches, i.e., the residual strength in presence of cracks, are not straightforwardly enforceable in composites. The nonhomogeneous nature of such materials gives rise to several failure mechanisms and, therefore, the definition of an ultimate load carrying capacity is ambiguous. Nondestructive techniques are thus increasingly required, where the damage severity is quantified not only in terms of damage extension, but also in terms of material response of the damaged region. Based on different approaches, many nondestructive techniques have been proposed in the literature, which are able to provide a quantitative description of the material state. In the p

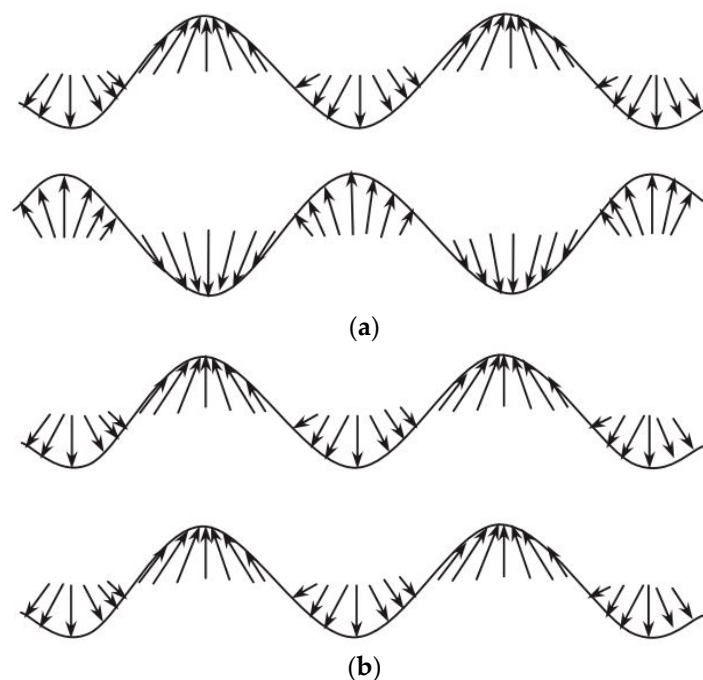
Figure 2. Symmetric (a) and anti-symmetric (b) Lamb waves [29].

Multiple propagating modes can be excited for the nondestructive inspection. Usually, the investigating frequency range is limited and only the first two fundamental modes are observed: the anti-symmetric mode, called a_0 and the symmetric mode, called s_0 , which are shown in Figure 2, taken from [29].
