Procedure for Technological Diagnosis of Oily Residuals Management in Cubans Distributed Generation Power Plants

# Procedure for technological diagnosis of oily residuals management in Cubans distributed generation power plants

In Cuba, more than 50 % of the electricity generation capacity is based on small-scale distributed power plants, which guarantee the energy supply demand from fossil fuels. Several negative environmental impacts are associated with this, including contamination by oily residuals. The purpose was to diagnose oily residuals management in Cubans distributed generation power plants from a technological approach. Ten generating power plants from Cienfuegos territory were selected as a case study. A methodological procedure, supported in the general method of problem solving was designed. The environmental audit was used as a fundamental tool for the verification of technical requirements regarding the containment, collection, evacuation, treatment, and final disposal of oily waste. For deployment of causes identified as evidence of auditory, failures modes and effects analysis (FMEA) were used. Hydrocarbon concentrations at sampling points in the external envir

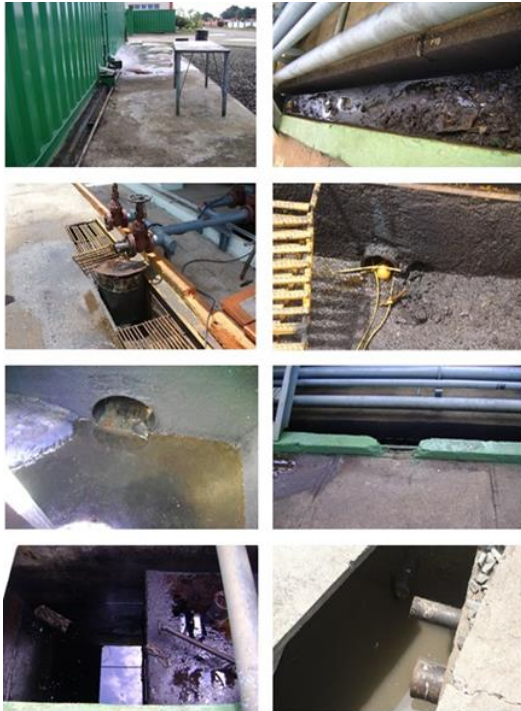
**Appendix A. Some graphical evidence from on-site audit activities in different power plants.**

From an exhaustive diagnosis in the power plants subsystems, attending to the criteria of design requirements, technical status, functional performance, operating conditions, and maintenance aspects; an abundant amount of evidence was documented. This evidence was collected among pictures, sketches, check sheets, reports, and notes. In the Appendix A is shown a sampled of some pictures as primary evidence collected in the power
