Disasters, Memory and Liturgy. Liturgical Spaces in the Reconstruction Process of Historical Churches Damaged by Earthquakes

Giulia De Lucia· Politecnico di Torino (Turin, Italy), giulia.delucia@polito.it

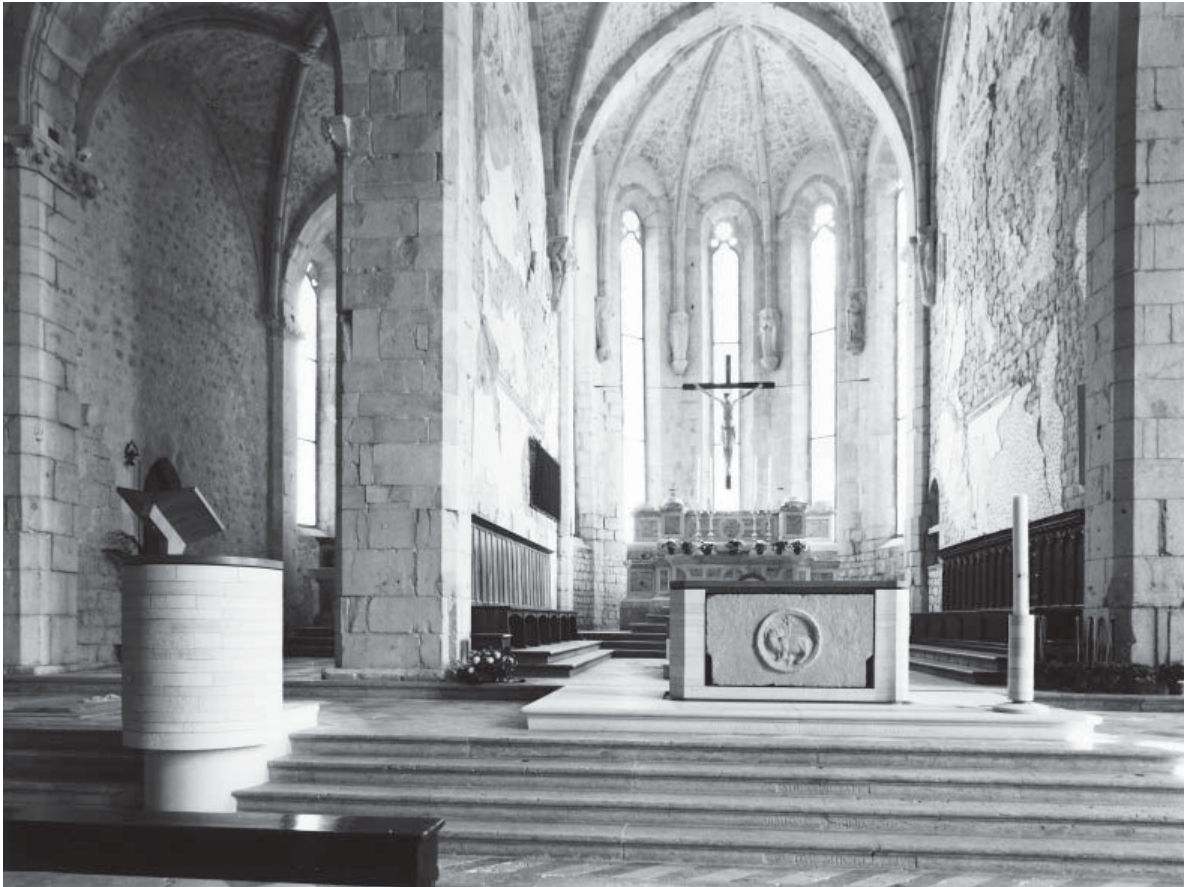
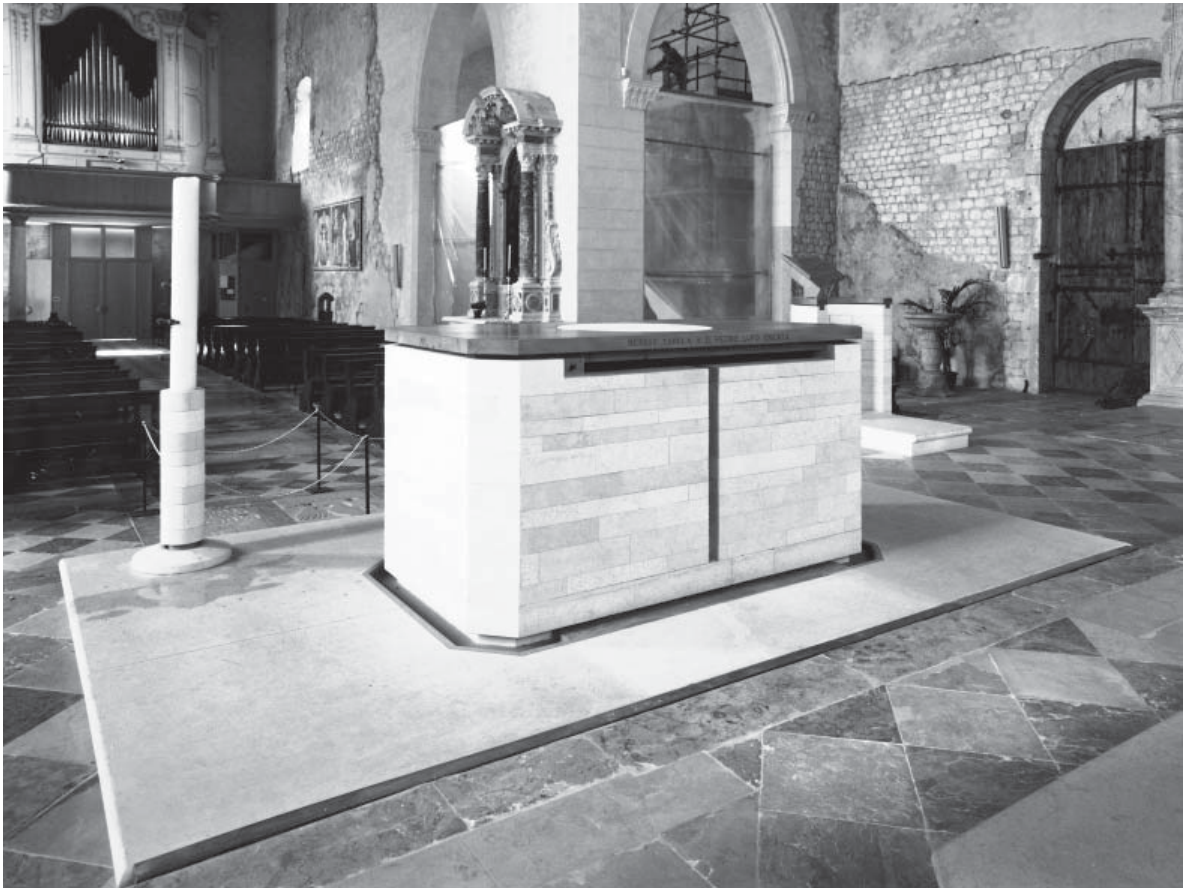
Fig. 01. Sandro Pittini. Sant'Andrea Apostolo, Venzone (Italy), 1995; liturgical reordering.

Gemona, the medieval structural skeleton was maintained through a massive structural intervention. A point worth of attention is the choice to *freeze* the structure with its deformations due to the seismic loads. In fact, church walls are not straight but partially inclined. This effect is underlined by the lighting designed by the architect Giorgio Della Longa. During the post-seismic reconstruction the presbytery was reformulate. The presbytery area was extended: a first portion, hosting the historical marmoreal altar, extends to the first couple of columns, and the second portion exceeding them. Two stone lecterns are symmetrically arranged (the one on the

left is used as ambo). The presbytery is raised from the floor with five steps. Three stone blocks compose the chair and the central one is different for quality (data from the Italian Census of Churches). For what concerns the Duomo of Venzone, it is the most representative example of reconstruction *how it was, where it was*. After the seismic event, every single stone rubble was orderly placed and catalogued. This is probably due to the shared conviction that the stones of the church were different from the others, they had a value and they should not go to landfill as the other rubble. Then architect Francesco Doglioni rebuilt the church by using original materials (Dalai Emiliani 2016). Architect Sandro Pittini designed the liturgical reordering in 1995. The project was carried on through the new *ornamenta ecclesiae* such as the altar, the ambo, the chairs, the Eucharistic custody, and the baptismal font. These liturgical centers were studied focusing their liturgical meaning and the choice of materials and decorations (that resume the stone blocks of the pillars) allowed their uniformity with the rest of the church (Pittini 2013) (Fig. 01-02).

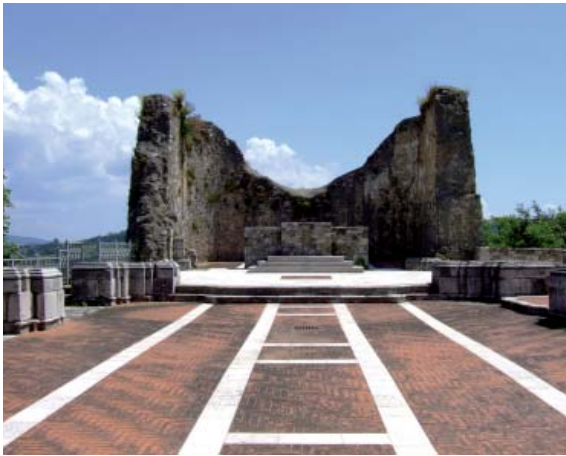
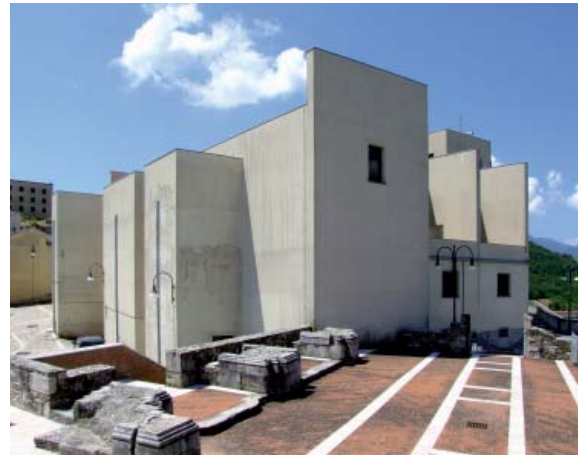
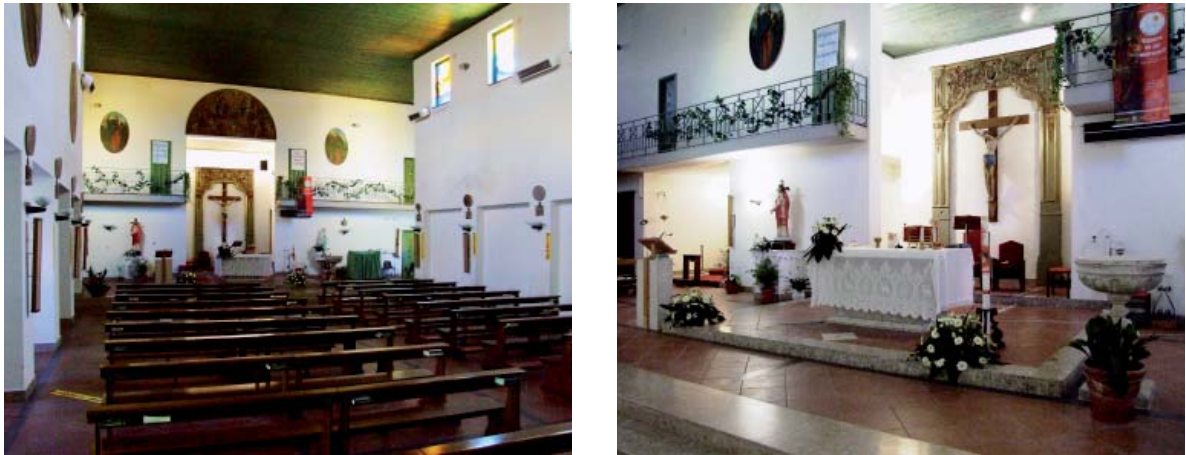
Fig. 03-04. Giorgio Grassi. Chiesa Madre, Teora (Italy), 1981-83/2011.

—The last one is the case of the Teora town. In this case, pre and post-earthquake coexist. Due to the high level of seismic risk of this area, the settlement

reconstruction was planned in compartments, totally changing the historical conformation of the towns. Some part of the historical settlement could not be rebuilt. For this research is interesting the case of the new church, designed by Giorgio Grassi over the same area of the old church. In this way, the Mother Church of Teora is linked to the past and the memory of the settlement. The destroyed church was left as a ruin and it is used a large churchyard instead (Crespi and Deگو 2004). Also in this case the old church artistic objects have been transported into the new church (Fig. 03-06).

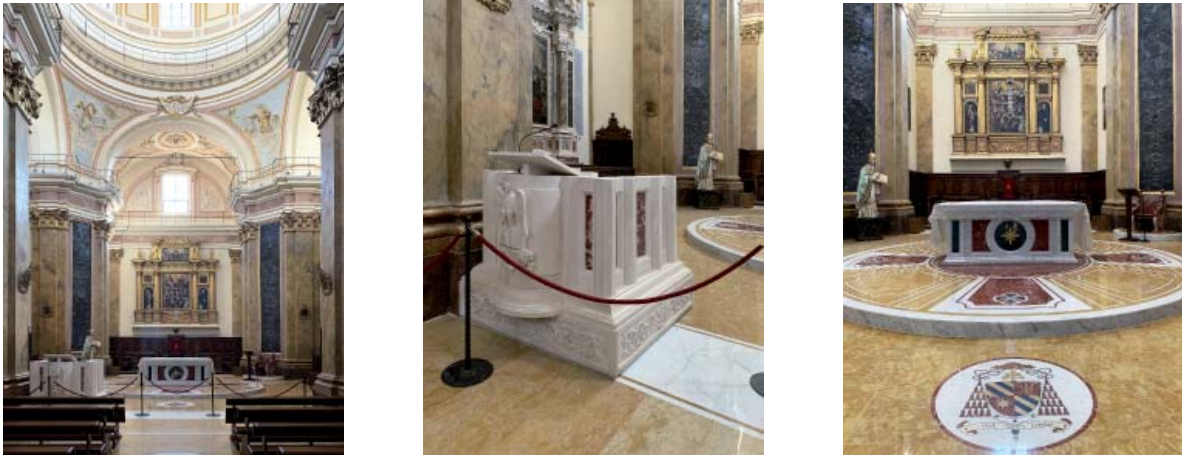
Fig. 07-09. Santa Maria del Suffragio, L'Aquila (Italy), 2019; liturgical reordering.

—The church of Santa Maria del Suffragio (commonly called the church of Holy Souls because was built in memory of people died in the 1703 seismic event) was severely damaged during the 2009 earthquake. The most damaged part of the structure was the masonry dome, which become the symbol of

the L' Aquila seismic event. In scientific literature, there are extensive technical researches about the structural interventions applied to the dome because its reconstruction was an important engineering challenge (Boscato et al. 2012). The church was reopened in 6 December 2018 with a touching ceremony. The church reconstruction cost is Euro 6,5 mln, financed by Italian and French government. In addition to the new dome and the chapel in memory of the 309 victims in 2009, a new liturgical reordering can be observed (Fig. 07-09). A circular marmoreal footplate is placed under the dome. In the center, there is the altar in polychromatic marble. The other liturgical poles are in marble with stylistic uniformity. The chair is to the right rear of the altar, against the pillar. The ambo is on the limit between the presbytery and the liturgical room, accordingly to the CEI indications. Very interesting is the solution of the cross that is suspended on the altar, through invisible cables, that give a very poetical result.

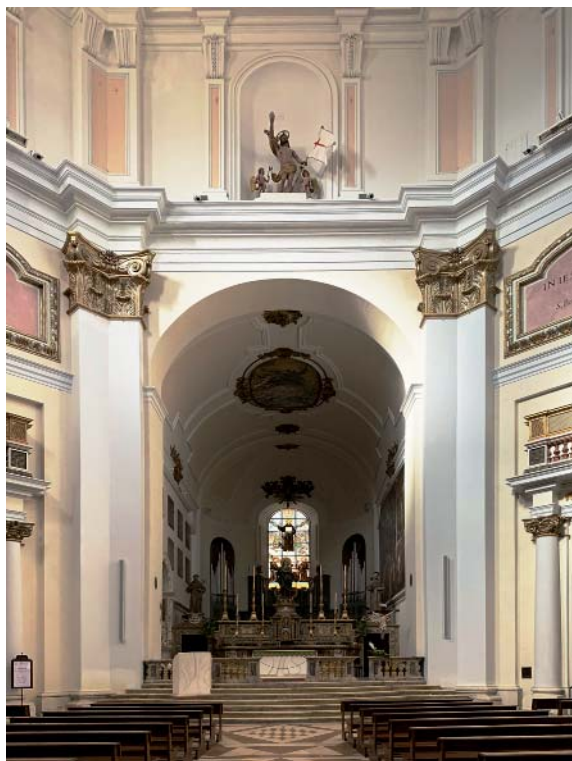
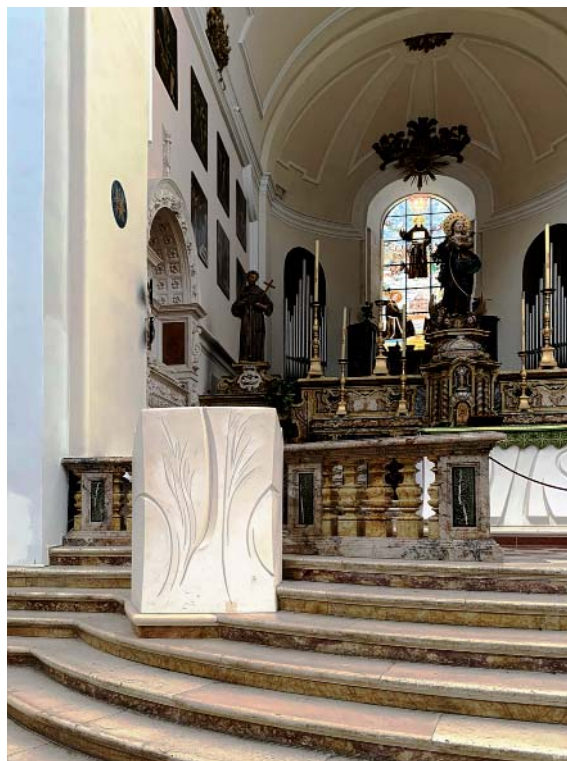
Fig. 10-11. Basilica di San Bernardino, L'Aquila (Italy), 2019; liturgical reordering.

restore interventions. A liturgical reordering was then applied (Fig. 10-11). The nun architect Michelangela Ballan designed it. Surely, the most distinctive feature of this liturgical reordering is the insertion of white marmoreal blocks for the altar and the ambo. The aim is to resume the traditional white local stone. However, the opera is deliberately in dissonance with the rest of the church in order to diversify new and old elements. The liturgical reordering entailed a new altar in substitution to the oldest, a '70s wood altar without particular artistic relevance, and a new ambo, placed after the balustrade, on the presbytery steps. The intervention is entirely reversible, including the marmoreal addition to the presbytery steps that is removable. However, due to the marked difference between the new intervention and the baroque deco-

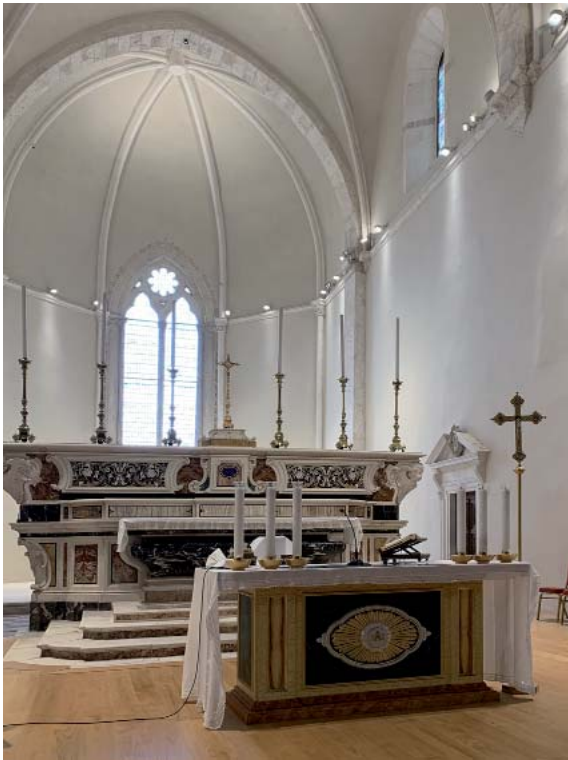
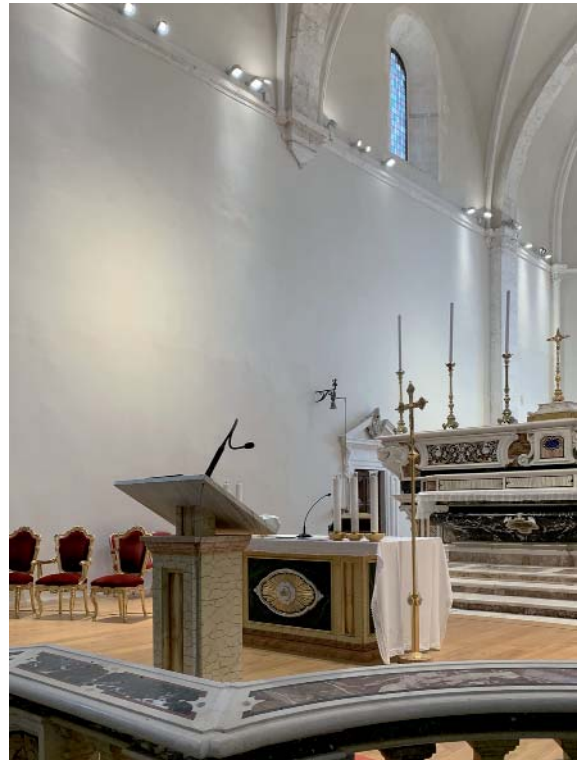
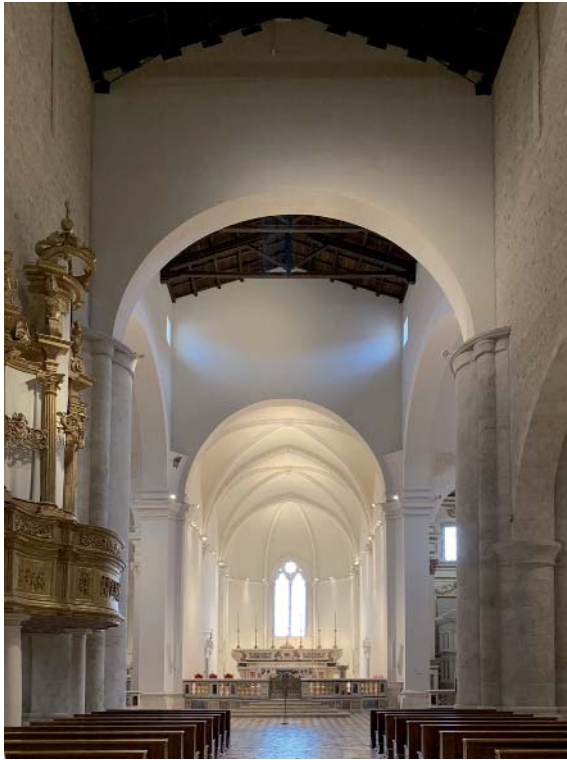
Fig. 12-13. Basilica di Santa Maria di Collemaggio, L'Aquila (Italy), 2019; after the restoration.

—The Basilica di Santa Maria di Collemaggio is one of the most relevant churches in the city. It was severely damaged by the 2009 earthquake: the transept vaults, the triumphal arch and the dome-drum system collapsed, and serious damaged were detected in the presbytery area. In this church, the restoration works have been very considerable (with an estimated cost of more than Euro 15 mln) with a courageous decision to entirely remove the baroque interior decoration, radically changing the stylistic configuration of the church, restored in its medieval features. Nevertheless, the great restoration has not considered for a liturgical reordering and the presbytery has been substantially untouched (Fig. 12-14).
