Disasters, Memory and Liturgy. Liturgical Spaces in the Reconstruction Process of Historical Churches Damaged by Earthquakes / DE LUCIA, Giulia. - In: ACTAS DEL CONGRESO INTERNACIONAL DE ARQUITECTURA RELIGIOSA CONTEMPORÁNEA. - ISSN 2340-5503. - ELETTRONICO. - 6:2019(2019), pp. 194-207.
[<https://doi.org/10.17979/aarc.2019.6.0.6239>]

Disasters, Memory and Liturgy. Liturgical Spaces in the Reconstruction Process of Historical Churches Damaged by Earthquakes

Giulia De Lucia· Politecnico di Torino (Turin, Italy), giulia.delucia@polito.it

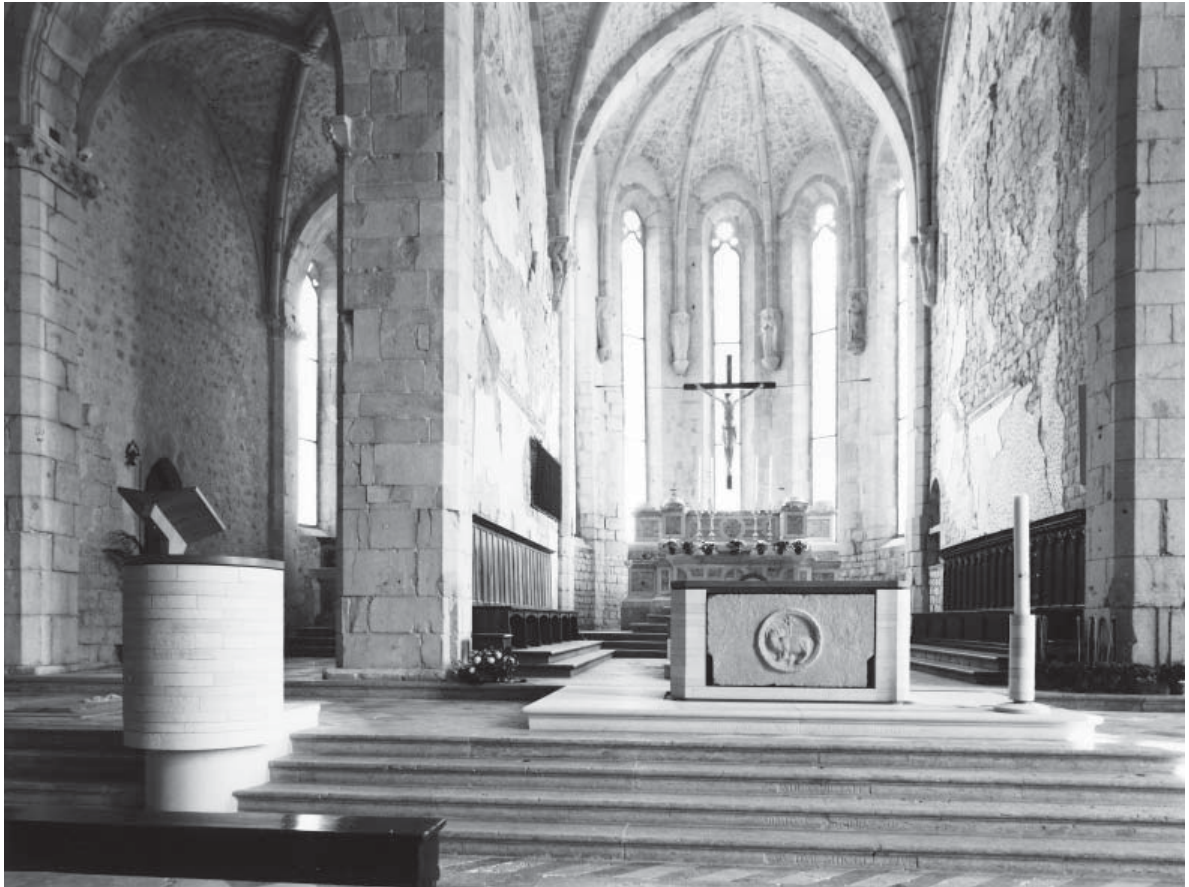
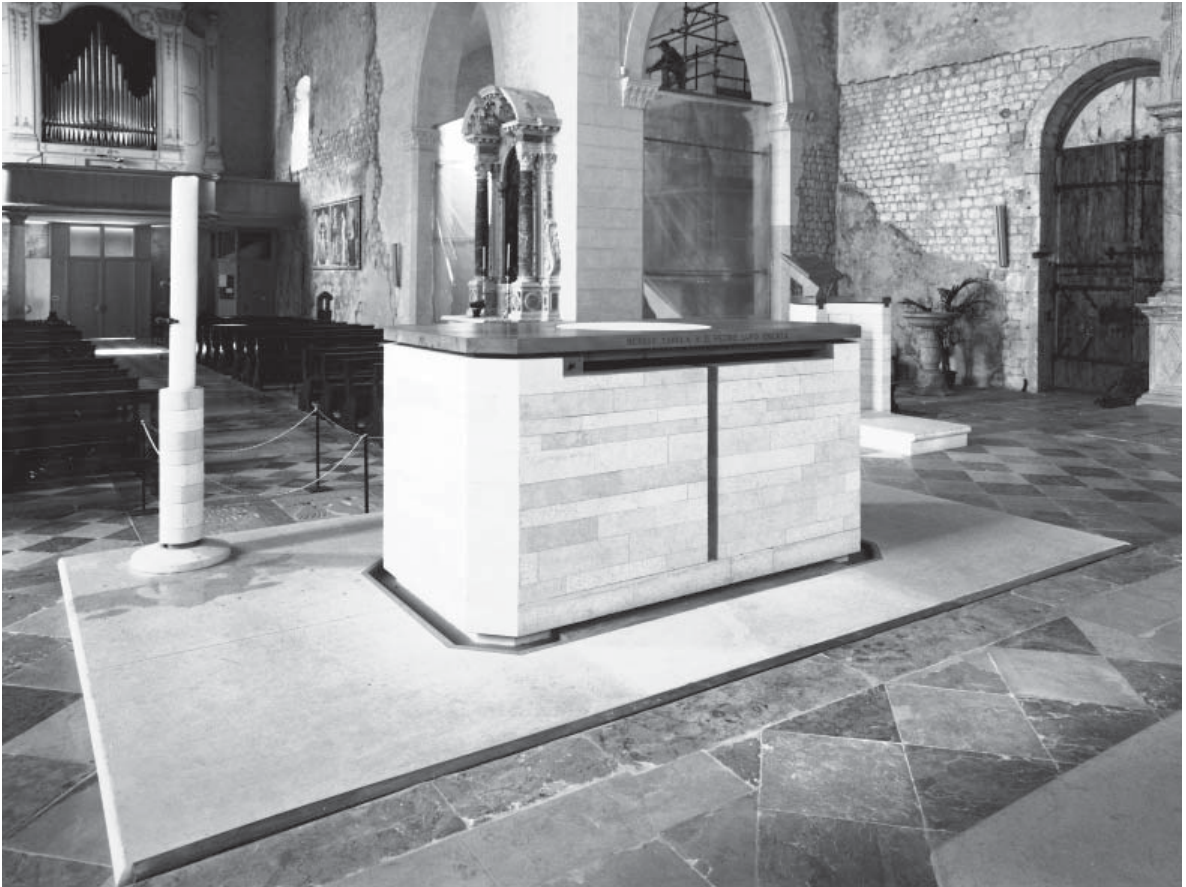
Fig. 01. Sandro Pittini. Sant'Andrea Apostolo, Venzone (Italy), 1995; liturgical reordering.

Fig. 02. Sandro Pittini. Sant'Andrea Apostolo, Venzone (Italy), 1995; liturgical reordering.

Gemona, the medieval structural skeleton was maintained through a massive structural intervention. A point worth of attention is the choice to *freeze* the structure with its deformations due to the seismic loads. In fact, church walls are not straight but partially inclined. This effect is underlined by the lighting designed by the architect Giorgio Della Longa. During the post-seismic reconstruction the presbytery was reformulate. The presbytery area was extended: a first portion, hosting the historical marmoreal altar, extends to the first couple of columns, and the second portion exceeding them. Two stone lecterns are symmetrically arranged (the one on the

left is used as ambo). The presbytery is raised from the floor with five steps. Three stone blocks compose the chair and the central one is different for quality (data from the Italian Census of Churches). For what concerns the Duomo of Venzone, it is the most representative example of reconstruction *how it was, where it was*. After the seismic event, every single stone rubble was orderly placed and catalogued. This is probably due to the shared conviction that the stones of the church were different from the others, they had a value and they should not go to landfill as the other rubble. Then architect Francesco Doglioni rebuilt the church by using original materials (Dalai Emiliani 2016). Architect Sandro Pittini designed the liturgical reordering in 1995. The project was carried on through the new *ornamenta ecclesiae* such as the altar, the ambo, the chairs, the Eucharistic custody, and the baptismal font. These liturgical centers were studied focusing their liturgical meaning and the choice of materials and decorations (that resume the stone blocks of the pillars) allowed their uniformity with the rest of the church (Pittini 2013) (Fig. 01-02).

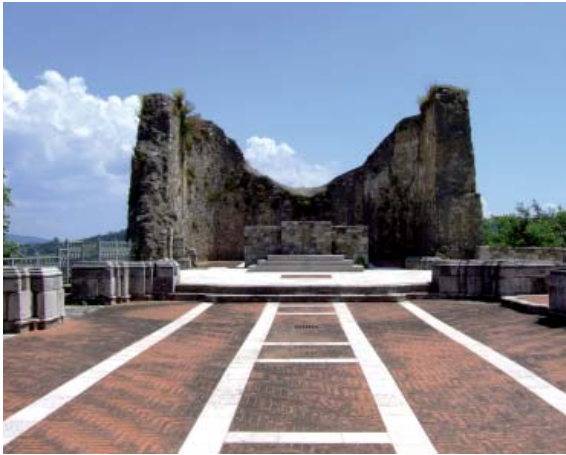
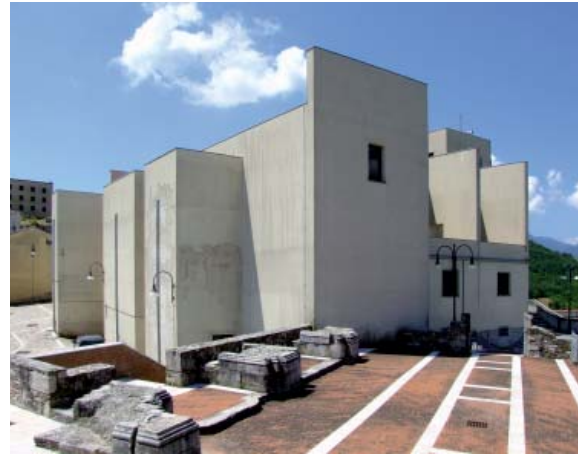
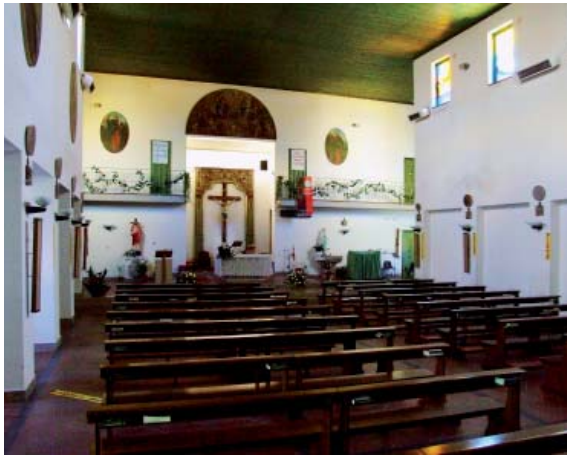
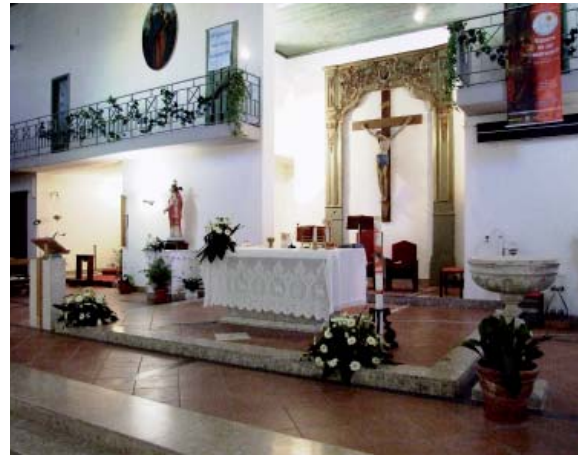
Fig. 03-04. Giorgio Grassi. Chiesa Madre, Teora (Italy), 1981-83/2011.

Fig. 05-06. Giorgio Grassi. Chiesa Madre, Teora (Italy), 1981-83/2011.

—The last one is the case of the Teora town. In this case, pre and post-earthquake coexist. Due to the high level of seismic risk of this area, the settlement

reconstruction was planned in compartments, totally changing the historical conformation of the towns. Some part of the historical settlement could not be rebuilt. For this research is interesting the case of the new church, designed by Giorgio Grassi over the same area of the old church. In this way, the Mother Church of Teora is linked to the past and the memory of the settlement. The destroyed church was left as a ruin and it is used a large churchyard instead (Crespi and Dego 2004). Also in this case the old church artistic objects have been transported into the new church (Fig. 03-06).

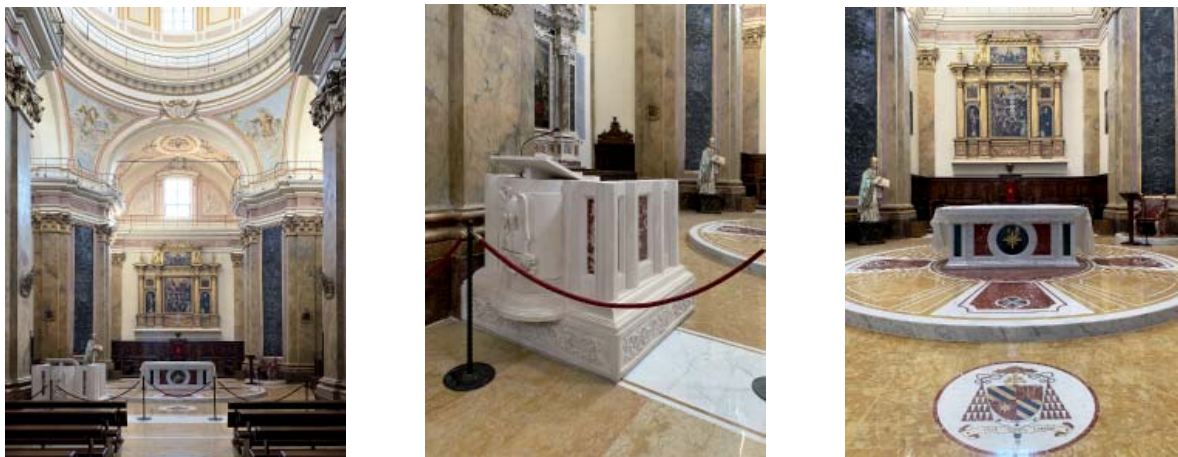
Fig. 07-09. Santa Maria del Suffragio, L'Aquila (Italy), 2019; liturgical reordering.

—The church of Santa Maria del Suffragio (commonly called the church of Holy Souls because was built in memory of people died in the 1703 seismic event) was severely damaged during the 2009 earthquake. The most damaged part of the structure was the masonry dome, which become the symbol of

the L' Aquila seismic event. In scientific literature, there are extensive technical researches about the structural interventions applied to the dome because its reconstruction was an important engineering challenge (Boscato et al. 2012). The church was reopened in 6 December 2018 with a touching ceremony. The church reconstruction cost is Euro 6,5 mln, financed by Italian and French government. In addition to the new dome and the chapel in memory of the 309 victims in 2009, a new liturgical reordering can be observed (Fig. 07-09). A circular marmoreal footplate is placed under the dome. In the center, there is the altar in polychromatic marble. The other liturgical poles are in marble with stylistic uniformity. The chair is to the right rear of the altar, against the pillar. The ambo is on the limit between the presbytery and the liturgical room, accordingly to the CEI indications. Very interesting is the solution of the cross that is suspended on the altar, through invisible cables, that give a very poetical result.

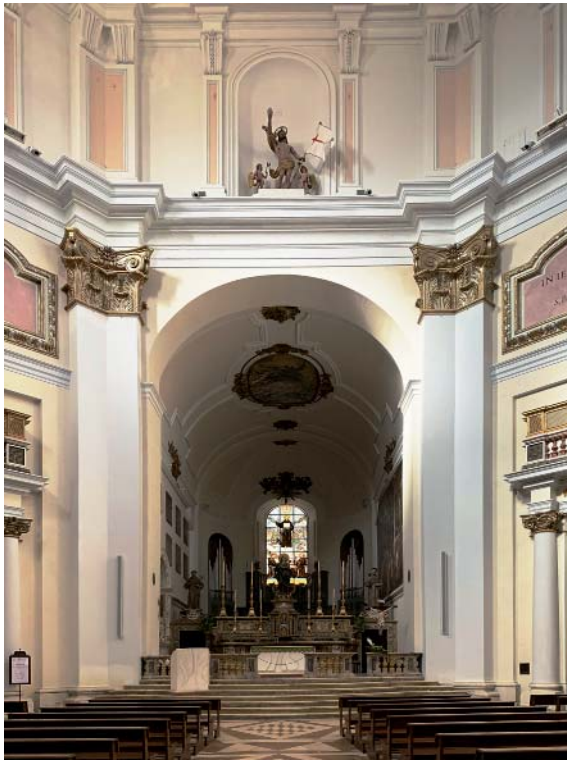
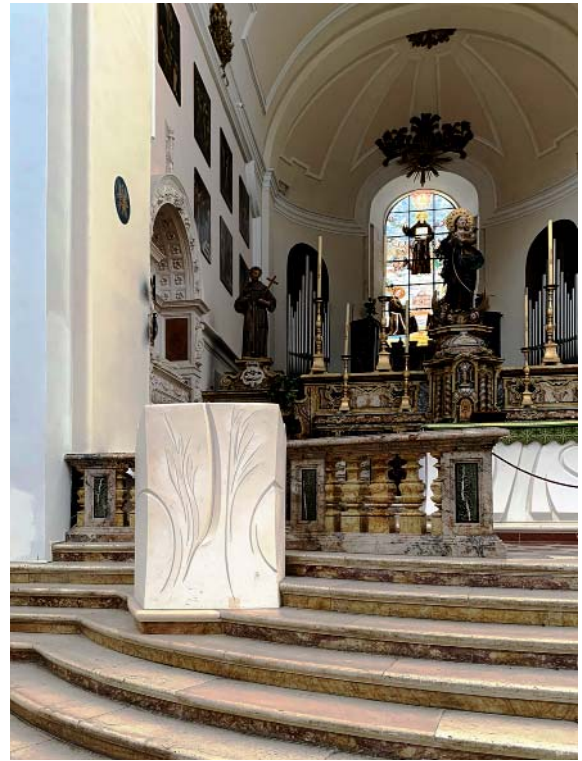
Fig. 10-11. Basilica di San Bernardino, L'Aquila (Italy), 2019; liturgical reordering.

restore interventions. A liturgical reordering was then applied (Fig. 10-11). The nun architect Michelangela Ballan designed it. Surely, the most distinctive feature of this liturgical reordering is the insertion of white marmoreal blocks for the altar and the ambo. The aim is to resume the traditional white local stone. However, the opera is deliberately in dissonance with the rest of the church in order to diversify new and old elements. The liturgical reordering entailed a new altar in substitution to the oldest, a '70s wood altar without particular artistic relevance, and a new ambo, placed after the balustrade, on the presbytery steps. The intervention is entirely reversible, including the marmoreal addition to the presbytery steps that is removable. However, due to the marked difference between the new intervention and the baroque deco-

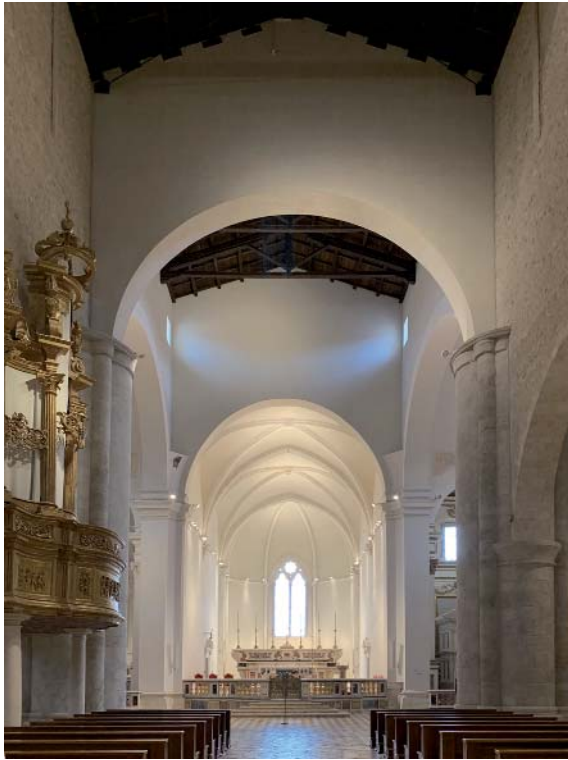
Fig. 12-13. Basilica di Santa Maria di Collemaggio, L'Aquila (Italy), 2019; after the restoration.

Fig. 14. Basilica di Santa Maria di Collemaggio, L'Aquila (Italy), 2019; after the restoration.

—The Basilica di Santa Maria di Collemaggio is one of the most relevant churches in the city. It was severely damaged by the 2009 earthquake: the transept vaults, the triumphal arch and the dome-drum system collapsed, and serious damaged were detected in the presbytery area. In this church, the restoration works have been very considerable (with an estimated cost of more than Euro 15 mln) with a courageous decision to entirely remove the baroque interior decoration, radically changing the stylistic configuration of the church, restored in its medieval features. Nevertheless, the great restoration has not considered for a liturgical reordering and the presbytery has been substantially untouched (Fig. 12-14).
