Static behaviour of in scale masonry vaults under imposed settlement of the supports

F. Roselli, M. Alforno & F. Venuti

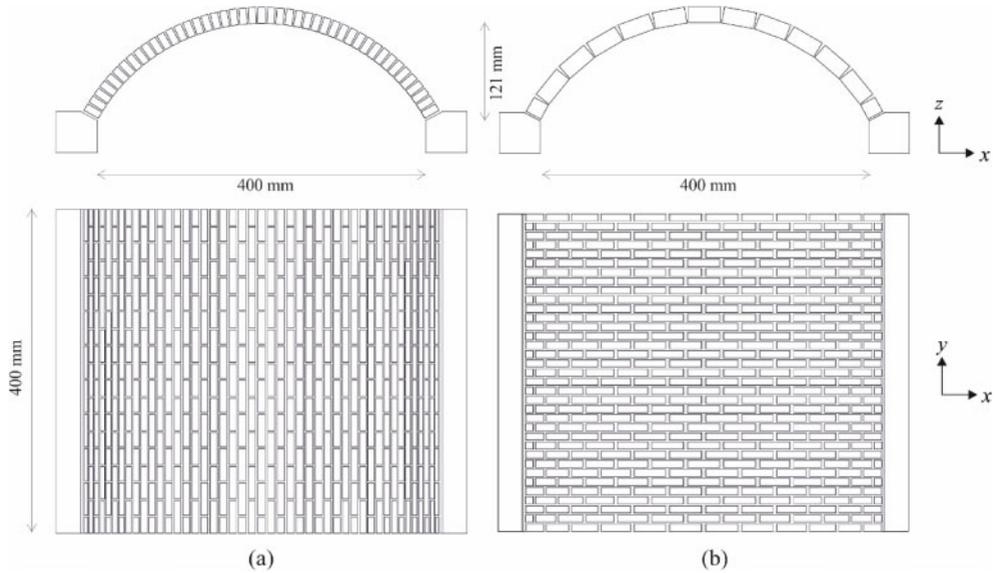
Figure 1. Geometry of the barrel vault in the radial (a) and vertical (b) configuration.

The adopted case study is a 1:5 model of a barrel vault with a square base: the net span of the vault is approximately 40 cm, the rise is about 12 cm, and the length of the vault is 40 cm (Figure 2). The barrel vault is made of blocks of dimensions $9 \times 20 \times 40$ mm, which mimic in scale 1:5 the dimensions of classic masonry bricks.

- a radial pattern (R), composed of multiple rows of rowlock oriented bricks, placed orthogonal to the main vertical plane of the vault (Figures 1a and 2a);
- a vertical pattern (V), where the bricks are laid in rows parallel to the main vertical plane of the structure (Figures 1b and 2b).

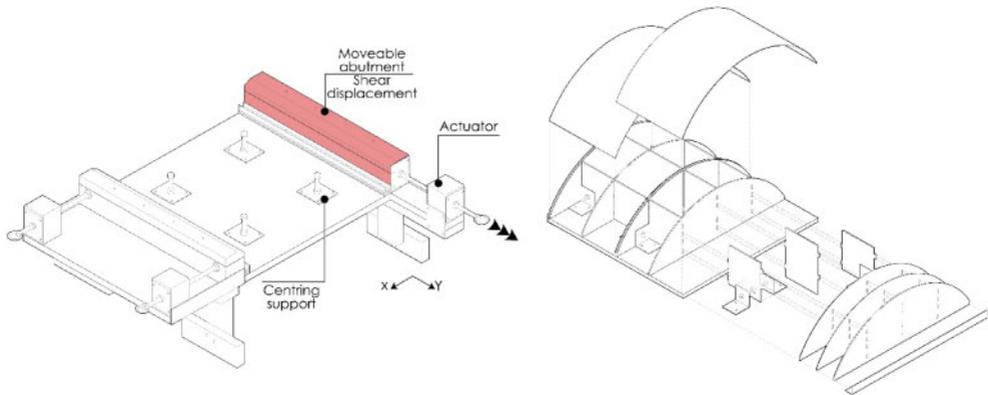
Figure 2. Experimental set up of the barrel vault: testing device and detail of the centring.

The experimental set up of the barrel vault was designed to allow both opening and shear tests to be performed (Figure 2). Specifically, one of the abutments is fixed in the x direction and allowed to move in y direction (simple shear mechanism), while the other abutment is fixed in the y direction and can be moved in x direction (opening mechanism). Four pins support the centring, and the slab where they are fixed can be lowered to allow the centring removal after completion of the vault.

Imposed settlements are measured by a digital calliper installed in correspondence of the moving abutment.

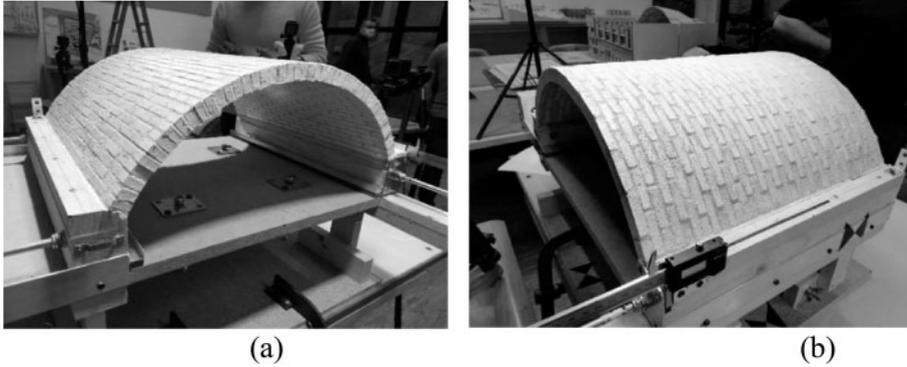
Figure 3. The built model in the radial (a) and vertical (b) configuration.

All the built models (Figure 3) are composed of 450 bricks with a similar global mortar quantity. A total of 4 models, two for each arrangement, are tested under shear displacement.

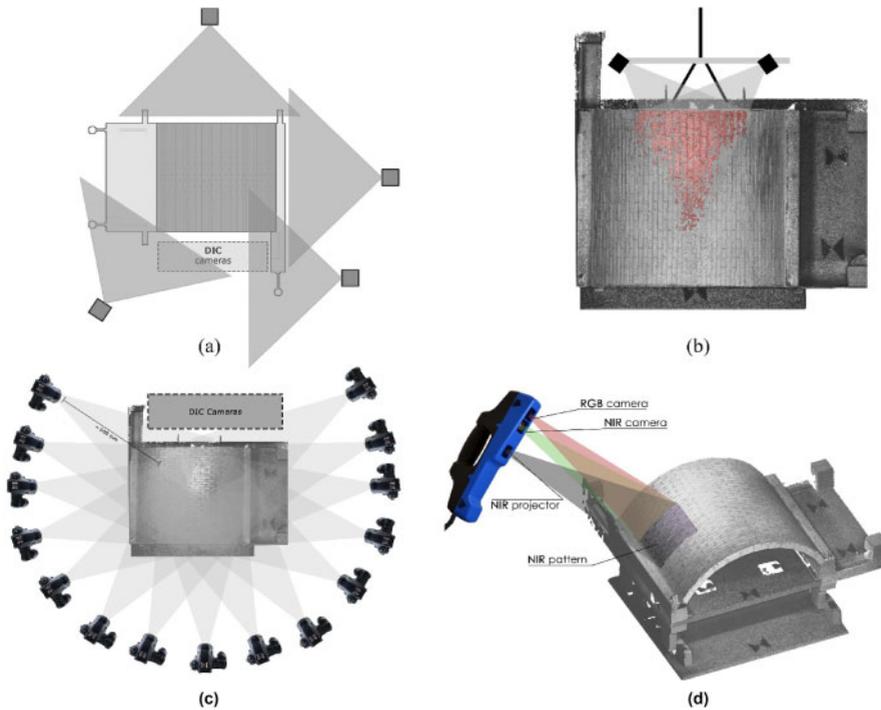
Figure 4. Summary of the adopted acquisition methodologies: (a) GoPro Hero 5 session cameras, (b) DIC cameras, (c) close-range photogrammetry, (d) range-based structured light scanning.

During the tests, the direct observation of the phenomena occurred to the structures is accompanied by the acquisition of relevant data. These acquisitions are performed with contactless solutions to avoid alterations of the test proceeding. A constant video acquisition is performed by four synchronized GoPro Hero 5 session cameras distributed around the vault models (Figure 4a) with the aims of relating the cracking phenomena with the imposed displacement, monitored with

a digital calliper, and capturing the collapse mechanism of the structures. Due to the destructive nature of the tests, three-dimensional data of the models are acquired in several steps of the imposed displacement in order to manage the spatial data of the structures after their failure. Image-based close-range photogrammetry (Figure 4c) and range-based structured light scanning (Figure 4d) solutions are used with these aims, because of their common use in literature in the data acquisition for moveable heritage (Patrucco et al. 2019). At the end of the process, the result obtained is a series of three-dimensional dense point-clouds with an estimated error of about 1 mm. Furthermore, Digital Image Correlation (DIC) is performed, on a little portion of the models (corresponding with the key voussoirs of the vaults) (Figure 4b), for monitoring the three-dimensional deformations of the structures. The data are acquired, as couples of stereoscopic images, by steps of 0.1 mm of imposed displacement. The result obtained is a series of quadrangular meshes with a submillimeter estimated error.

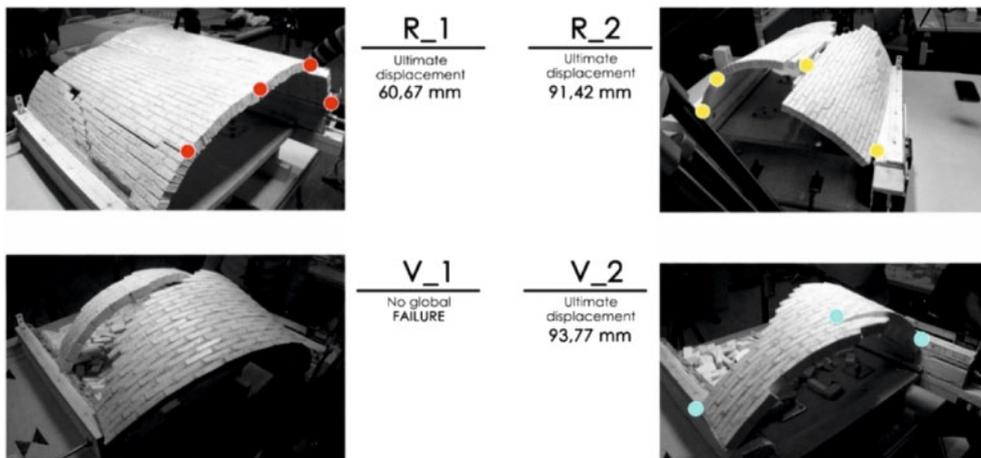
Figure 5. Collapse mechanisms of the tested models.

The high-speed and high-resolution cameras provide images of the collapse mechanisms of the tested models. In Figure 5 a selection of images of the failure, from the most representative perspective, is reported. Differently from arches, vaults involve complex three-dimensional failure mechanisms. The latter are quite different for vaults with different brick pattern, but also between vaults with the same brick arrangement.

The R models show a four-hinge mechanism, even though they reach the collapse at quite different ultimate displacements (60.67 mm in R_1 and 91.42 mm in R_2). The hinges run across the whole depth of the model following the longitudinal joints, with two of them placed at the abutment interface and one in the proximity of the key bricks. On the contrary, the V models show a different behaviour, characterized by the local collapse of some arches and by the rigid rotation of the separated portions of the vault. The rigid rotation of the vault on the abutment is particularly evident in the V_1 model, which reaches the end of displacement range (fixed at 150 mm) without a global failure. The V_2 model collapses at 93.77 mm of imposed displacement with a three-hinge mechanism, developed among the arches still in compression, with the slipping of the structure from one of the abutments.

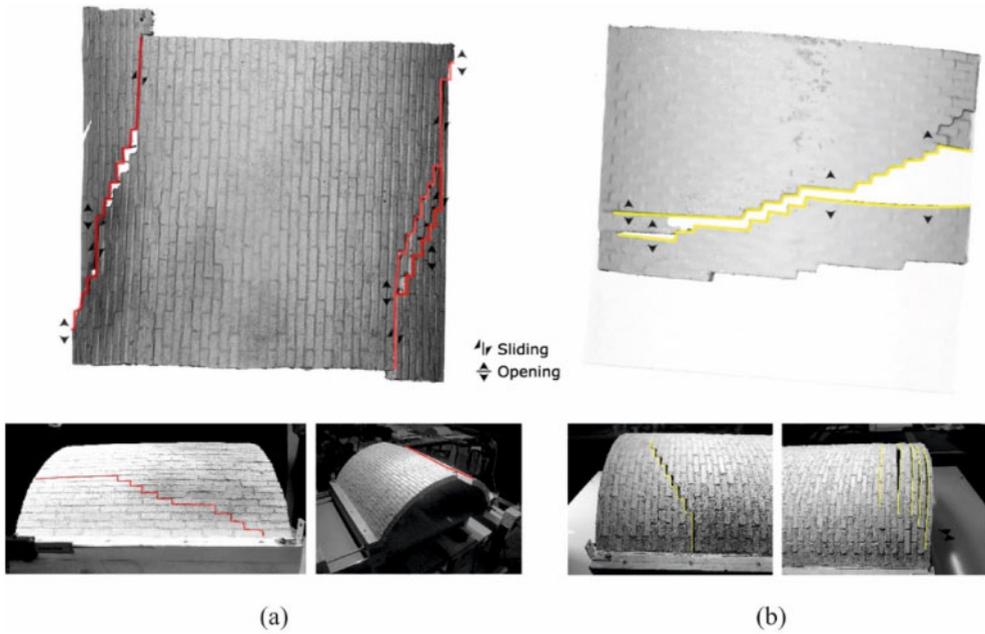
Figure 6. Crack pattern of R (a) and V (b) vaults.

The critical analyses of the crack patterns experienced in the models reveal substantial differences between the two bricks patterns (Figure 6). In the R models most of the cracks are represented by fractures occurring along the longitudinal joints. These major cracks appear to be quite straight

along a single longitudinal joint or inclined involving multiple rows of bricks (Figure 6a). On the other hand, in the V models the major cracks occur in the radial joints, leading to the formation of separate portions of the structure (Figure 6b) that lead to local collapses. Also in V models, the major cracks can assume either straight or inclined directions, reasonably depending on construction issues.

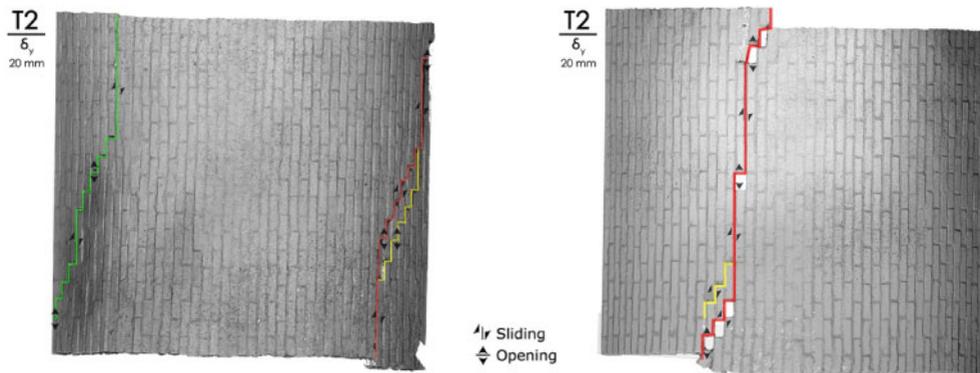
Figure 7. Crack pattern of R_1 (a) and R_2 (b) vaults for imposed displacement of 20 mm.

Besides the described main differences in the crack pattern between vaults arranged with different brick patterns, some minor differences occur between vaults arranged with the same pattern, as clearly visible in Figure 7 for the R_1 and R_2 vaults. Specifically, the major crack position varies due to construction issue, i.e., to the impossibility to perfectly replicate the model construction. In the R_1 vault the two major cracks lead to the separation of the central portion, that starts rotating upon the sliding haunches; in the R_2 model, the major crack along the top of the vaults extrados

leads to a major sliding between the two portions, which cause small local failures near the heads and the rigid rotation of the two haunches upon the abutment, while the contact surface between them is reducing. This difference in the collapse mechanism induces quite different displacement capacity, being the ultimate displacement of the R_2 vault 50% higher than the one of the R_1 vault.

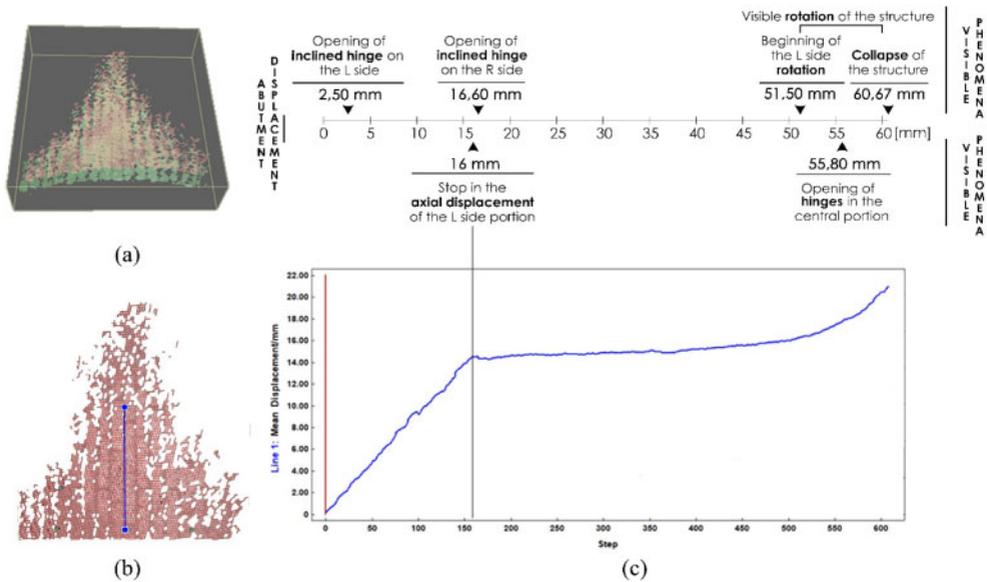
Figure 8. DIC cameras' field of view at step 0 (red) and 244 (green) of the imposed displacement (a), position of the linear strain-gauge (b), time history of mean displacement of the linear strain-gauge on the R1 vault (c).

A deeper insight into the phenomena observed and recorded on each vault during the tests is provided in Figure 8 for the R_1 vault, as an example. In particular, Figure 8 compares the macroscopic visible phenomena reconstructed by direct observation, video acquisition and three-dimensional data managing of the range-based and image-based acquisition techniques at different stages of imposed displacement (Figure 8c top) to the mean displacement of a control linear strain-gauge (Figure 8b, corresponding with the key voussoirs of the vault) versus imposed displacement recorded through DIC (Figure 8c bottom). This comparison shows how the mean displacement linearly increases until the step (about 16 mm) corresponding to the reduction in the axial displacement (y) of the central portion of the vault and to the development of the inclined longitudinal crack that separates the right haunch portion. Then, the mean displacement remains almost constant and start increasing again in correspondence of the step (about 51 mm) when the structure starts rotating until collapse.
