Dynamic Structural Identification of a Portion of the Medieval Defensive Walls of Verona, Italy, Through Ambient Vibration Test

Dynamic Structural Identification of a Portion of the Medieval Defensive Walls of Verona, Italy, Through Ambient Vibration Test / Azzara, R. M.; Tanganelli, M.; Trovatelli, F.; Venini, P.. - In: BUILDINGS. - ISSN 2075-5309. - 16:5(2026), pp. 1-17. [10.3390/buildings16050895]

The study focuses on the results of the analysis of data recorded during Ambient Vibration Tests (AVT) conducted on a portion of the Medieval Walls of Verona (Northern Italy). Seismometric stations were installed both at the top and at the base of the walls, recording the free vibrations of the structure. Spectral analyses provide information about the principal modal frequencies, which are compared with the results obtained through Operational Modal Analysis (OMA) techniques. Numerical models were developed to describe the elastic behavior of the walls and to support the interpretation of the experimentally identified modes. Seismic noise measurements were also performed on the ground to characterize the spectral response of the soil and to estimate the soil–structure interaction. T

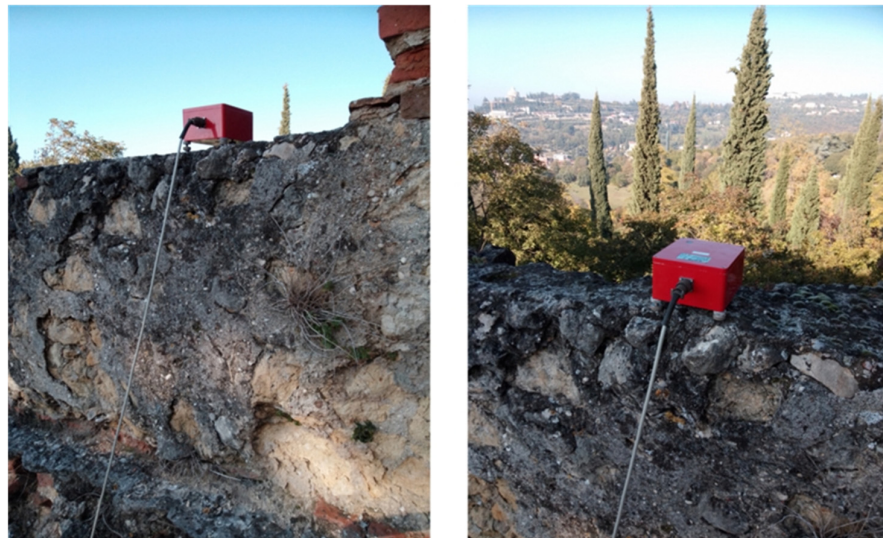
**Figure 1.** Example of a sensor installed on the top of the walls.

The free vibration campaign involved the use of equipment from SARA Electronic Instruments, which includes nine three-axis seismometers with eigenfrequencies of 2.0 and 4.5 Hz, coupled to 24-bit Digital Acquisition Systems (DAS). Using a forklift, the sensors were positioned on top of the Walls and connected to the DAS on the ground via a cable (Figure 1). Each device was synchronized through a GPS connection.

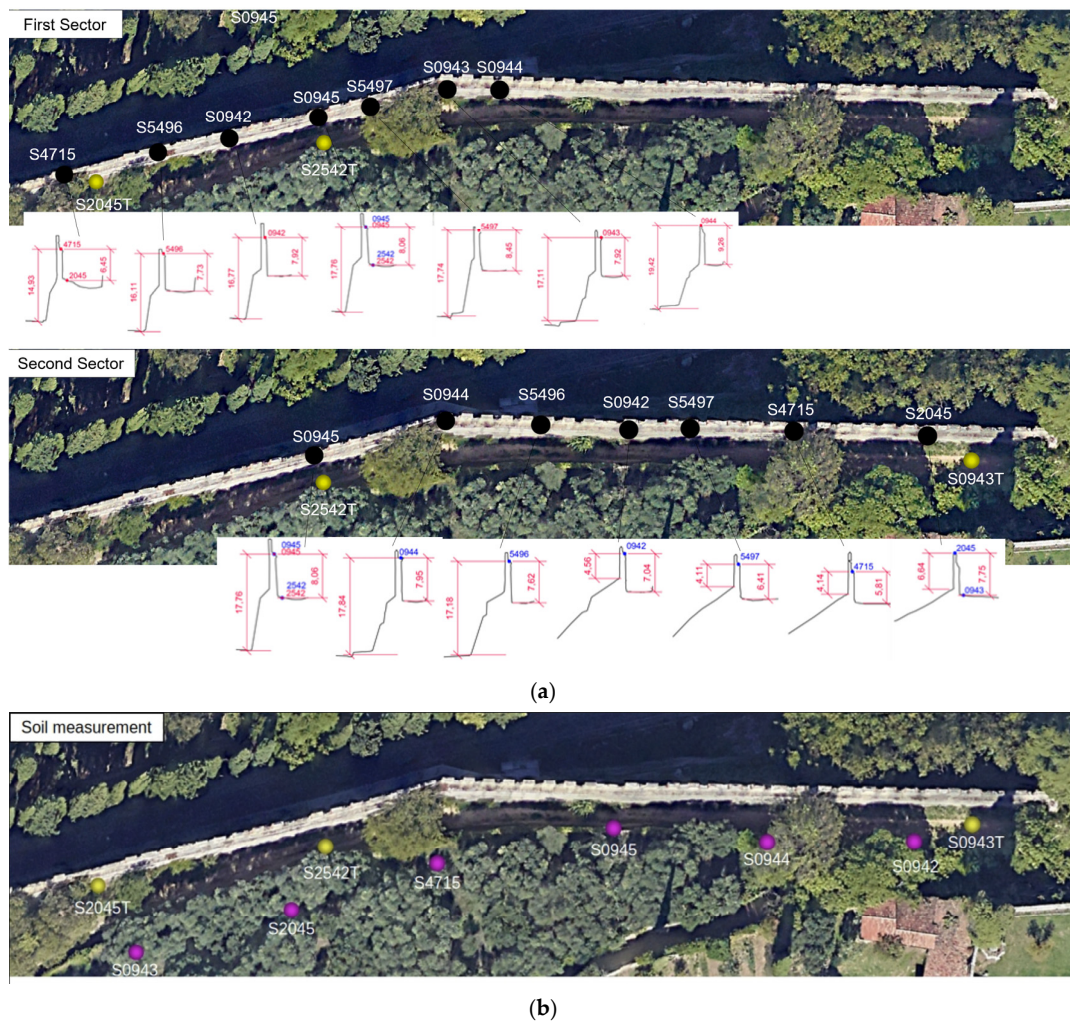
**Figure 2.** (a) Measurement points on the Walls during the two days (black circles); for each point, the corresponding cross-section of the Walls is shown. At the top is shown the first sector monitored during the first day; at the bottom, the second sector. In yellow the seismic stations installed at the base of the Walls during the first and second experiments. (b) Map of the seismic stations installed on the ground on the third day of measurements (in magenta); in yellow, those installed at the base of the Walls during the first and second experiments.

To characterize the elastic properties of the ground, seismic noise measurements were performed on the surrounding terrain on the third day. Figure 2a shows the location of the measurement points on the Walls; Figure 2b shows the distribution of the measurement points on the terrain.

During the first day, the sector between the SW bastion and the point where the Walls bend towards NE was monitored (first sector in Figure 2a), and the following section was monitored on the second day. At the beginning and end of each sector, two seismic stations (in yellow in Figure 2) were installed at the base of the Walls, to be used as a reference on the ground.

The sensor spacing on the Walls was optimized to not exceed 15 m, with the aim of obtaining a good spatial resolution for defining the modal shapes of the structure. The three-axis velocimeters were oriented so that at each point the X-axis corresponded to the longitudinal direction of the Walls (in-plane) and the Y-axis to the transverse direction (out-of-plane), in the direction of the public park (Figure 1). The data, sampled at 100 sps, were recorded for three hours during each experiment. Before proceeding with the analysis, the data were corrected for the instrumental curve.

Simultaneously with the measurements on the Walls, seismic ambient noise was recorded on the ground. The position of the seismic station installed at the base of the Walls is depicted in yellow in Figure 2a,b.

After the experiment on the Walls, a third experiment was performed on the ground (Figure 2b): six 2.0 Hz seismometers were installed along a linear profile parallel to the Walls, along the path that runs alongside them at a distance of approximately four meters, oriented in the same direction as the stations installed on the Walls.

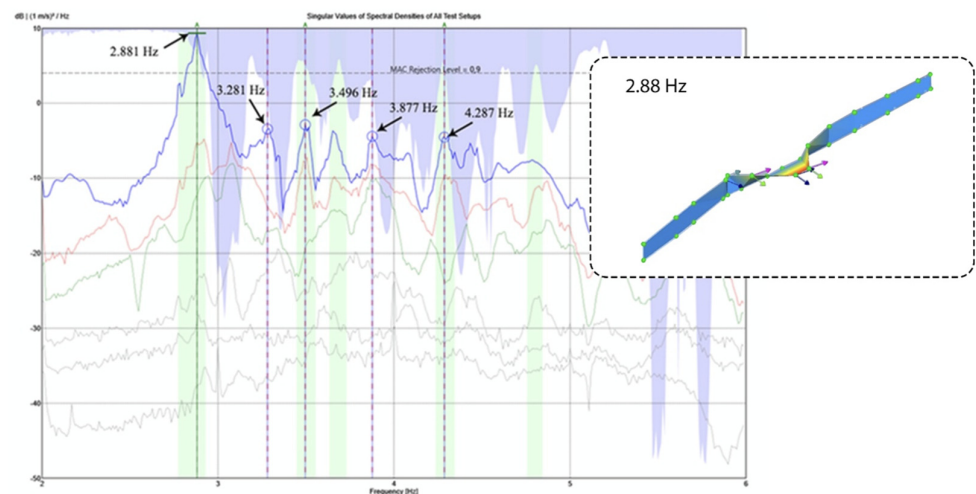
**Figure 13.** Average spectrum for the model of the second sector of the Walls; the average spectrum (FDD), highlighted in green, is the 2.88 Hz main frequency. The spectral domain ranges from 2 to 6 Hz. The insert corresponds to the mode shape associated with the main frequency.

For this reason, an additional analysis was conducted, taking into account only the last monitoring point of the first section of the Walls and all the points of the second segment. Figure 13 shows the results for this additional model.

Also in this case, the 2.88 Hz mode clearly emerges, relating to the initial segment of the second sector, characterized by an out-of-plane motion and corresponding to the highest area of the Walls, as can be recognized from the associated modal shape.
