REINFORCEMENT DESIGN AND CONTROL OF ROCK SLOPES ABOVE TUNNEL PORTALS IN NORTHERN ITALY

O. Del Greco¹, C. Oggeri²

Abstract: The stability features of slopes located above the portals of tunnels along important roads are here presented, together with two examples for reinforcement and protection works. The investigation phase and the reinforcement works have considered also the purpose of avoiding the interruption of the traffic when this would cause unacceptable consequences. The first case refers about the construction of a portal along a narrow and steep valley in a volcanic rock formation. The control of the vibration of the blasting action has been carried out for the period of the excavation in order to foresee the occurrence of potential dangerous situations. The second is the case of the portal of the East access to the Highway n.10. Even though the adits are protected by two portals, the occurrence of rock and debris falls from the upper part of the mountain could create a dangerous situation. Above the portals the morphology of the slope is characterized by two subvertical rock slopes, which are separated by an intermediate zone of debris material.

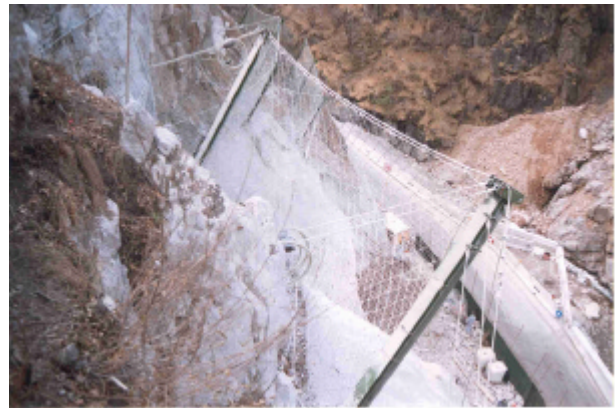
Figure 1. *View from the upper part of the rock slope: some net fences are visible and in the right side the existing road.*

One of the adits was arranged with limited excavation at the external part of the steep and high rock slope, with heavy reinforcement of the rock mass and with the installation of passive protection; the rock reinforcement has been made by means of rock bolting and wire mesh, sometime coupled with shotcrete, while the passive protection has been made of net fences.

In the area surrounding the adit also some detritic surface formation occurred and for this reason the remedial works were made of wire mesh and bolting (for the fractured rock mass) and net fences (for the debris protection).

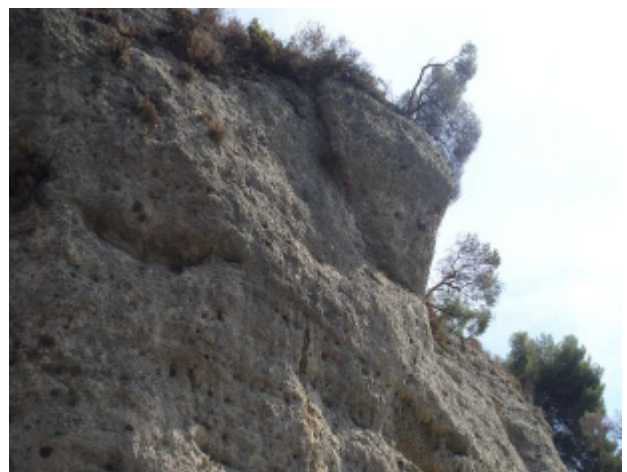
Figure 5. Detail of the unstable element (ref.3 in fig.4)

- a rock volume in the highest part of the slope, above the southern portal, delimited by an extremely dipping fracture; at its base this volume appears to be at least partially connected to the continuous rock mass. The base discontinuity is open, although the exact geometry and persistence are not known precisely. The discontinuity can represent the surface of possible sliding of the entire rock block. The volume of this bloc can be evaluated as $110-120 \text{ m}^3$; its detachment, with sliding and collapse phenomenon, would involve at first the intermediate detritic slope and afterward directly the motorway lanes;

The surface of the 110 m³ rock volume will be temporarily consolidated with a harness of cables and will also be arranged for the possible removal of the blocks through slice cutting using a diamond wire cutter and removal with hoists towards the summit of the slope; this choice was made to allow a progressive improvement of the safety of the slope.
