REINFORCEMENT DESIGN AND CONTROL OF ROCK SLOPES ABOVE TUNNEL PORTALS IN NORTHERN ITALY

O. Del Greco¹, C. Oggeri²

Abstract: The stability features of slopes located above the portals of tunnels along important roads are here presented, together with two examples for reinforcement and protection works. The investigation phase and the reinforcement works have considered also the purpose of avoiding the interruption of the traffic when this would cause unacceptable consequences. The first case refers about the construction of a portal along a narrow and steep valley in a volcanic rock formation. The control of the vibration of the blasting action has been carried out for the period of the excavation in order to foresee the occurrence of potential dangerous situations. The second is the case of the portal of the East access to the Highway n.10. Even though the adits are protected by two portals, the occurrence of rock and debris falls from the upper part of the mountain could create a dangerous situation. Above the portals the morphology of the slope is characterized by two subvertical rock slopes, which are separated by an intermediate zone of debris material.

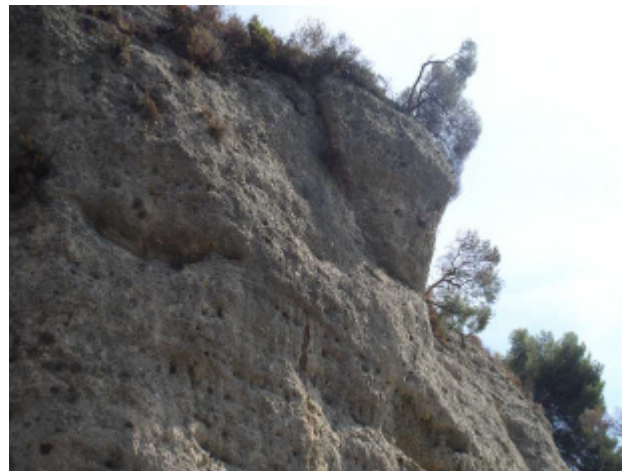
Figure 5. Detail of the unstable element (ref.3 in fig.4)

The surface of the 110 m³ rock volume will be temporarily consolidated with a harness of cables and will also be arranged for the possible removal of the blocks through slice cutting using a diamond wire cutter and removal with hoists towards the summit of the slope; this choice was made to allow a progressive improvement of the safety of the slope.

Finally, a monitoring of the main fractures close to these volumes is foreseen for any possible emergency interventions. This monitoring is based on measurements using crack gauges and load cells
