Reinforcement design and control of rock slopes above tunnel portals in Northern Italy

# REINFORCEMENT DESIGN AND CONTROL OF ROCK SLOPES ABOVE TUNNEL PORTALS IN NORTHERN ITALY

**Abstract:** The stability features of slopes located above the portals of tunnels along important roads are here presented, together with two examples for reinforcement and protection works. The investigation phase and the reinforcement works have considered also the purpose of avoiding the interruption of the traffic when this would cause unacceptable consequences. The first case refers about the construction of a portal along a narrow and steep valley in a volcanic rock formation. The control of the vibration of the blasting action has been carried out for the period of the excavation in order to foresee the occurrence of potential dangerous situations. The second is the case of the portal of the East access to the Highway n.10. Even though the adits are protected by two portals, the occurrence of rock and debris falls from the upper part of the mountain could create a dangerous situation. Above the portals the morphology of the slope is characterized by two subvertical rock slopes, which are separated

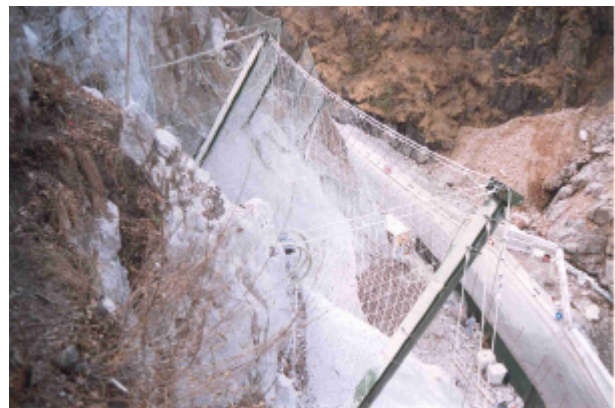
Figure 1. *View from the upper part of the rock slope: some net fences are visible and in the right side the existing road.*

One of the adits was arranged with limited excavation at the external part of the steep and high rock slope, with heavy reinforcement of the rock mass and with the installation of passive protection; the rock reinforcement has been made by means of rock bolting and wire mesh, sometime coupled with shotcrete, while the passive protection has been made of net fences.

In the area surrounding the adit also some detritic surface formation occurred and for this reason the remedial works were made of wire mesh and bolting (for the fractured rock mass) and net fences (for the debris protection).

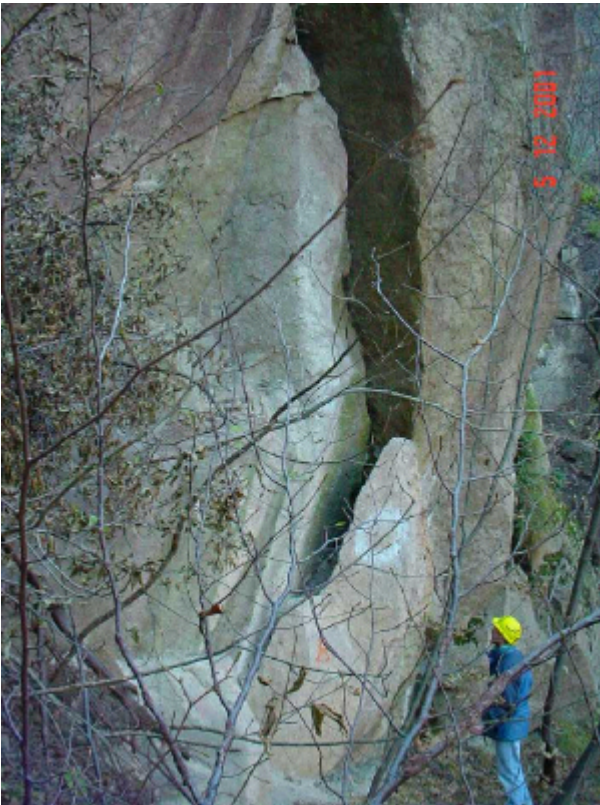
Figure 2. Detail of the rock mass structure 30 m above the tunnel portal.

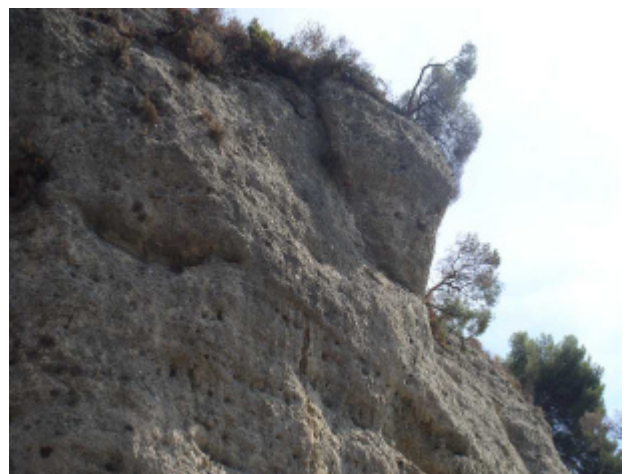
Figure 5. Detail of the unstable element (ref.3 in fig.4)

The surface of the 110 m<sup>3</sup> rock volume will be temporarily consolidated with a harness of cables and will also be arranged for the possible removal of the blocks through slice cutting using a diamond wire cutter and removal with hoists towards the summit of the slope; this choice was made to allow a progressive improvement of the safety of the slope.

Finally, a monitoring of the main fractures close to these volumes is foreseen for any possible emergency interventions. This monitoring is based on measurements using crack gauges and load cells
