The mechanical resistance of saturated stones

The mechanical resistance of saturated stones / Marini, P., Bellopede, R.. - ELETTRONICO. - (2010). (Global Stone Congress 2010 Alicante (ES) 2-5 marzo 2010).

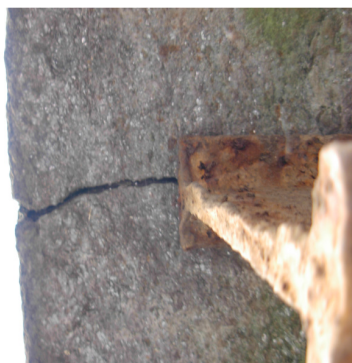
Figure 3: Details of a balcony where the beam leans in correspondence to a fracture.
