The mechanical resistance of saturated stones

Availability:

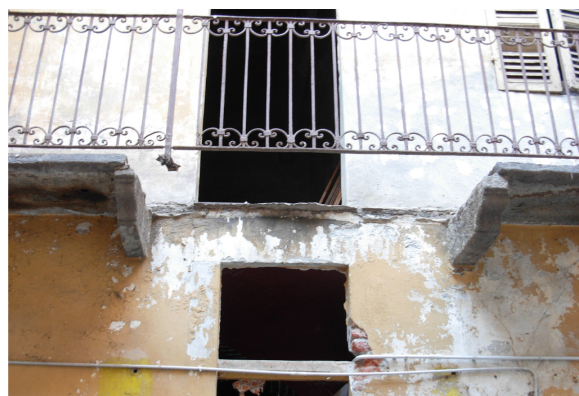
Figure 1: The remains of a balcony in Pietra di Courtil.

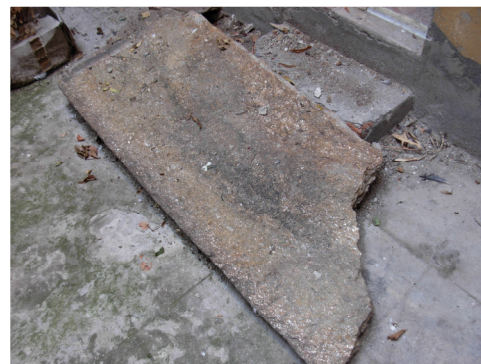
Figure 2: The broken balcony slab of figure 1.

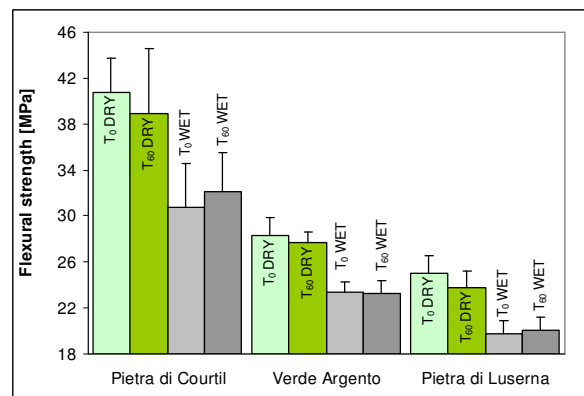
Figure 5: Flexural strength results in dry and wet conditions at T_0 and T_{60} ageing steps.
