The mechanical resistance of saturated stones

Availability:

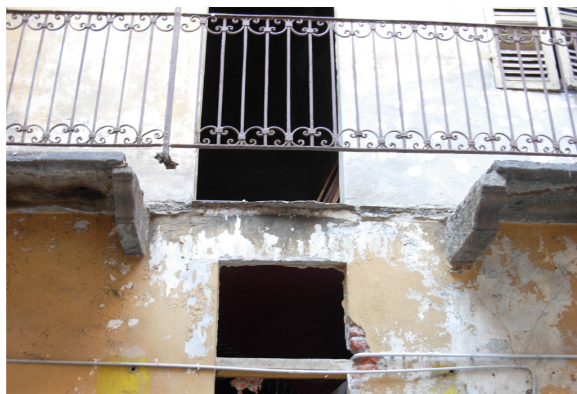
Figure 1: The remains of a balcony in Pietra di Courtil.

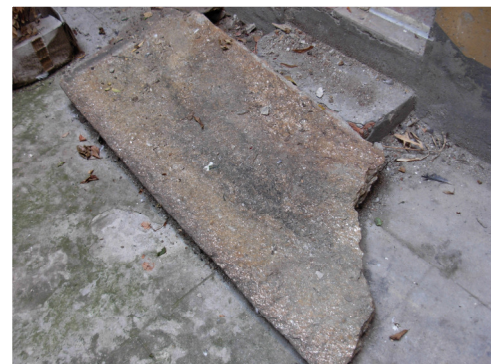
Figure 2: The broken balcony slab of figure 1.

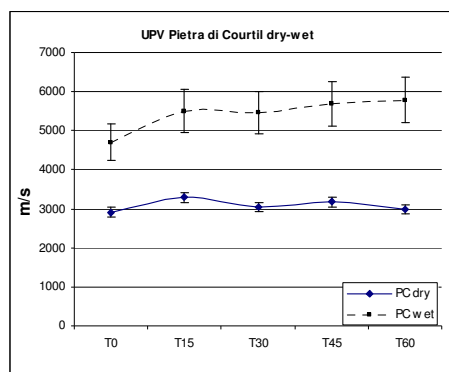
Figure 4: UPV (indirect method) on Pietra di Courtil in wet and dry conditions for each ageing step.

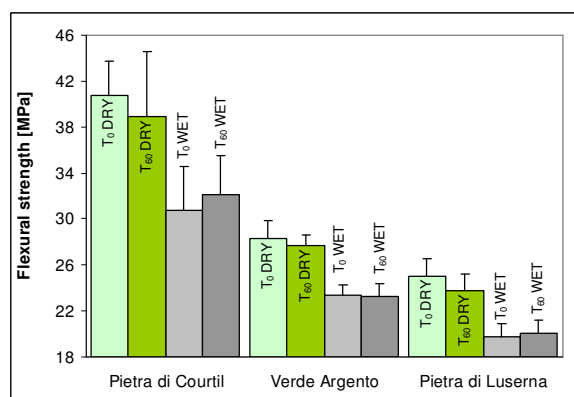
Figure 5: Flexural strength results in dry and wet conditions at T_0 and T_{60} ageing steps.
