AGEING CHARACTERIZATION OF EXHAUST FLEXIBLE COUPLINGS

Francesca Curà^(*), Andrea Mura, Raffaella Sesana

Department of Mechanics, Politecnico di Torino, Torino, Italy

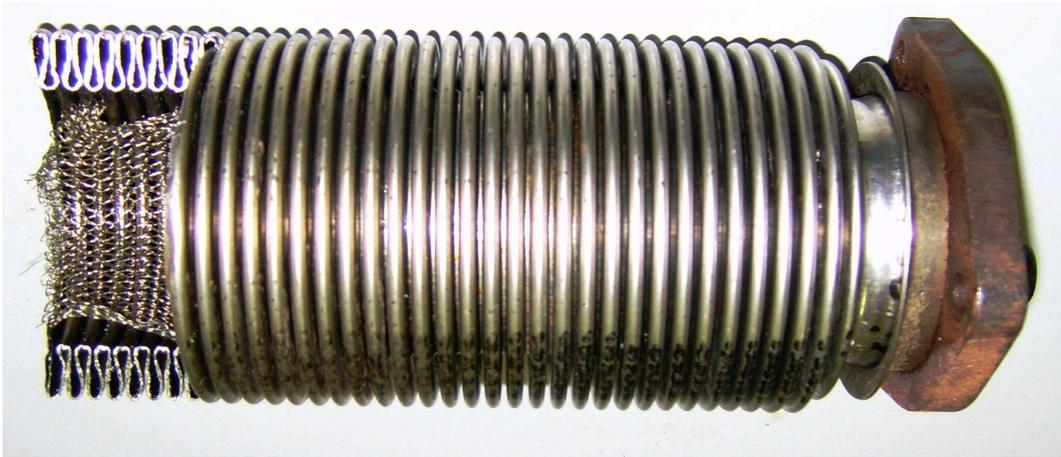
The flexible exhaust coupling, represented in Figure 1, is composed of two metal layers. All components tested in this work have the same shape geometry and dimensions, but they are made using different materials: three stainless steels (AISI 309, AISI 321, AISI 316 Ti) and a nickel alloy (Incoloy 825). In this work five kinds of flexible exhaust couplings have been tested, four made of a single material, respectively AISI 309, AISI 321, AISI 316 Ti and Incoloy 825, and one made of two materials Incoloy 825 and AISI 321.

Fig.1 Flexible exhaust coupling

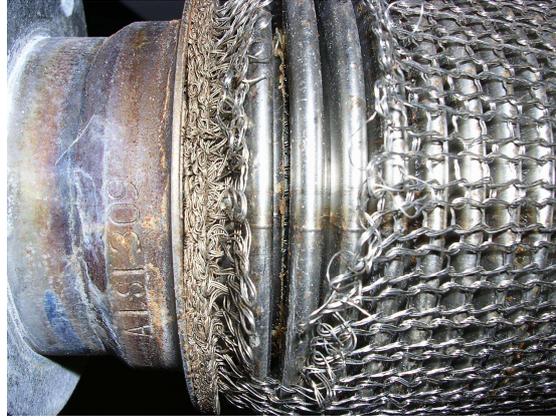
In this work totally 39 components have been tested. During the aging tests many mechanical failures occurred on the components, as an example Figure 2 shows a fatigue crack occurred on an AISI 309 component.

Fig.2 Fatigue crack on a AISI 309 component

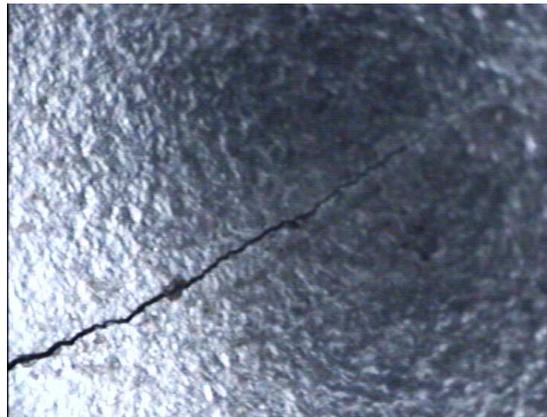
Figure 3 shows a detail (400X magnification) of a crack growth of an AISI321 component.

Fig.3 Fatigue crack propagation on a AISI 321 component (400X magnification)

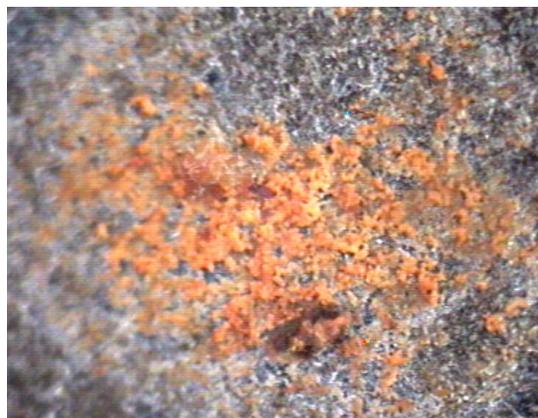
As an example, Figure 4 shows a particular of general corrosion on an AISI 309 component, and Figure 5 shows pitting corrosion phenomena on AISI 321 component.

Fig.4 General corrosion on a AISI 309 component (800X magnification)

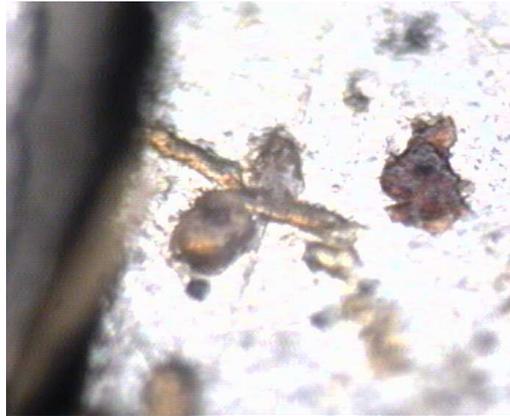
Fig.5 Pitting on a AISI 316Ti component (800X magnification)

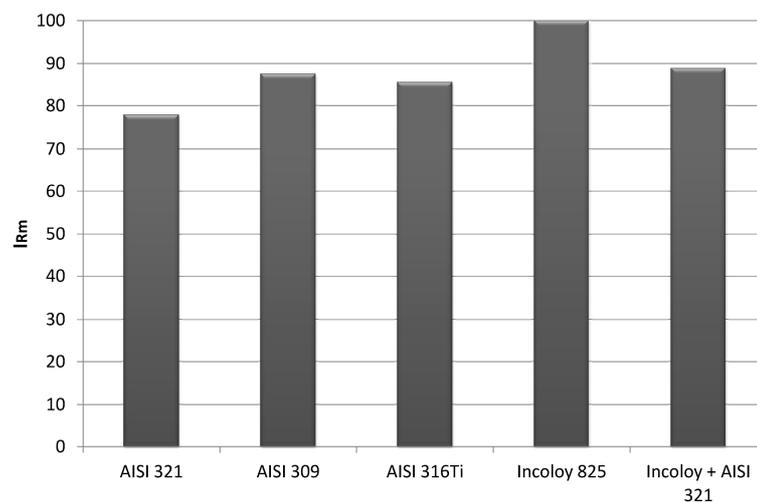
Figures 6 to 10 show respectively the tensile strength, the yield strength, low cycle fatigue, corrosion, and cost normalised indexes.

Fig.6 Tensile strength index I_{Rm}

Tensile strength index I_{Rm} has been calculated by the following expression:

$$I_{Rm} = (R_{mTe} - \sigma_{ref}) + (R_{m500} - \sigma_{ref}) \quad (1)$$

where: R_{mTe} is the ultimate tensile stress of the material at room temperature, R_{m500} is the ultimate tensile stress at 500°C temperature, and σ_{ref} is the stress applied at the component during the ageing procedure.

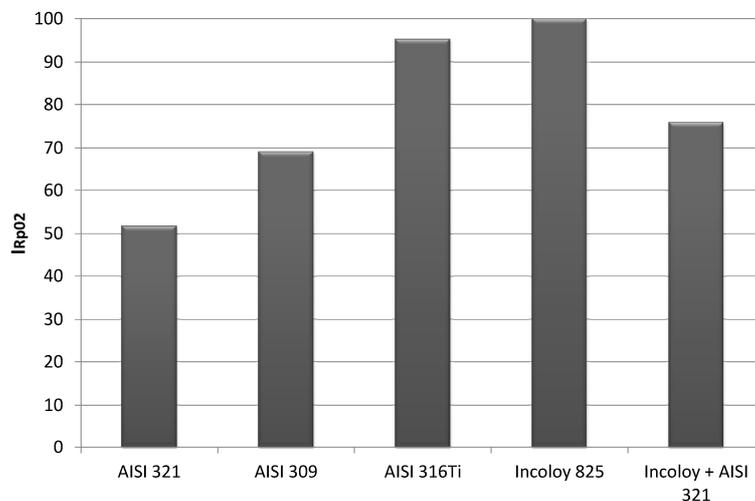
Fig.7 Yield strength index I_{Rp02}

Yield strength index I_{Rp02} has been calculated by the following expression:

$$I_{Rp02} = \frac{R_{p02Te} + 2 \cdot R_{p02500}}{3} \quad (2)$$

where: R_{p02Te} is the yield strength of the material at room temperature, R_{p02500} is the yield strength at 500°C temperature.

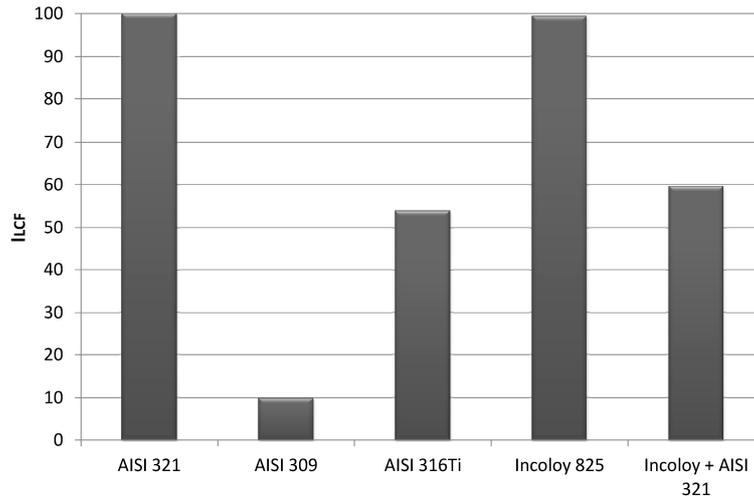
Fig.8 Low cycle fatigue index I_{LCF}

The low cycle fatigue index I_{LCF} has been calculated by the following expression:

$$I_{LCF} = 3.5 \left(\frac{R_{mTe}}{E} \right) N^{-0.12} + \Delta Z \cdot N^{-0.6} \quad (3)$$

where E is the young's modulus of the material, ΔZ is the necking deformation of the material and N is the number of cycle when the component presents any mechanical failure.

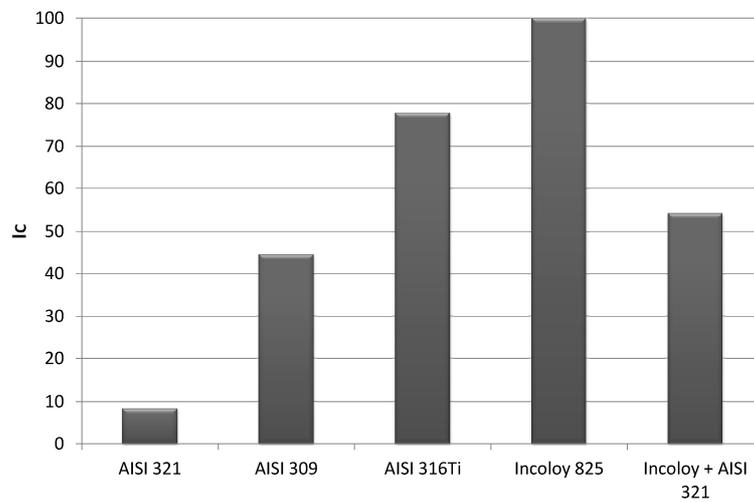
Fig.9 Corrosion index I_C

The corrosion index I_C has been obtained considering four kinds of corrosion phenomena: general corrosion, intergranular corrosion, pitting corrosion and hot salt corrosion. For each corrosion phenomena, two penalties have been assigned: one representing the level of danger related to the corrosion and the other concerning the entity of the corrosion attack, according to Table 2.

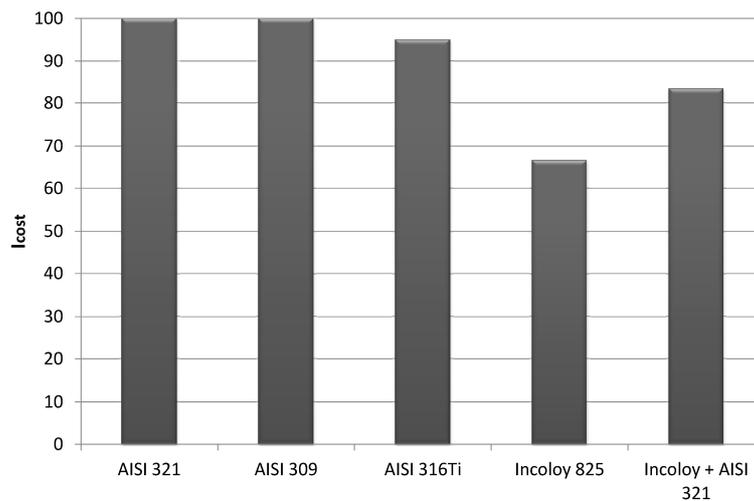
Fig.10 Cost index I_{cost}

The cost index I_{cost} has been obtained considering the material costs and normalising by the maximum cost value.

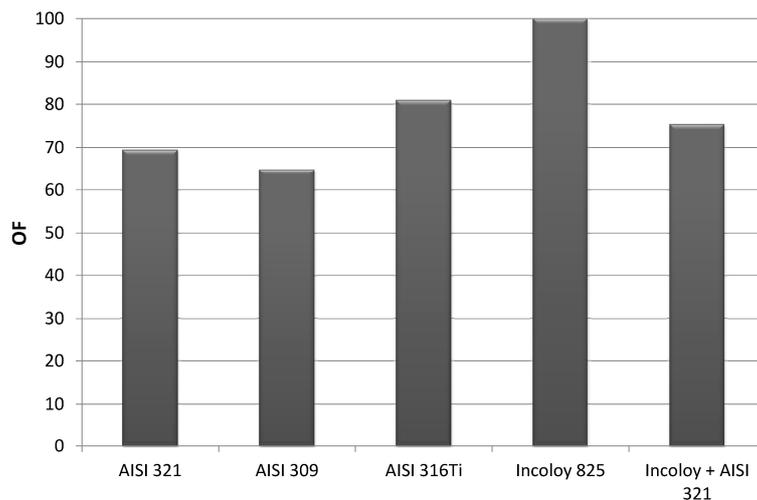
Figure 11 shows the final ranking of the analysed components. Components made of Incoloy 825 have the best scores given by CTQs analysis.

Fig.11 Final ranking of analyzed components

The ranking of analysed materials is obtained by means of the target function OF. The OF function is calculated by multiplying the normalized values of the indexes $CTQs_i$ with the associated weight C_i :

$$OF = \sum_i C_i \cdot CTQs_i \quad (4)$$

Weights considered in this work are: $C_{Rp02} = 1$; $C_{Rm} = 1$; $C_{LCF} = 2$; $C_C = 3$; $C_{cost} = 3$.
