## AGEING CHARACTERIZATION OF EXHAUST FLEXIBLE COUPLINGS

Francesca Curà<sup>(\*)</sup>, Andrea Mura, Raffaella Sesana

Department of Mechanics, Politecnico di Torino, Torino, Italy

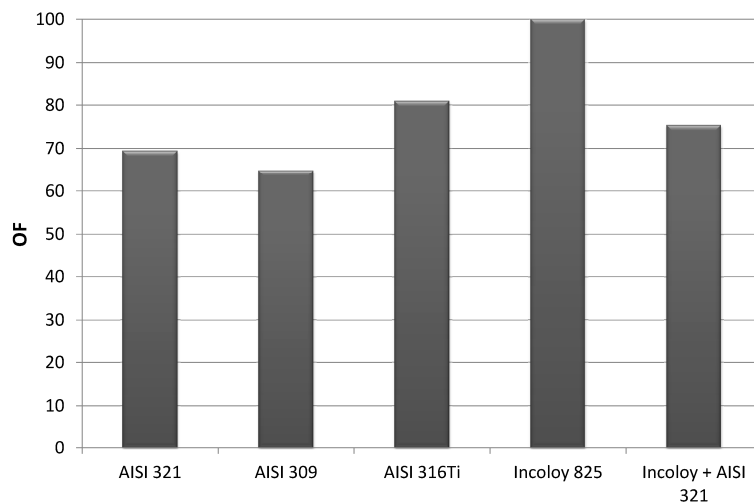
Figure 11 shows the final ranking of the analysed components. Components made of Incoloy 825 have the best scores given by CTQs analysis.

Fig.11 Final ranking of analyzed components

$$OF = \sum_i C_i \cdot CTQs_i \quad (4)$$

Weights considered in this work are:  $C_{Rp02} = 1$ ;  $C_{Rm} = 1$ ;  $C_{LCF} = 2$ ;  $C_C = 3$ ;  $C_{cost} = 3$ .
