A new experimental snow avalanche test site at Seehore peak in Aosta Valley (NW Italian Alps) – Part II: Engineering aspects

A new experimental snow avalanche test site at Seehore peak in Aosta Valley (NW Italian Alps) – Part II: engineering aspects

Keywords Avalanches dynamics; small and medium avalanches; experimental site; NW Italian Alps

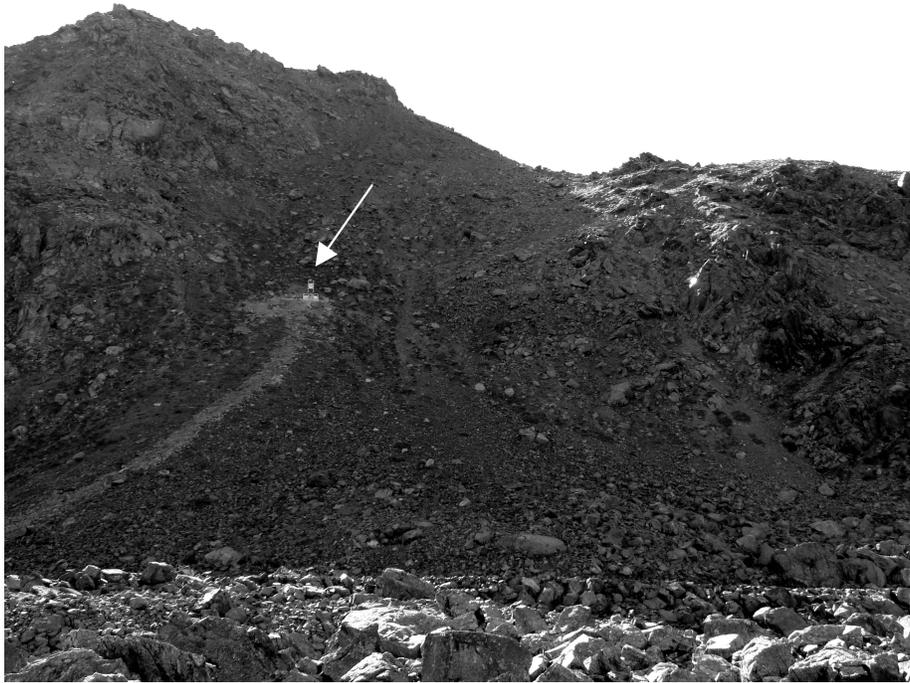
Figure 2: Frontal view of the test site in summer. The arrow marks the obstacle position.

Close to the location of the instrumented obstacle the following types of coverage were observed (see Figure 2):

- Gravitational deposits of a scree and an alluvial fan: it is mostly very coarse material, consisting of angular blocks typically of decimetre size, but also larger, practically without fine matrix, at least on the surface;
- Accumulation of rockfall blocks: these are very coarse deposits, sometimes with metric-sized blocks.

The obstacle and the measurement systems rest on a concrete slab 3 m long by 3 m wide and 0.6 m thick, placed approximately in the position shown in Figure 2. They were designed to resist the impact of avalanches running along the path and to measure velocity and impact forces. The foundation was embedded so that it emerges only 0.6 m from the natural slope. Gabions filled with material readily available on site were used to support the excavation; this choice helped to minimize the environmental impact, also reducing the amount of concrete to be cast in place (Figure 3).

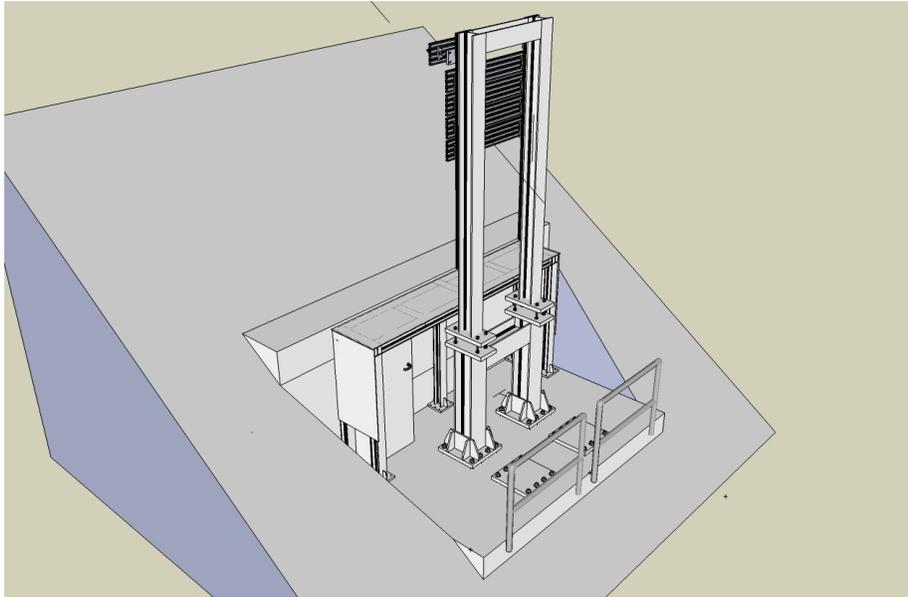
Figure 3: Sketch of the platform with the obstacle and the shed behind.

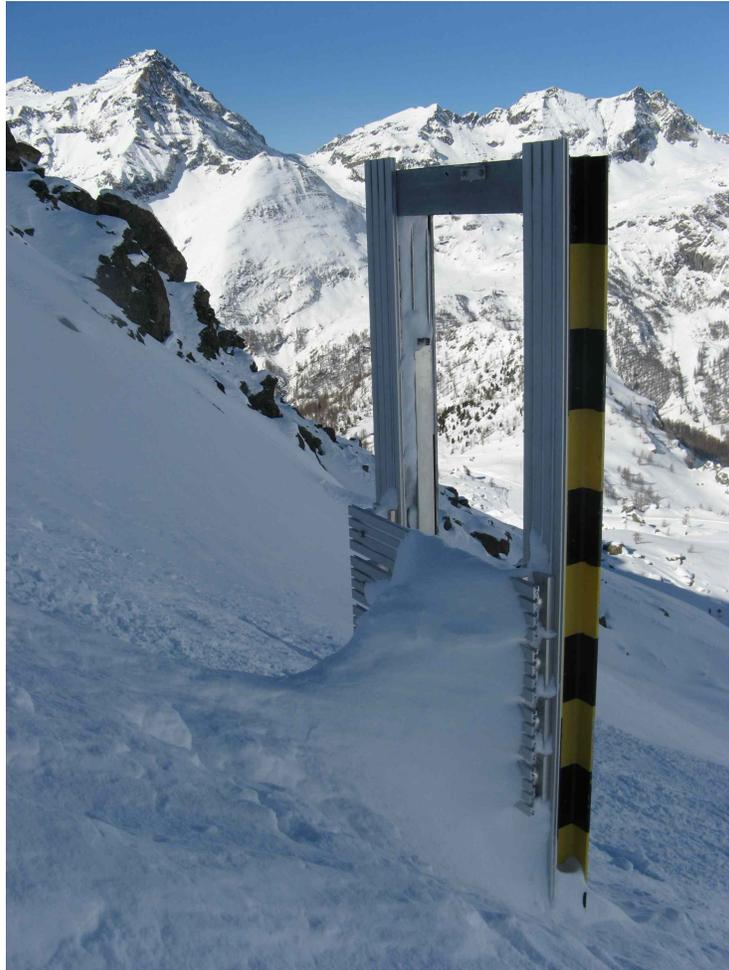
Figure 4: View of the obstacle after an avalanche event. Only the upper part of the steel structure emerges from the snowpack.

The following main parts were assembled (Figure 4):

1. a vertical obstacle made of galvanized steel profiles (4.0 m high, protruding 2.8 m from the natural slope profile), consisting of a lower section bolted to the concrete foundation, serving as a support for the upper part which carries the sensors, directly exposed to the avalanche impact;
2. a sealed electric cabinet that hosts the acquisition and control systems, terminal of the power supply line and of the optical fiber of the data transmission line, connected to the upper station of the Staffal-Gabiet cableway;
3. a galvanized steel shed that protects the cabinet from the direct impact of the avalanches and provides also a walking surface to reach the upper part of the obstacle for inspection and maintenance works.

The impact surface is made of an array of 5 aluminum grooved plates placed at different heights, each one supported by two load transducers, which are connected to the structure. The load transducers are, in turn, mounted on slides that can be easily moved along vertical guides: this design permits their positioning at the desired height above the ground level. The total area of the impact plates is 1 m² (Figure 4).

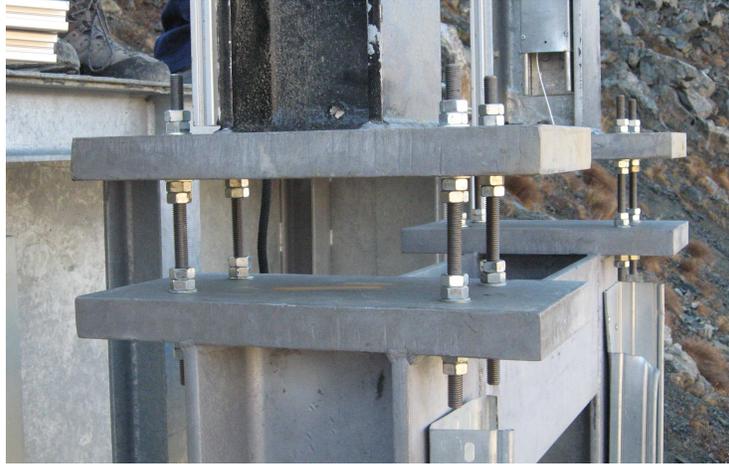
Figure 5: Detail of the load limiter device linking the two parts of the obstacle.

To ensure adequate safety margins to the platform in all the operating conditions, the decision was made to limit the load on the foundation, by sacrificing the structural integrity of the instrumented obstacle when an impact force would reach the prescribed limit value. To this purpose, the link between the lower and upper parts of the obstacle was designed as a weak point with a predefined limit load (Figure 5). The design followed the rules of capacity design, i.e., the increasing loads activate a prescribed sequence of failure mechanisms. According to these principles, the design of the structure is calibrated in such a way that the foundation would always be safe, even under extreme events.

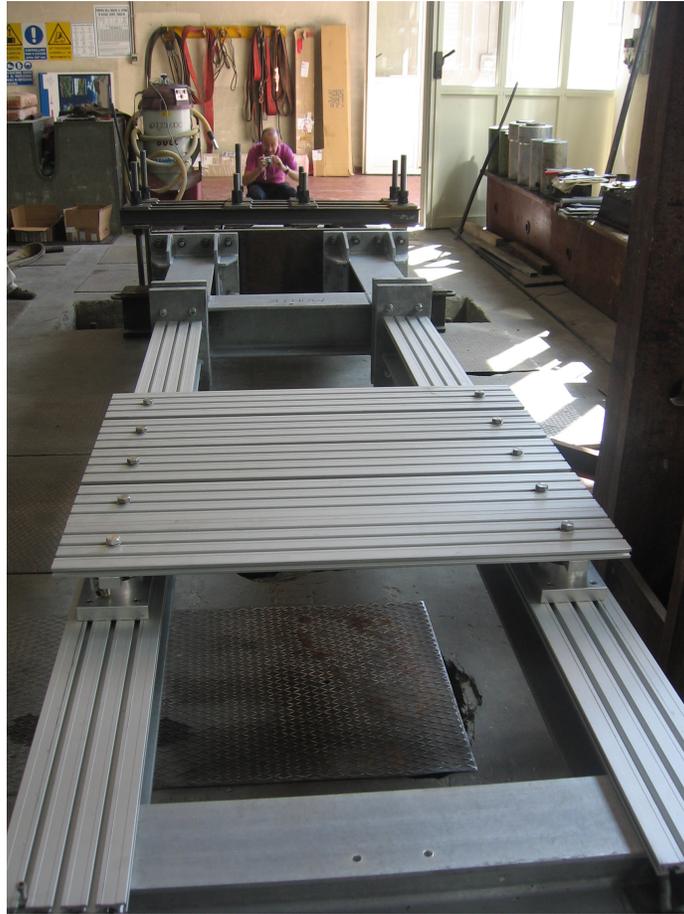
Figure 6: The obstacle mounted in horizontal position as tested in the laboratory.

In order to validate the design assumptions, a number of tests have been carried out at the laboratory of structural mechanics of the Department of Structural, Geotechnical and Building Engineering of the Politecnico di Torino. The complete structure had been assembled within a specially built testing frame in order to place the obstacle in a horizontal position (Figure 6).

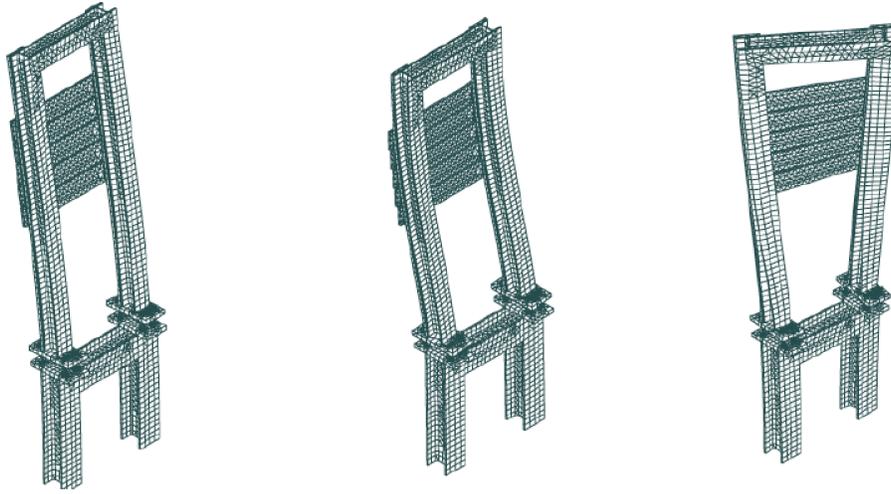
Figure 7: First three modes of vibrations, corresponding to the lowest frequencies, obtained through a numerical simulation.

In particular, experimental modal analysis has been performed in order to assess the dynamic properties of the obstacle and to validate the results obtained from numerical analyses (Figure 7), performed with the finite element code ADINA (ADINA R&D, Inc. (2012)).

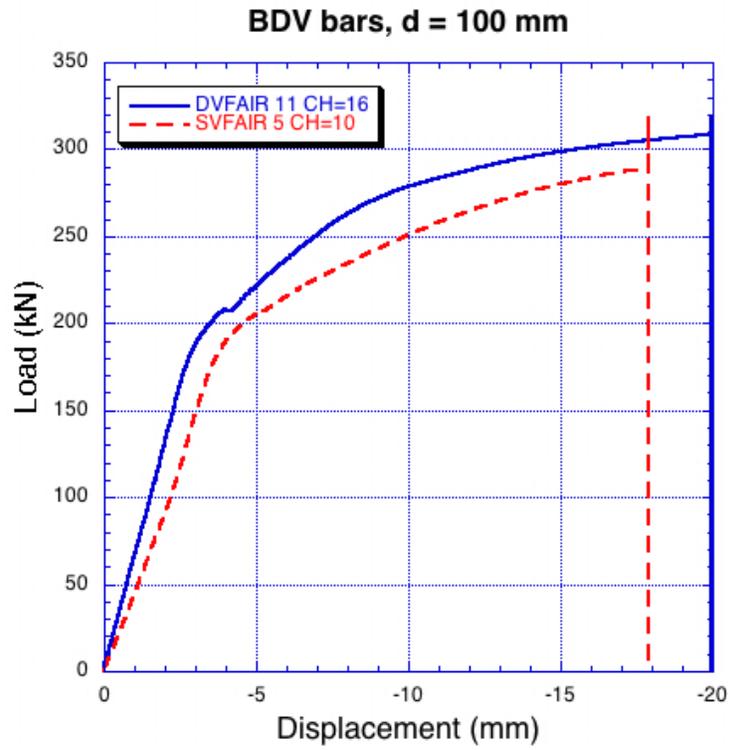
Figure 8: Total load vs. relative displacement for left (dashed) and right (solid) load limiter device (distance of load limiter plates equal to 100 mm).

In addition, static tests leading to failure of the load limiter device have been conducted, simulating different real loading conditions. Some results are presented in Figure 8, where the total load applied by the testing machine on the obstacle is plotted against the relative displacement of the load limiter plates. Such tests have been carried out for different distances of the load limiter plates, i.e., for different length of the steel bars linking the lower and the upper

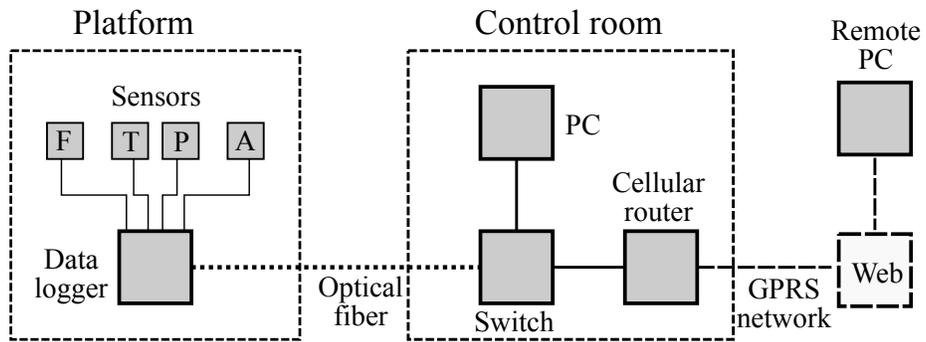
Figure 9: Block diagram of the communication network of the system. F, T, P, A denote the physical quantities measured by the groups of sensors: force, temperature, atmospheric pressure, acceleration, respectively.

The system conceived to fulfill the design tasks were divided logically into two main parts, namely, 1) the measuring and data logging part, located on the platform, near or onto the obstacle; 2) the data storage and control in a remote room, safe and easily accessible. The two parts are physically connected by a power line and an optical fiber for data transmission, both lying in a buried PVC duct, which ensures a permanent and reliable link. The control room is also connected, via cellular network, to the Internet, providing the possibility of remote operations. A scheme with the connections between the parts of the system is shown in Figure 9.

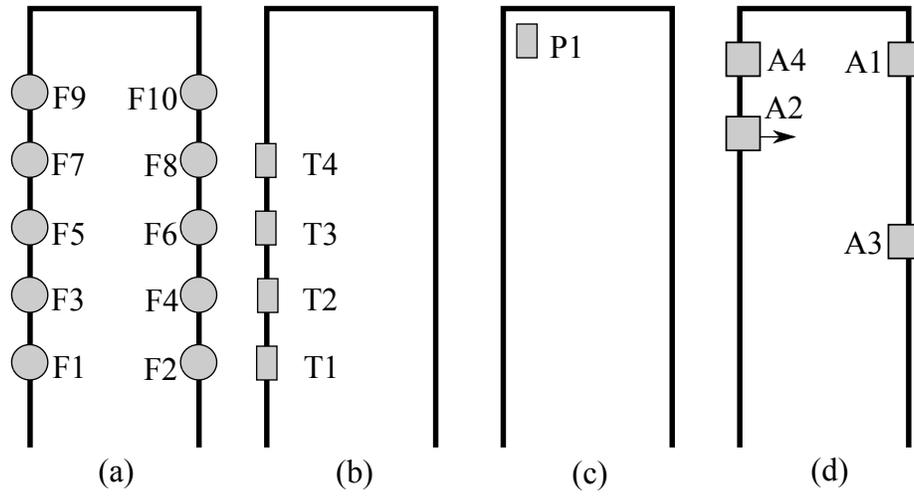
Figure 10: Schematic of the position of the sensors on the upper part of the obstacle, as seen looking downslope. Transducers of force (a), temperature (b), atmospheric pressure (c), acceleration (d).

In principle, any type of devices that measure physical quantities of the impacting avalanches can be installed on the obstacle. The present setup of the measuring system enables the measurement of the impact forces and of the acceleration of the resisting structure. A scheme of the installed sensors is shown in Figure 10.

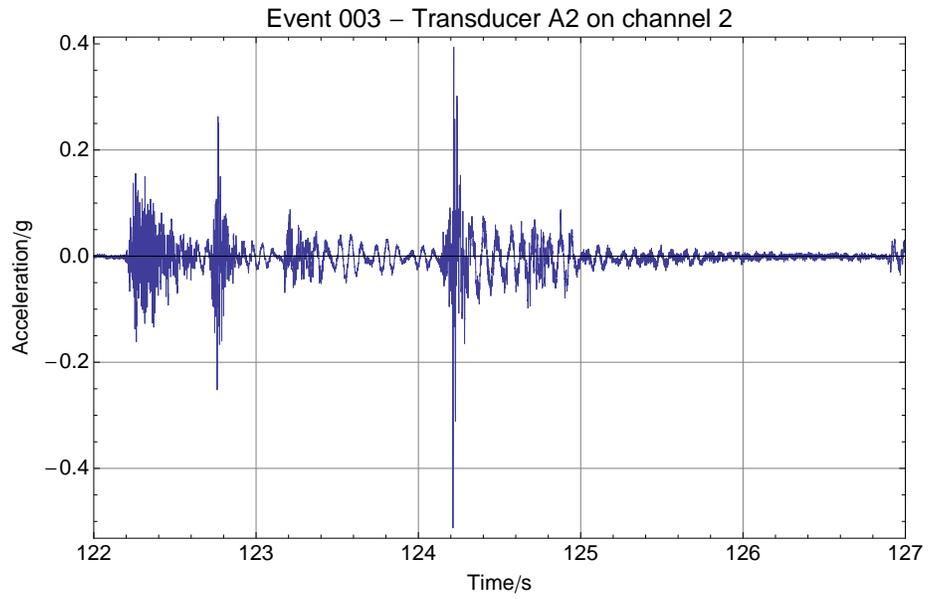
Figure 11: Example of measurements of acceleration plotted vs. elapsed time for an artificially triggered avalanche.

An example of the recorded data is shown in Figures 11 and 12, where the signals obtained from two sensors (an accelerometer and a load transducer), converted to engineering variables, are plotted for a time interval of 5 s beginning about 0.2 s before the impact of an avalanche.

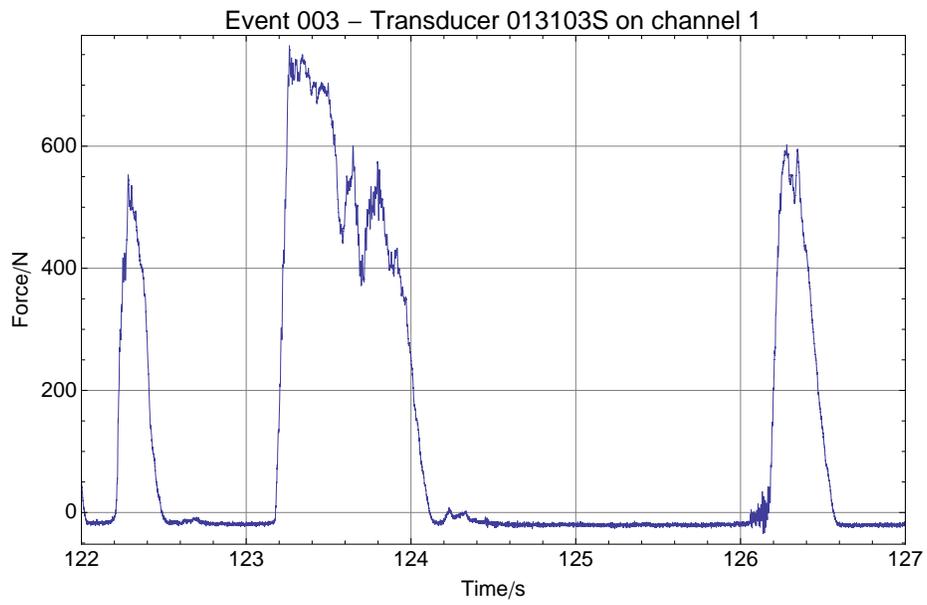
Figure 12: Example of measured force plotted vs. elapsed time for an artificially triggered avalanche.
