A new experimental snow avalanche test site at Seehore peak in Aosta Valley (NW Italian Alps) – Part II: engineering aspects

M. Barbero¹, F. Barpi¹, M. Borri-Brunetto¹, E. Bovet¹, B. Chiaia¹, V. De Biagi¹, B. Frigo¹, O. Pallara¹, M. Maggioni², M. Freppaz², E. Ceaglio^{2,4}, D. Godone³, D. Viglietti², E. Zanini²

Keywords Avalanches dynamics; small and medium avalanches; experimental site; NW Italian Alps

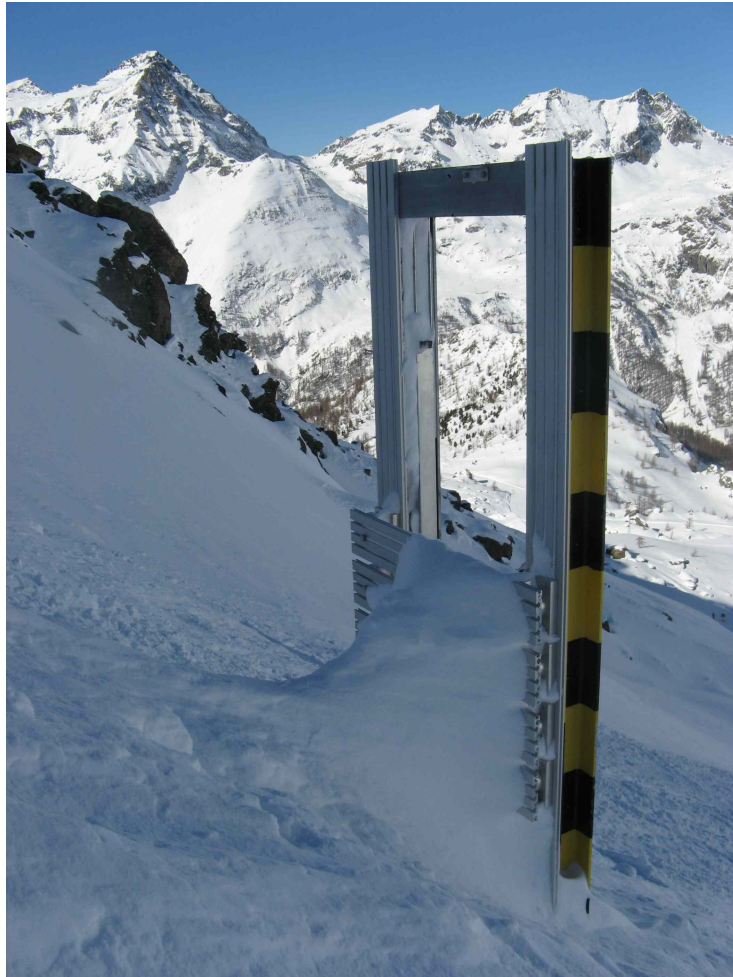
Figure 4: View of the obstacle after an avalanche event. Only the upper part of the steel structure emerges from the snowpack.

The following main parts were assembled (Figure 4):

1. a vertical obstacle made of galvanized steel profiles (4.0 m high, protruding 2.8 m from the natural slope profile), consisting of a lower section bolted to the concrete foundation, serving as a support for the upper part which carries the sensors, directly exposed to the avalanche impact;
2. a sealed electric cabinet that hosts the acquisition and control systems, terminal of the power supply line and of the optical fiber of the data transmission line, connected to the upper station of the Staffal-Gabiet cableway;
3. a galvanized steel shed that protects the cabinet from the direct impact of the avalanches and provides also a walking surface to reach the upper part of the obstacle for inspection and maintenance works.

The impact surface is made of an array of 5 aluminum grooved plates placed at different heights, each one supported by two load transducers, which are connected to the structure. The load transducers are, in turn, mounted on slides that can be easily moved along vertical guides: this design permits their positioning at the desired height above the ground level. The total area of the impact plates is 1 m² (Figure 4).
