DIGITAL PHOTOGRAMMETRY: A STANDARD APPROACH TO CULTURAL HERITAGE SURVEY

Andrea Lingua^a, Paolo Piumatti^b, Fulvio Rinaudo^a

The present work shows an application of digital photogrammetry to the survey of the remains of a church which will be converted into a conference hall for the University.

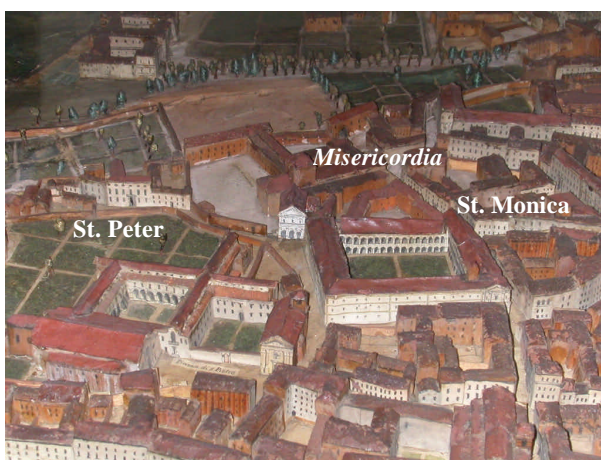
Figure 1. Urban hand made 3D model (M. Nicolosino, 1815) showing the church and the surrounding religious buildings (Local Museum of Savigliano)

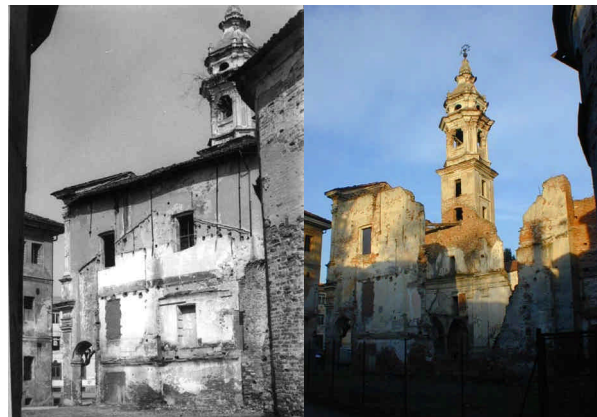
Figure 2. The church before and after the damage of 1984

Since then *Croce Nera* church has been a ruin: the roof, the vaults and part of the flanks and the apse have collapsed. The area where the church stands is still off-limits (see Fig. 2).

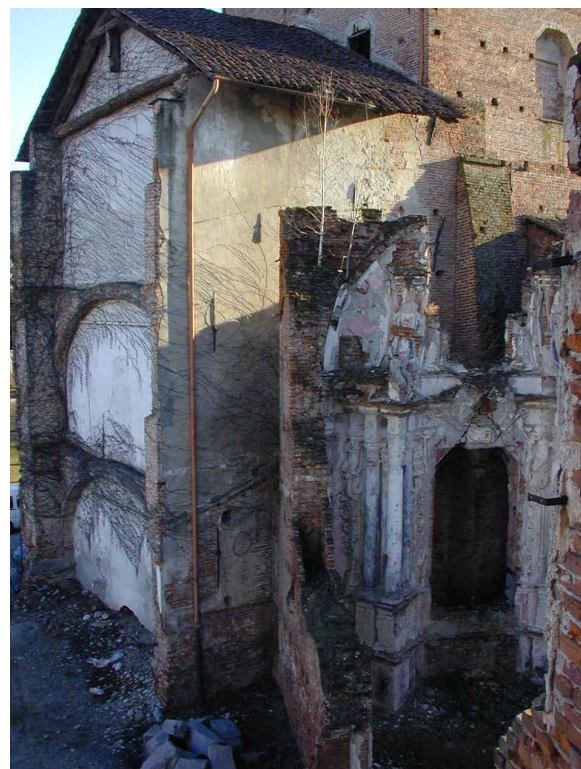
Figure 3. Rests of the vaults

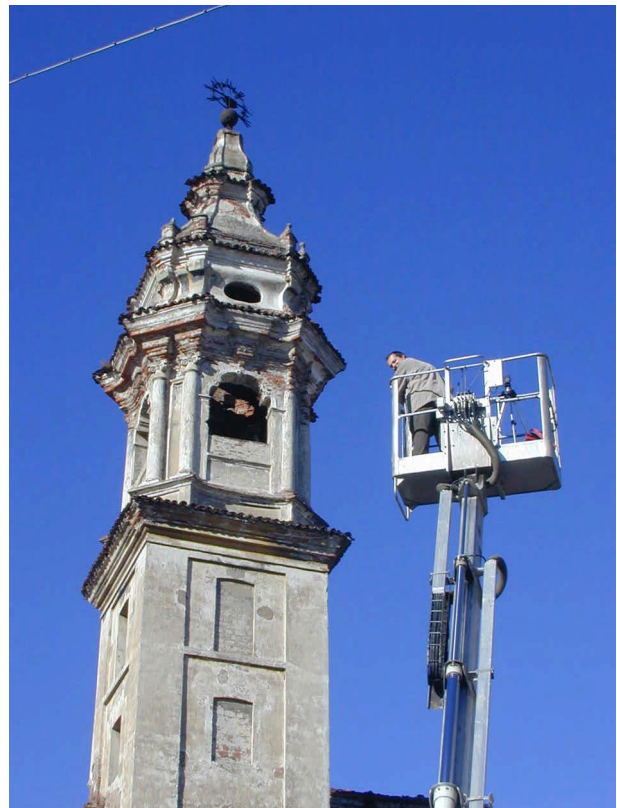
Figure 3. Photogrammetric taken of the bell tower

The images have been acquired by means of the semimetric ROLLEI 6008 camera ($f = 40$ mm): the scales of the images range from 1:800 to 1:400. In order to avoid perspective occlusions all the images have been recorded in the normal case of the photogrammetry. The images of the top parts of the buildings have been acquired by using "ad hoc" solutions (see Fig. 3).

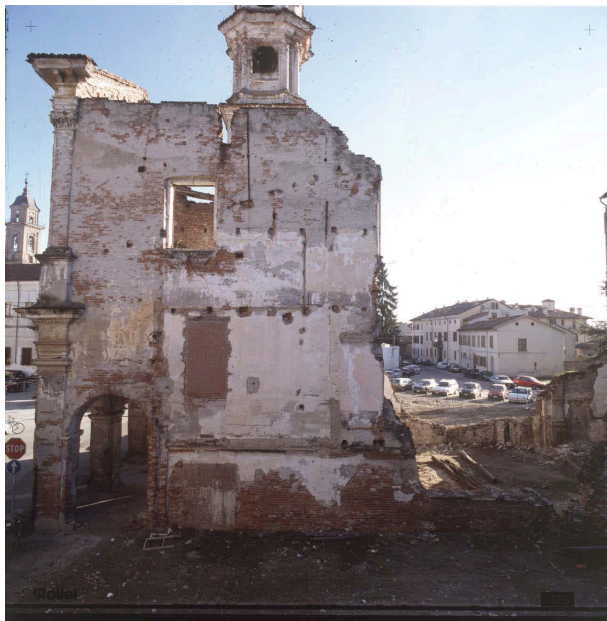
Figure 4. Semimetric image of the church

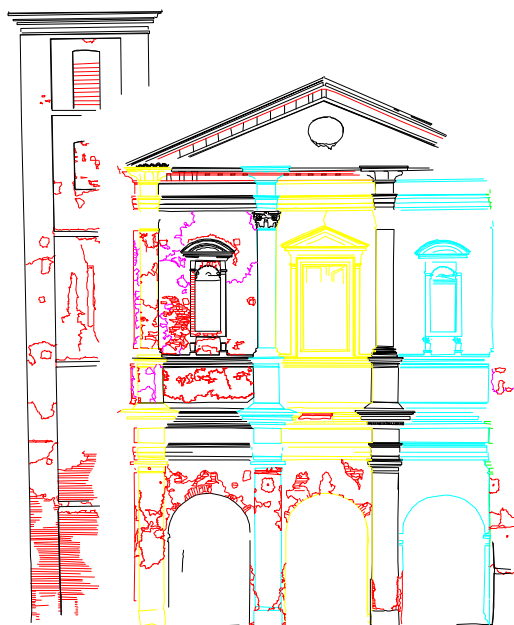
Figure 5. Plotting results of the main façade

30 of the 70 acquired images have been used during the restitution of the church. More than 25 logical levels of information have been used during the collection of the geometric data. Figure 5 shows the results of the plotting executed on the main façade of the church: different colours demonstrate the interpretation and classification performed during the restitution by the operator.

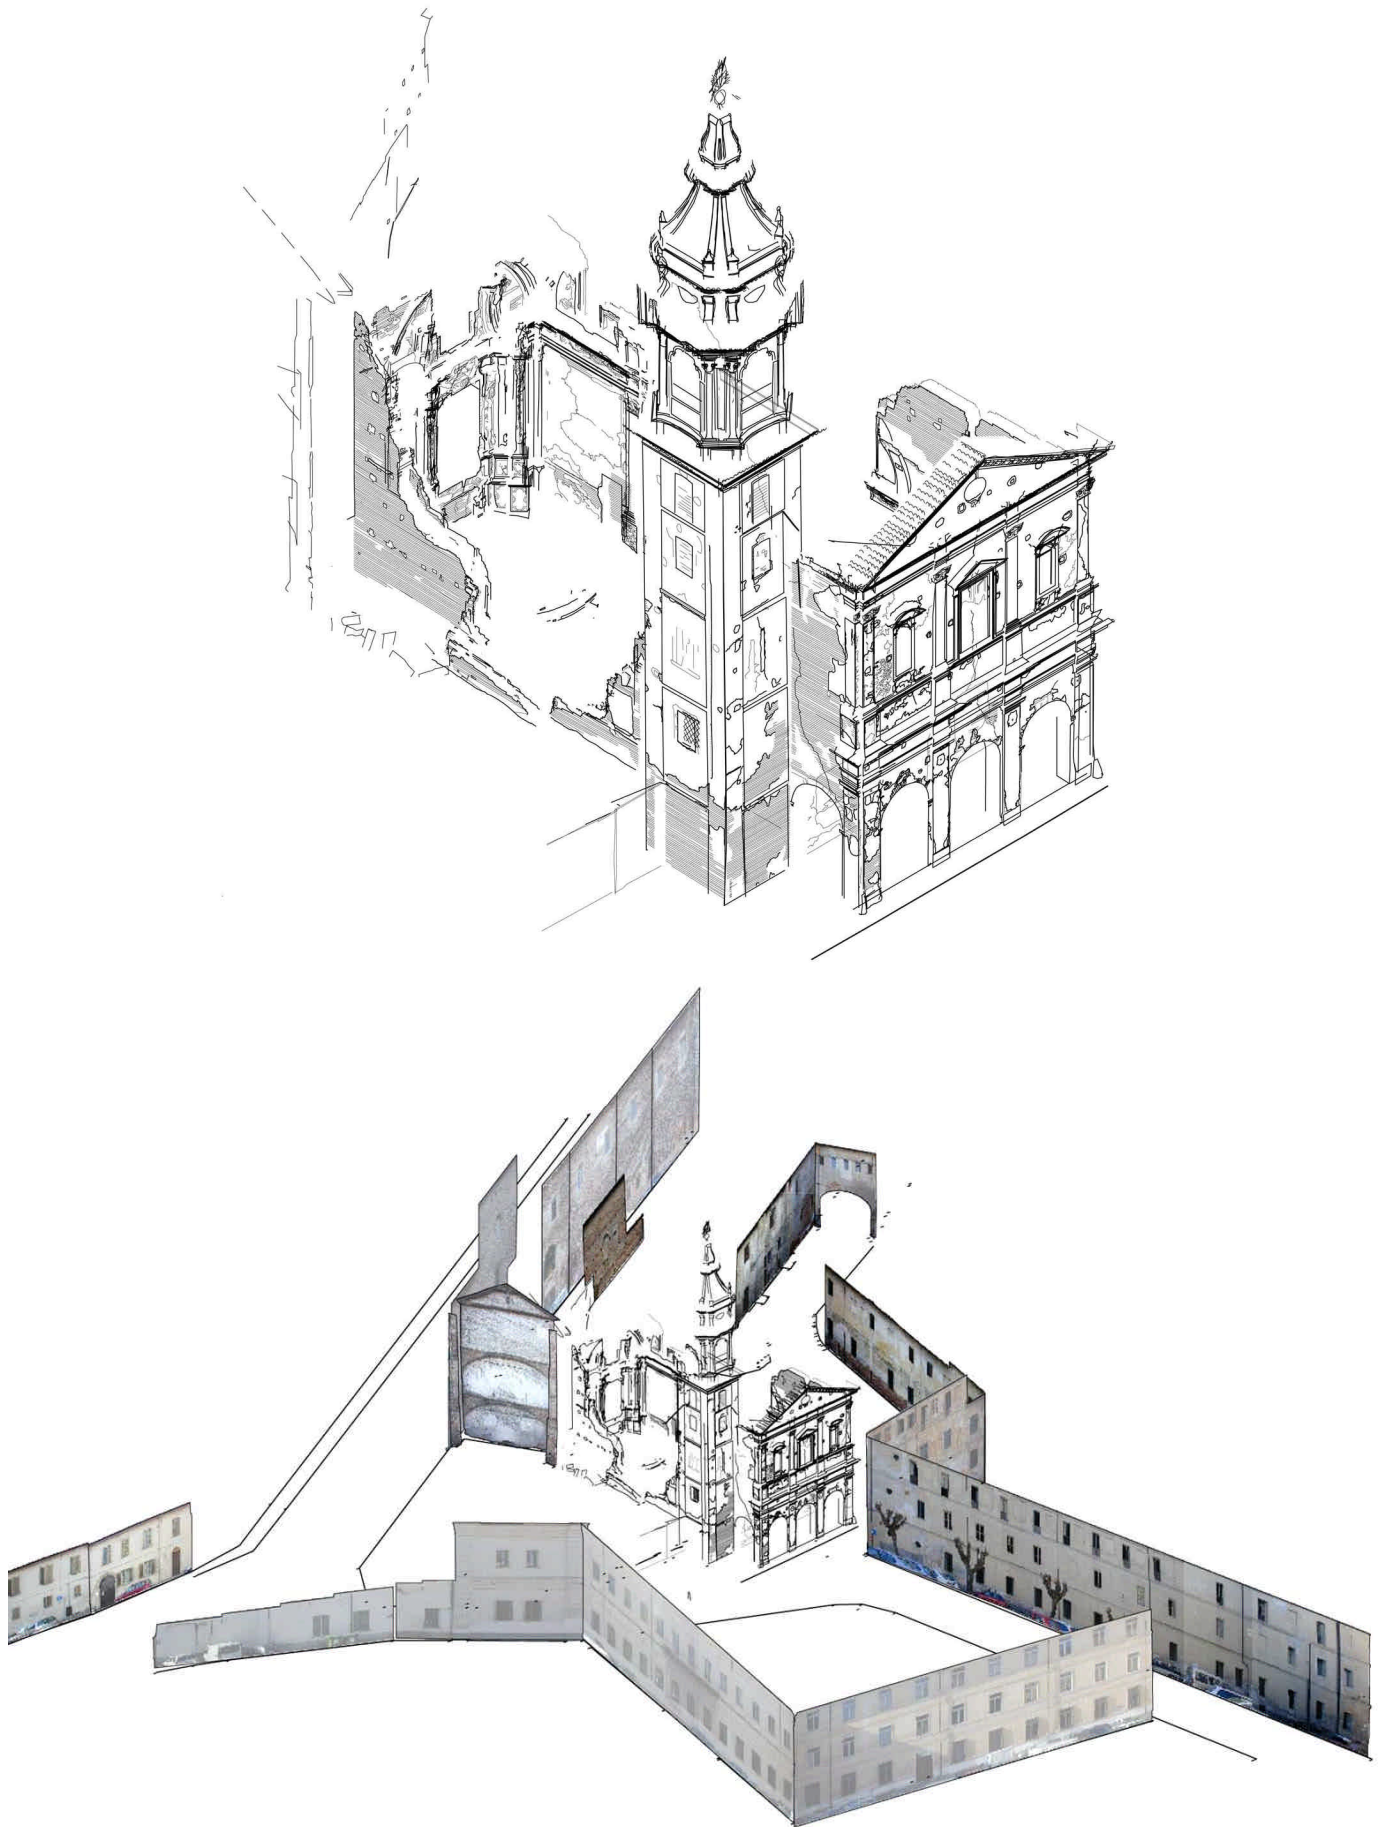
Figure 6. 3D models generated by the use of plotting and rectification results (drawing by Paolo Piumatti)

The representation of the results has been done both with digital and analogue (tables on paper) technology (see figures 6 and 7).

During the drawing assembly, both of the 3D and 2D models, different types of lines have been used in order to highlight different aspects: 0.4 mm thick lines for sections, 0.2 mm thick lines for principal visible elements, 0.13 mm thick lines for degradation, fissures, holes, missing bricks and rear elements and 0.05 mm thick black or grey lines for decorations and background elements.

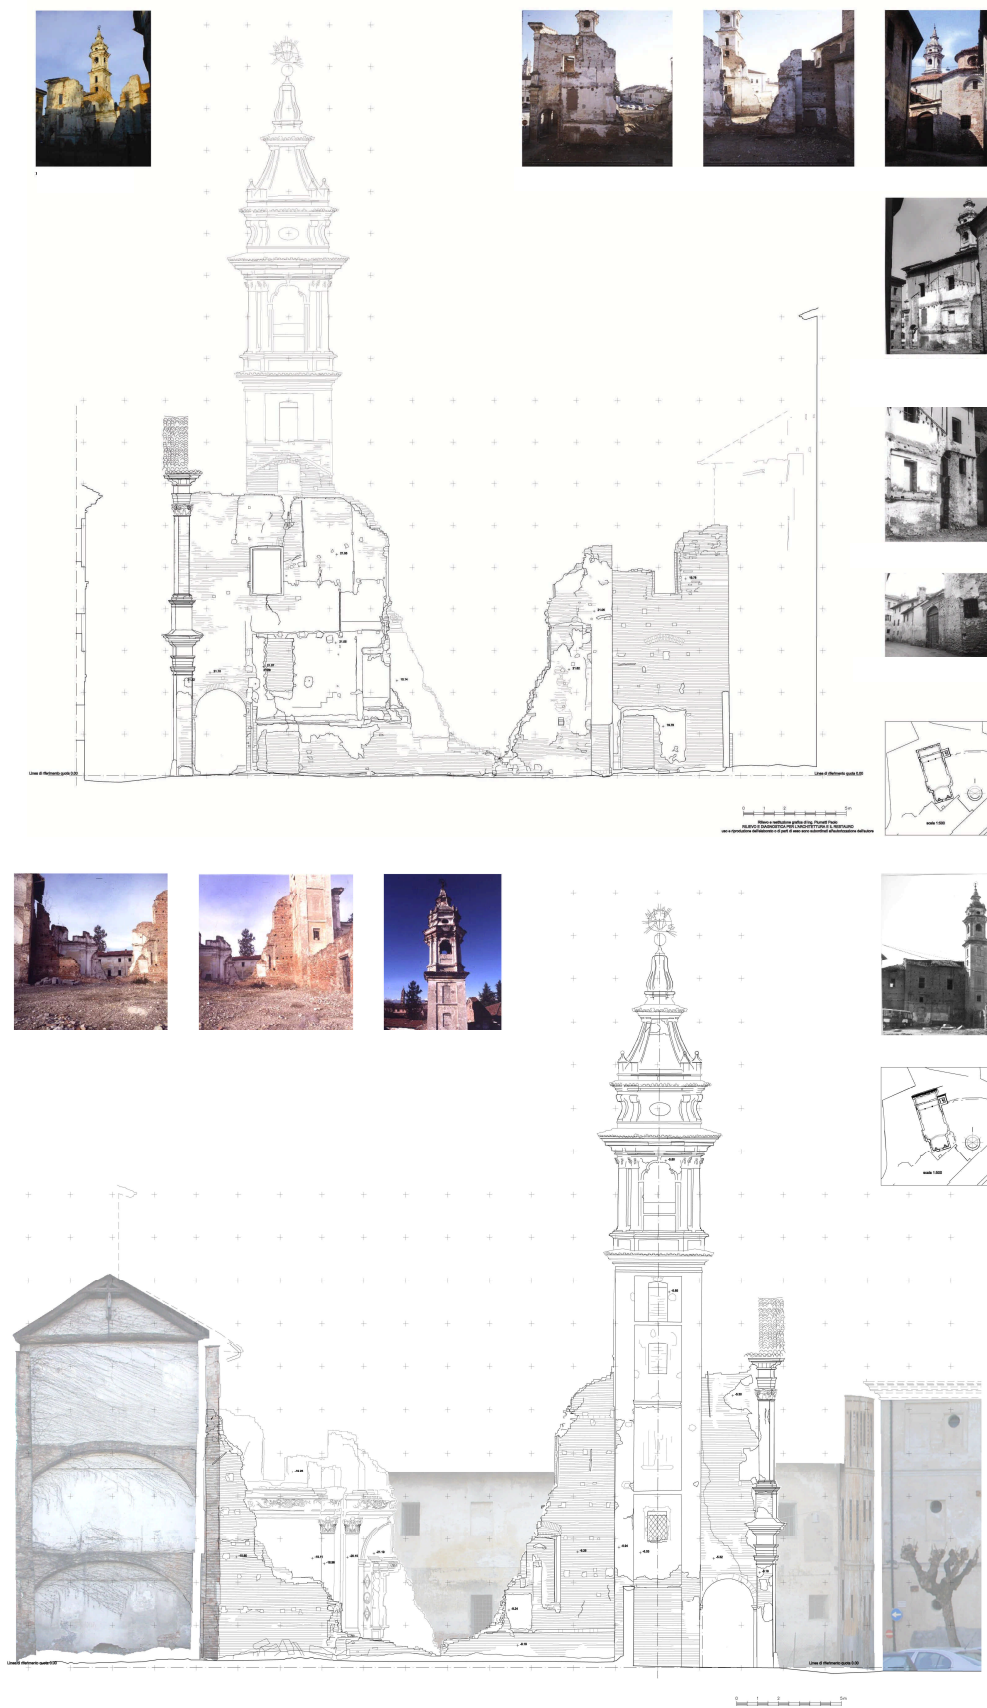
Figure 7. 2D representation of the results: photogrammetric survey, rectified images and photographic documentation (drawing by Paolo Piumatti)
