DIGITAL PHOTOGRAMMETRY: A STANDARD APPROACH TO CULTURAL HERITAGE SURVEY

Andrea Lingua^a, Paolo Piumatti^b, Fulvio Rinaudo^a

^a Politecnico di Torino – Dipartimento di Georisorse e Territorio

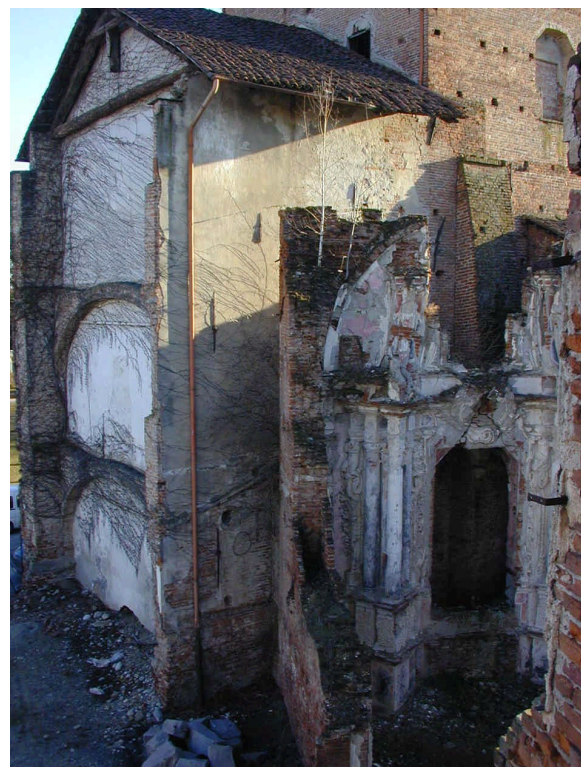
Figure 3. Rests of the vaults

- from the geometric point of view, even for the inaccessible parts, such as the bell tower and, above all, the remains of the vaults;
- from the point of view of decay analysis, determining the geometric conformation of the ruins at the same level as the original structure.
