DIGITAL PHOTOGRAMMETRY: A STANDARD APPROACH TO CULTURAL HERITAGE SURVEY

Andrea Lingua^a, Paolo Piumatti^b, Fulvio Rinaudo^a

The present work shows an application of digital photogrammetry to the survey of the remains of a church which will be converted into a conference hall for the University.

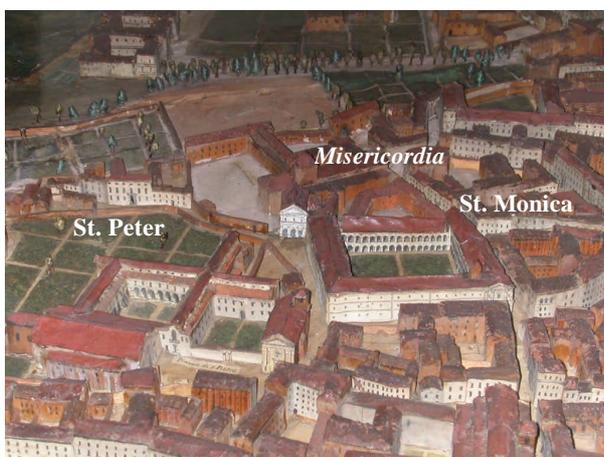
Figure 1. Urban hand made 3D model (M. Nicolosino, 1815) showing the church and the surrounding religious buildings (Local Museum of Savigliano)

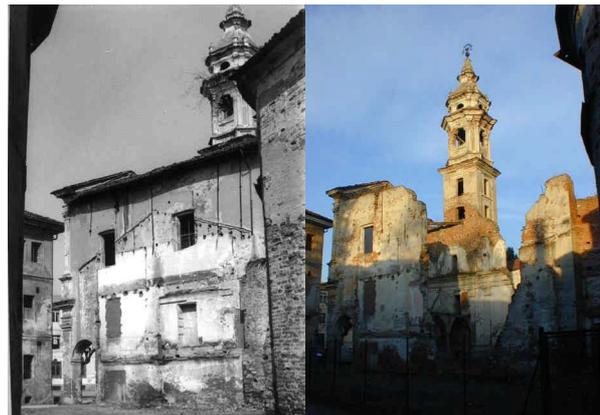
Since then *Croce Nera* church has been a ruin: the roof, the vaults and part of the flanks and the apse have collapsed. The area where the church stands is still off-limits (see Fig. 2).

Figure 2. The church before and after the damage of 1984

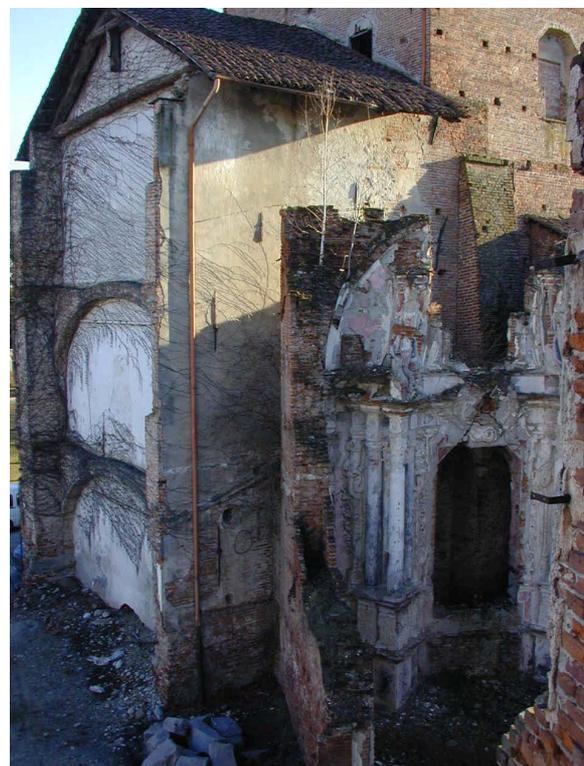
Figure 3. Rests of the vaults

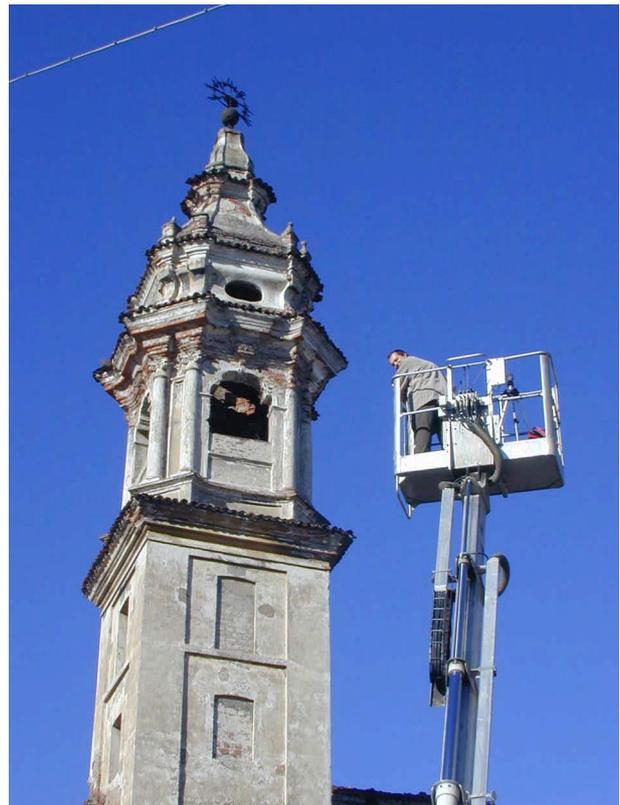
Figure 3. Photogrammetric taken of the bell tower

The images have been acquired by means of the semimetric ROLLEI 6008 camera ($f = 40$ mm): the scales of the images range from 1:800 to 1:400. In order to avoid perspective occlusions all the images have been recorded in the normal case of the photogrammetry. The images of the top parts of the buildings have been acquired by using "ad hoc" solutions (see Fig. 3).

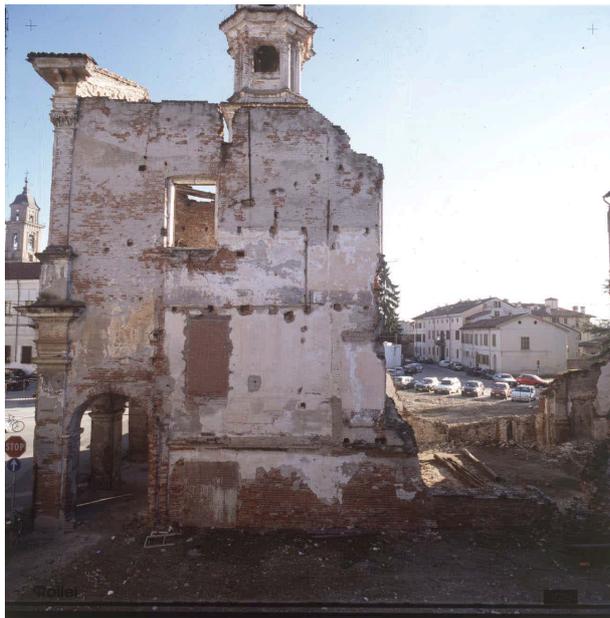
Figure 4. Semimetric image of the church

The photographic images have been digitised by the RM2 (by Wehrli) photogrammetric scanner at 2100 dpi geometric resolution.

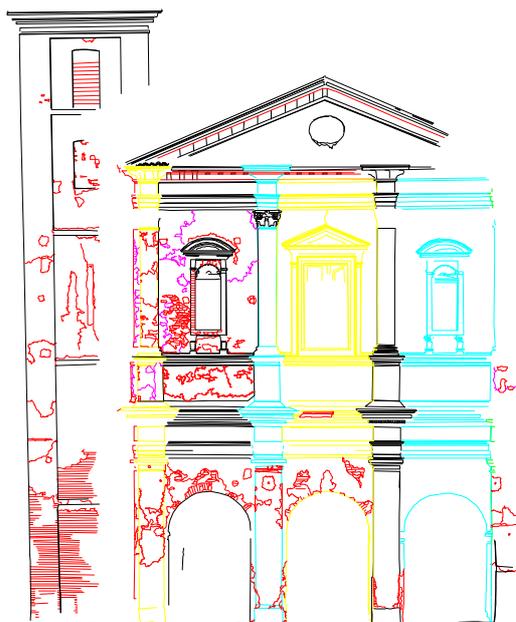
30 of the 70 acquired images have been used during the restitution of the church. More than 25 logical levels of information have been used during the collection of the geometric data. Figure 5 shows the results of the plotting executed on the main façade of the church: different colours demonstrate the interpretation and classification performed during the restitution by the operator.

Figure 5. Plotting results of the main façade

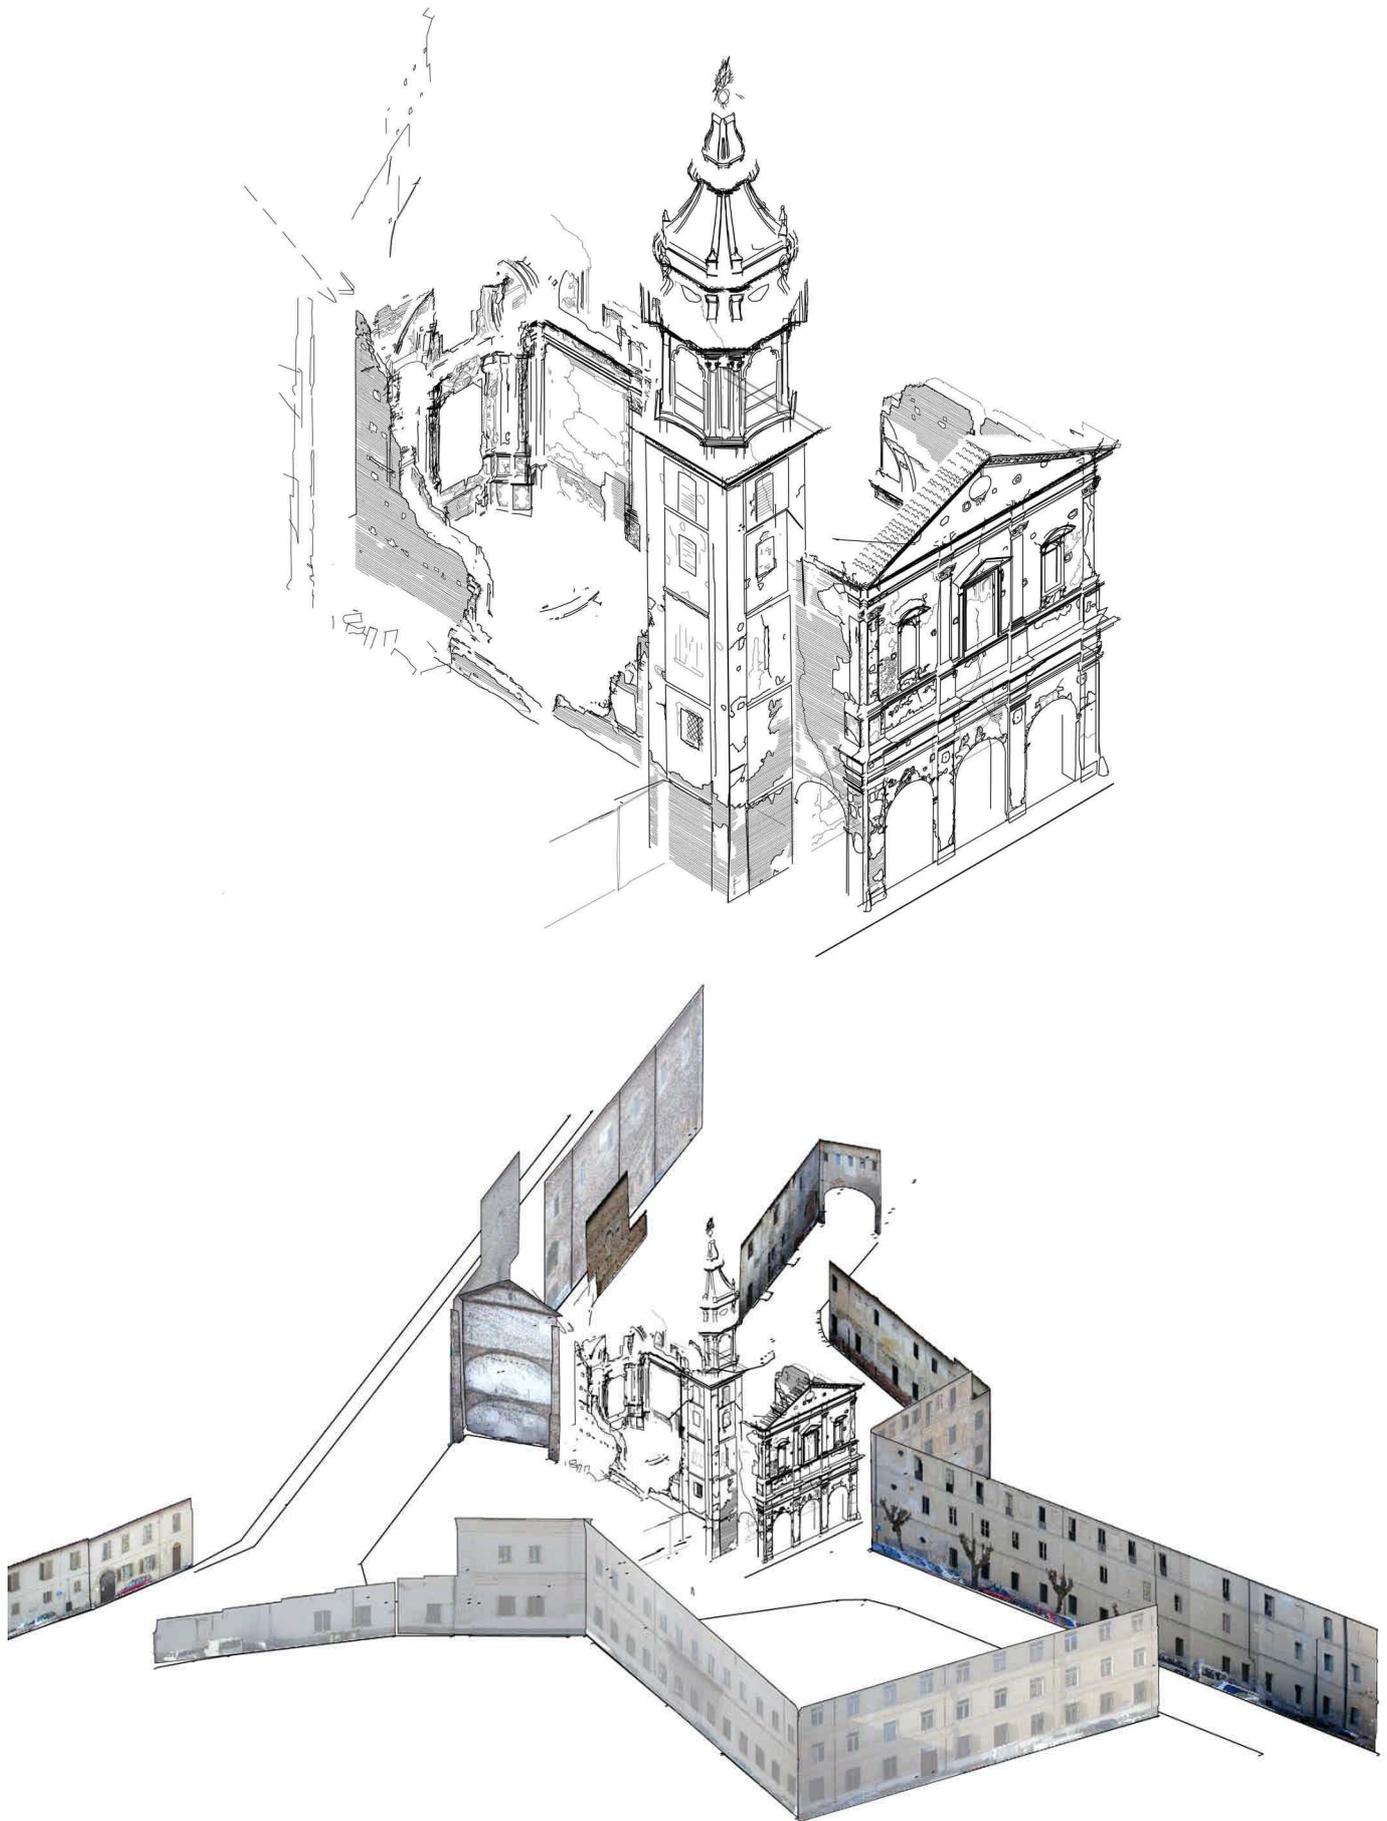
Figure 6. 3D models generated by the use of plotting and rectification results (drawing by Paolo Piumatti)

The representation of the results has been done both with digital and analogue (tables on paper) technology (see figures 6 and 7).

During the drawing assembly, both of the 3D and 2D models, different types of lines have been used in order to highlight different aspects: 0.4 mm thick lines for sections, 0.2 mm thick lines for principal visible elements, 0.13 mm thick lines for degradation, fissures, holes, missing bricks and rear elements and 0.05 mm thick black or grey lines for decorations and background elements.

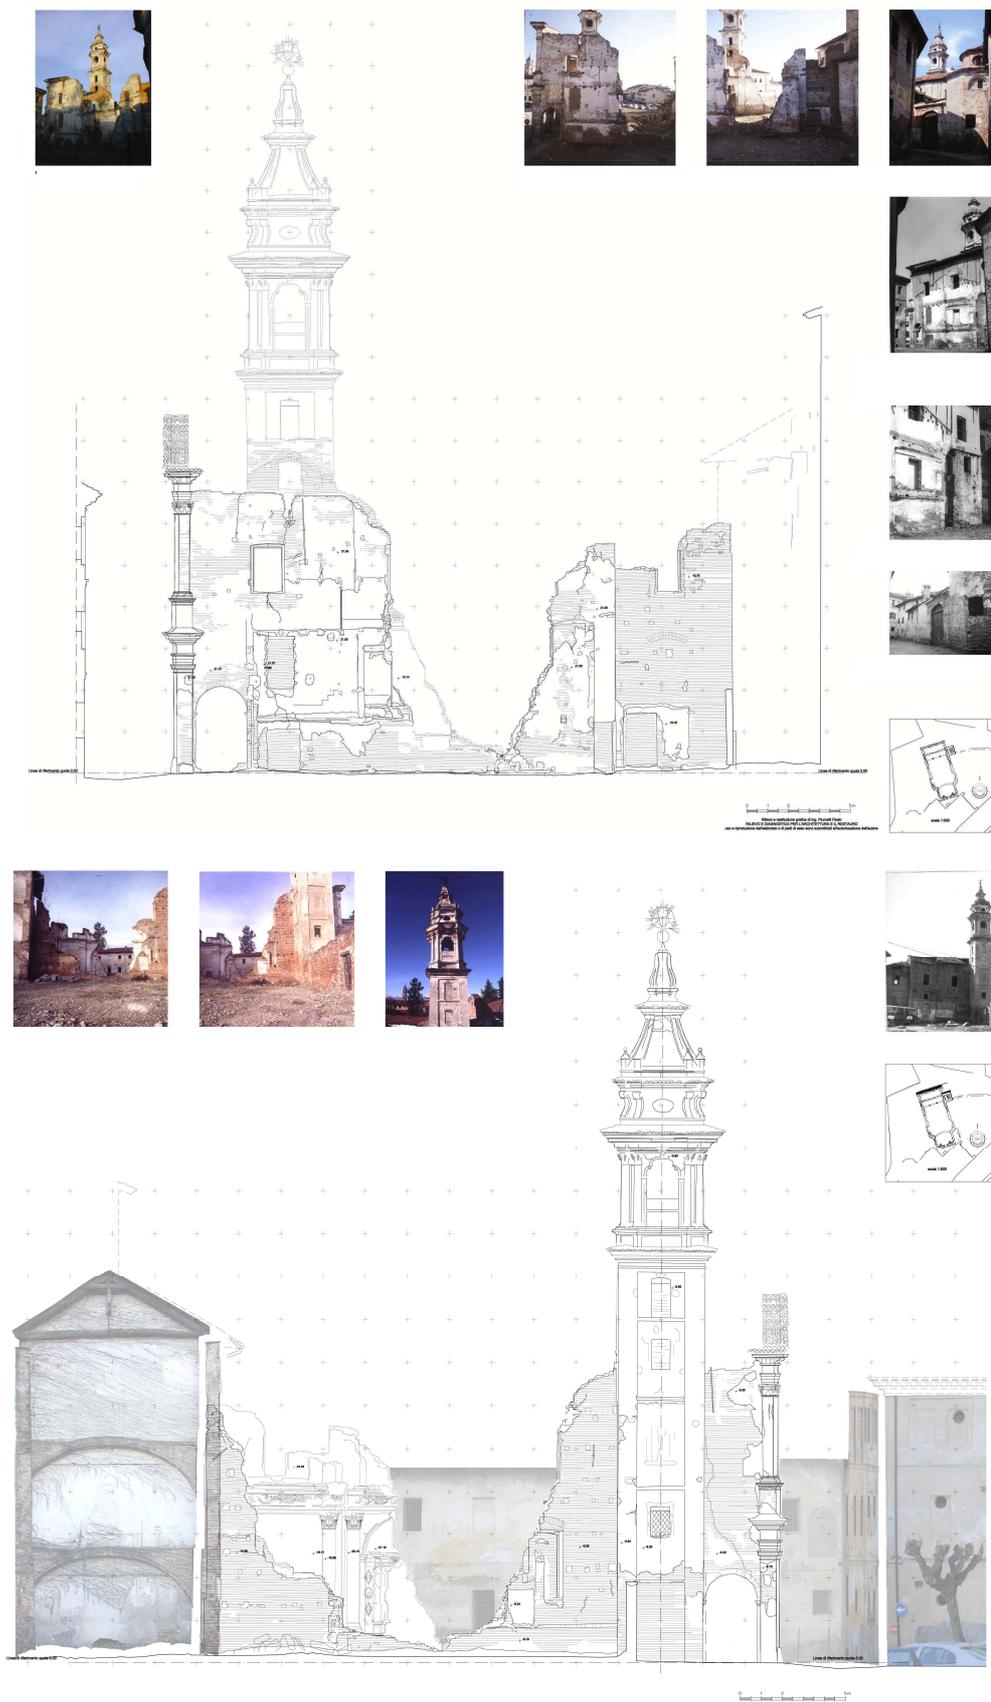
Figure 7. 2D representation of the results: photogrammetric survey, rectified images and photographic documentation (drawing by Paolo Piumatti)

The decay survey has been performed by mainly putting the structural problems of the building in evidence. The following topics have been particularly selected: wall fissures, principal plaster fissures due to the static assessment of the walls, brick placing, holes and missing parts, tie rods and chains, restructured elements, wood elements, signs of ancient adjoined buildings, plaster lacks and main plaster exfoliations.
