DIGITAL PHOTOGRAMMETRY: A STANDARD APPROACH TO CULTURAL HERITAGE SURVEY

Andrea Lingua^a, Paolo Piumatti^b, Fulvio Rinaudo^a

ABSTRACT

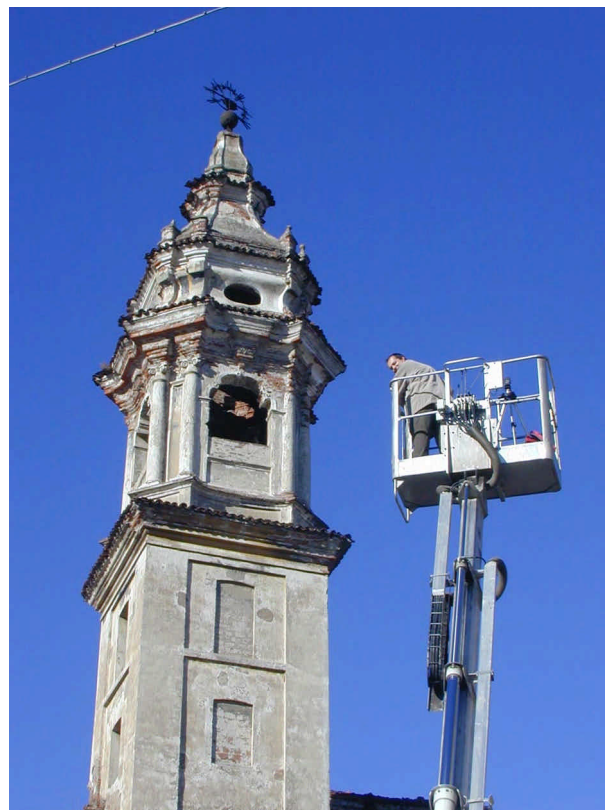
Figure 3. Photogrammetric taken of the bell tower

The images have been acquired by means of the semimetric ROLLEI 6008 camera ($f = 40$ mm): the scales of the images range from 1:800 to 1:400. In order to avoid perspective occlusions all the images have been recorded in the normal case of the photogrammetry. The images of the top parts of the buildings have been acquired by using "ad hoc" solutions (see Fig. 3).
