Fretting damage parameters in splined couplings

V. Cuffaro, F. Curà, A. Mura

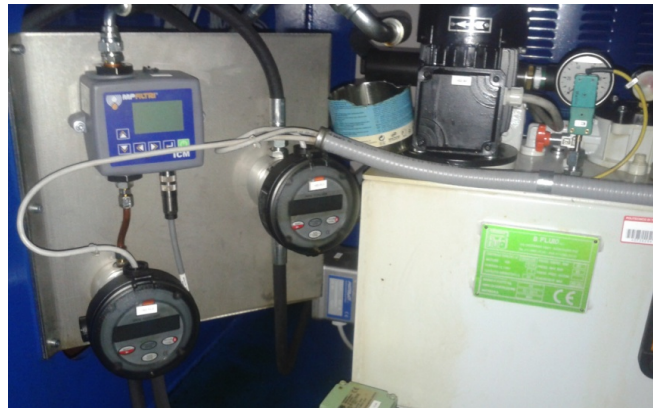
Figure 1: Inline contamination monitor connected to the lubrication system of the splined couplings test rig.

During the tests it is possible to monitor a lot of experimental data (debris present in the oil, temperature and strain of the specimen, speed rotation, torque, etc.), in particular the debris monitoring has been done by means of the inline contamination monitor (ICM) that measures and quantifies the numbers of solid contaminants in hydraulic, lubrication and transmission applications [13]. The instrument uses a light extinction principle whereby a specially collimated precision LED light source shines through the fluid and lands on a photodiode. When a particle passes through the beam it reduces the amount of light received by the diode, and from this change in condition, the size of the particle can be deduced.

The ICM is designed to be an accurate instrument for permanently installed applications utilizing mineral oil as the operating fluid. The unit can operate using any of the international standard formats ISO 4406:1999, NAS 1638, AS 4059E and ISO 11218 [12].
