Auditoria and Public Halls. The preserved Architectonic Heritage, in the Perspective of Sustainability / Maahsen Milan, Andreina; Simonetti, Marco. - In: PROCEDIA ENGINEERING. - ISSN 1877-7058. - ELETTRONICO. - 21:(2011), pp. 711-720. [10.1016/j.proeng.2011.11.2069]

2011 International Conference on Green Buildings and Sustainable Cities

Auditoria and public halls. The preserved architectonic heritage, in the perspective of sustainability.

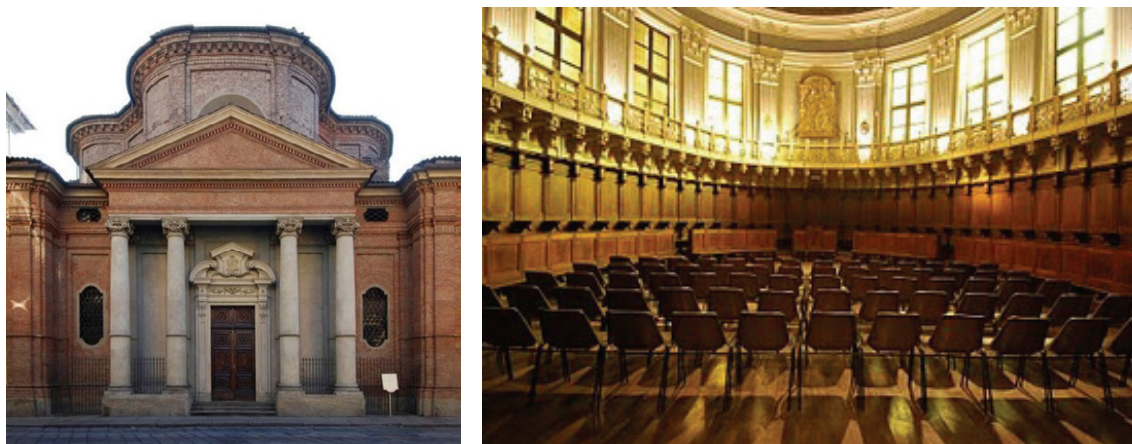
Fig. 2. (a,b) Church and Choir of Santa Pelagia, Torino. Choir detail. [Pictures © Bruna Biamino]

Air diffusion varies in the two areas: in the main hall the air supply is performed via jet nozzle diffusers masked by the choir wooden gratings of the mezzanine floor; the return air is instead performed via the grill inlets obtained in some doors leading to ancillary areas under the choir/organ.

In the hall of the large semi-elliptical choir, the supply has been carried out in the floor and the return takes place through gratings masked in the choir itself. Floor diffusers are placed under the choir stalls, along the whole perimeter of the semi-ellipsis.

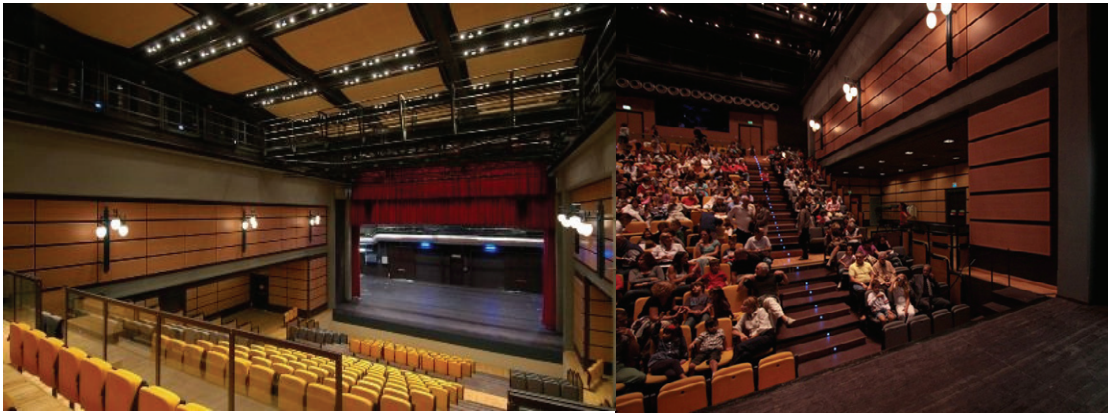
Fig. 3. (a,b), “Casa del teatro Giovani e Ragazzi”, Torino. Hall detail, reverse angle of the hall towards the stage. [Pictures © Bruna Biamino]

The main hall is equipped with two independent sections of 21.000m³/h, one for the stage area and one for the audience area; they have variable capacity as per occupation level. The foyer area is equipped with an additional section of the same capacity. Air is supplied via slot and jet nozzle diffusers in the halls and the return is made via ceiling gratings.
