2011 International Conference on Green Buildings and Sustainable Cities

Auditoria and public halls. The preserved architectonic heritage, in the perspective of sustainability.

Andreina Maahsen-Milan^{a*}, Marco Simonetti^b

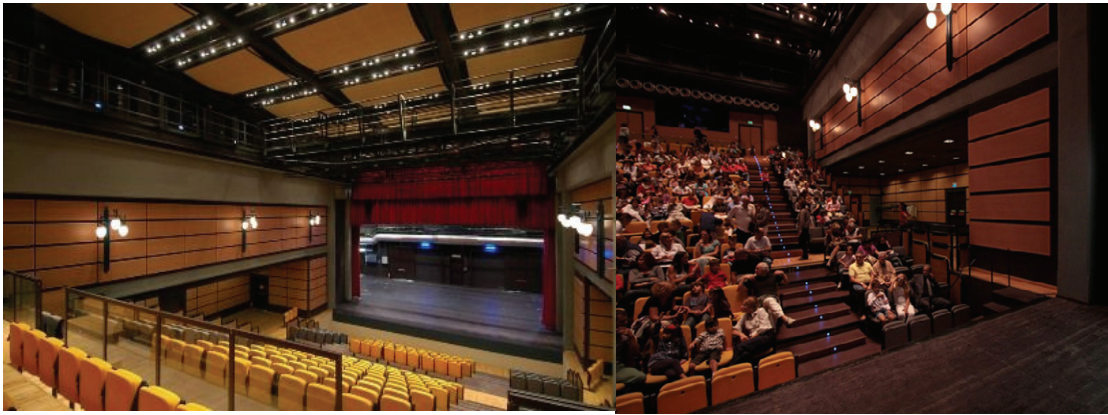
Fig. 3. (a,b), “Casa del teatro Giovani e Ragazzi”, Torino. Hall detail, reverse angle of the hall towards the stage. [Pictures © Bruna Biamino]

The main hall is equipped with two independent sections of 21.000m³/h, one for the stage area and one for the audience area; they have variable capacity as per occupation level. The foyer area is equipped with an additional section of the same capacity. Air is supplied via slot and jet nozzle diffusers in the halls and the return is made via ceiling gratings.
