Auditoria and Public Halls. The preserved Architectonic Heritage, in the Perspective of Sustainability / Maahsen Milan, Andreina; Simonetti, Marco. - In: PROCEDIA ENGINEERING. - ISSN 1877-7058. - ELETTRONICO. - 21:(2011), pp. 711-720. [10.1016/j.proeng.2011.11.2069]

2011 International Conference on Green Buildings and Sustainable Cities

Auditoria and public halls. The preserved architectonic heritage, in the perspective of sustainability.

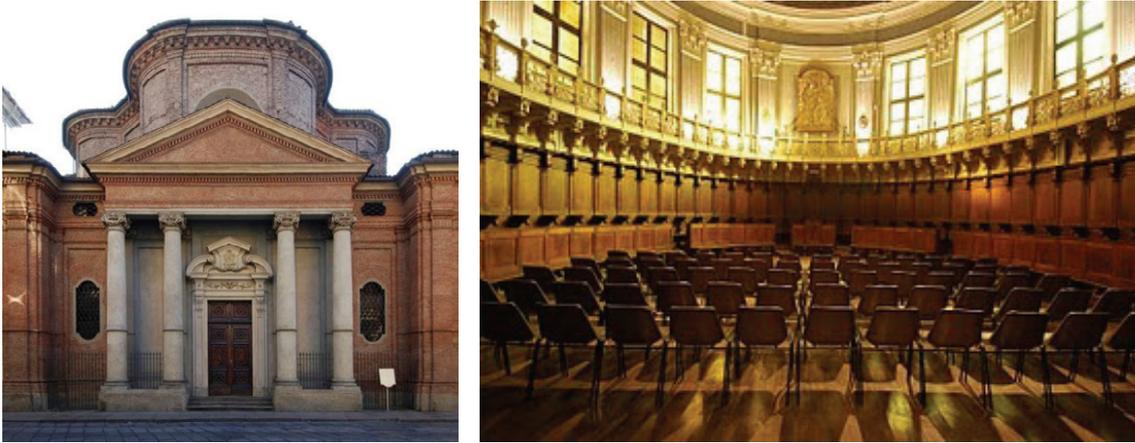
Fig. 2. (a,b) Church and Choir of Santa Pelagia, Torino. Choir detail. [Pictures © Bruna Biamino]

Air diffusion varies in the two areas: in the main hall the air supply is performed via jet nozzle diffusers masked by the choir wooden gratings of the mezzanine floor; the return air is instead performed via the grill inlets obtained in some doors leading to ancillary areas under the choir/organ.

In the hall of the large semi-elliptical choir, the supply has been carried out in the floor and the return takes place through gratings masked in the choir itself. Floor diffusers are placed under the choir stalls, along the whole perimeter of the semi-ellipsis.

In the Choir, the duct pathway, serving all floor inlets, has been developed partly in the underground areas and partly in the technical inner courtyard dug in cutting at the basis of the external wall of the choir. From here, the network reaches the outside AHU by passing through the adjacent court.

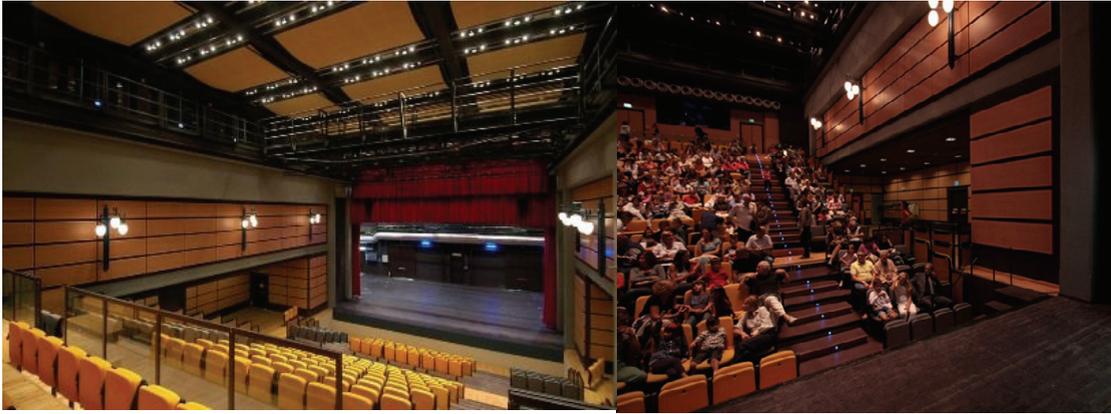
Fig. 3. (a,b), “Casa del teatro Giovani e Ragazzi”, Torino. Hall detail, reverse angle of the hall towards the stage. [Pictures © Bruna Biamino]

The main hall is equipped with two independent sections of 21.000m³/h, one for the stage area and one for the audience area; they have variable capacity as per occupation level. The foyer area is equipped with an additional section of the same capacity. Air is supplied via slot and jet nozzle diffusers in the halls and the return is made via ceiling gratings.
