2011 International Conference on Green Buildings and Sustainable Cities

Auditoria and public halls. The preserved architectonic heritage, in the perspective of sustainability.

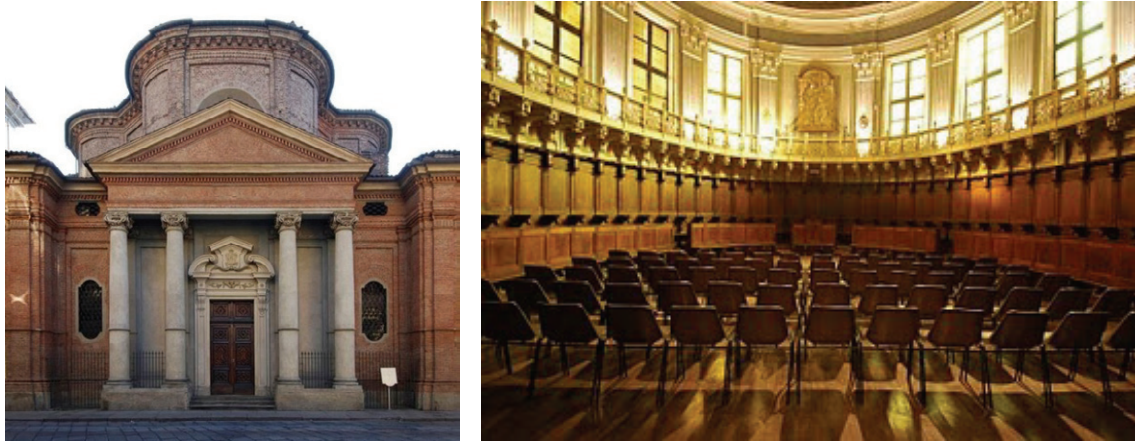
Fig. 2. (a,b) Church and Choir of Santa Pelagia, Torino. Choir detail. [Pictures © Bruna Biamino]

Air diffusion varies in the two areas: in the main hall the air supply is performed via jet nozzle diffusers masked by the choir wooden gratings of the mezzanine floor; the return air is instead performed via the grill inlets obtained in some doors leading to ancillary areas under the choir/organ.

In the hall of the large semi-elliptical choir, the supply has been carried out in the floor and the return takes place through gratings masked in the choir itself. Floor diffusers are placed under the choir stalls, along the whole perimeter of the semi-ellipsis.

In the Choir, the duct pathway, serving all floor inlets, has been developed partly in the underground areas and partly in the technical inner courtyard dug in cutting at the basis of the external wall of the choir. From here, the network reaches the outside AHU by passing through the adjacent court.

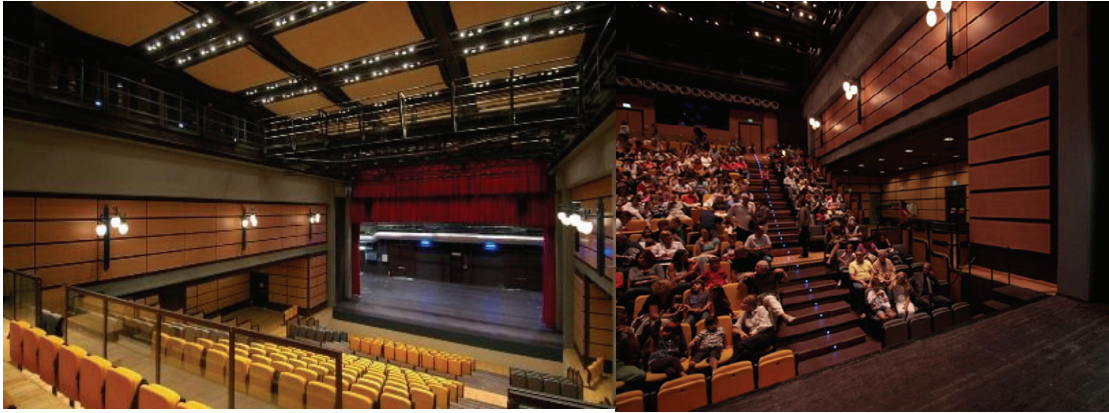
Fig. 3. (a,b), “Casa del teatro Giovani e Ragazzi”, Torino. Hall detail, reverse angle of the hall towards the stage. [Pictures © Bruna Biamino]

The main hall is equipped with two independent sections of 21.000m³/h, one for the stage area and one for the audience area; they have variable capacity as per occupation level. The foyer area is equipped with an additional section of the same capacity. Air is supplied via slot and jet nozzle diffusers in the halls and the return is made via ceiling gratings.
