A Power and Energy Procedure in Operating Photovoltaic Systems to Quantify the Losses According to the Causes

F. Spertino¹, A. Ciocia¹, P. Di Leo¹, R. Tommasini¹, I. Berardone², M. Corrado², A. Infuso²,
M. Paggi³

¹ Politecnico di Torino, Energy Department, ² Department of Structural, Geotechnical and Building Engineering, corso Duca degli Abruzzi, 24 – 10129 Torino, Italy

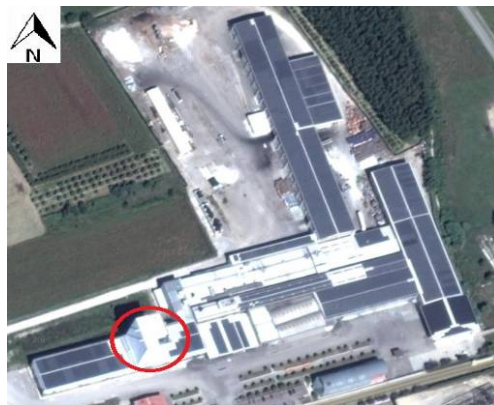
Fig. 2. Satellite image of the 2.5 MWp *BIPV* system.

During the inspection of the *BIPV* plant, it was observed that a remarkable obstacle (Fig. 2 inside the red circle) can put into shade a part of the PV modules. The 3D model of the obstacle (a tower in the factory) in SketchUp with the near roofs, subject to lateral shades of tower, was created to estimate the resulting power losses on the PV modules. In details, the tower is 25-m higher than the roofs, where these PV modules are placed. The tilt of the roof is 6° , whereas the azimuths are -17° (southeastern) and $+163^\circ$ (northwestern). The decrease of productivity is different for each individual string and depends on the position in which it is installed. To carry out daily simulations representative of the yearly behavior, spring, summer and autumn days are chosen: the winter impact is negligible. The Sun-beam evolution is analyzed with respect to the projected shades on the PV modules: 109 strings in different colors in Fig. 3 at right and left sides of the tower. The irradiance profiles, only for 10 strings with SE (left side) and NW (right side) orientations, are shown in Fig. 4, in which the steep increments and decrements represent the end of shadows in the morning and their beginning in the afternoon on the involved strings. PVGIS [12] provides data on global irradiance and diffuse contribution in monthly mean conditions. The diffuse irradiance is considered, if the shadow of the tower covers at least one of the string modules, neglecting the action of the bypass diodes inside the modules with a pessimistic estimation. As main findings of the simulation on a 272-kWp portion of *BIPV* system, the energy losses are $\approx 6\%$ in spring, $\approx 9\%$ in summer and $\approx 3\%$ in autumn (negligible in winter) with respect to the calculation without the shade effect. However, these losses have an impact $< 1\%$ on yearly basis (0.7%, 1.1% and 0.3% in the three seasons, respectively), taking into account the relative weight (12% of 2.3 MWp) of the PV system portion in the energy production. In addition, other obstacles, as e.g. balustrades and chimneys, provide losses concentrated in winter (it accounts for 9% of the yearly production) with noticeable deviations with respect to energy calculated without shades. Even if the shades have an impact month by month, the energy reduction per year can be estimated within 1—2%.

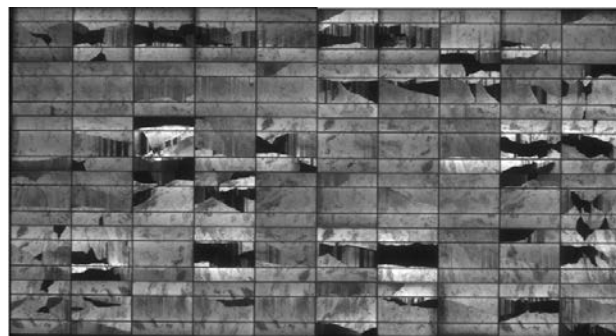
Fig. 16. EL image of a 60 p-Si cell module with high occurrence of cracks.

Regarding the same *BIPV* system, the high occurrence of cracks was noticed not only in m-Si modules, but also in p-Si modules (Fig. 16).

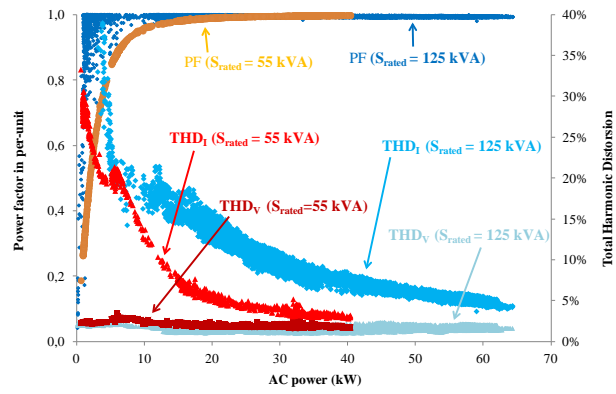
Fig. 19. Power factor and total harmonic distortion of current/voltage in *GMPV* and *BIPV* inverters.
