A Power and Energy Procedure in Operating Photovoltaic Systems to Quantify the Losses According to the Causes

F. Spertino¹, A. Ciocia¹, P. Di Leo¹, R. Tommasini¹, I. Berardone², M. Corrado², A. Infuso²,
M. Paggi³

Abstract: Recently, after high feed-in tariffs in Italy, retroactive cuts in the energy payments have generated economic concern about several grid-connected photovoltaic (PV) systems with poor performance. In this paper the proposed procedure suggests some rules for determining the sources

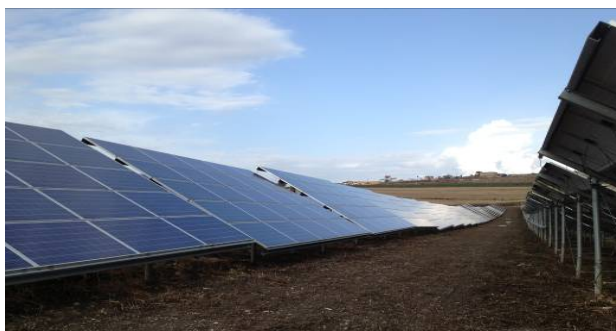
Fig. 1. Photo of two successive rows of PV modules in the *GMPV* system.

The *GMPV* system includes both PV modules in poly-crystalline silicon (p-Si), accounting for 3 MWp, and the remainder (0.3 MWp) in mono-crystalline silicon (m-Si). Fig. 1 shows two successive rows of PV modules mounted on open structures close to the terrain. They are arranged in PV arrays which supply MPPT racks with 55 kW rated power. Nine 330 kVA inverters with six MPPT racks each convert DC energy into AC energy delivered to the medium voltage grid.

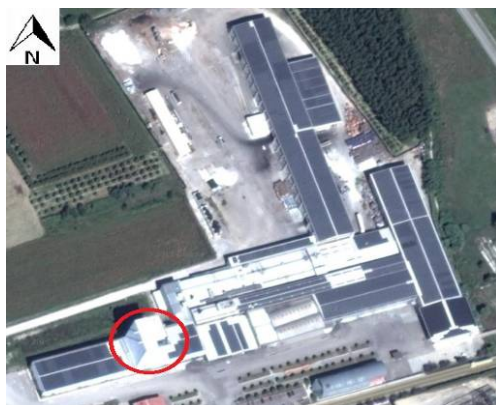
Fig. 2. Satellite image of the 2.5 MWp *BIPV* system.

During the inspection of the *BIPV* plant, it was observed that a remarkable obstacle (Fig. 2 inside the red circle) can put into shade a part of the PV modules. The 3D model of the obstacle (a tower in the factory) in SketchUp with the near roofs, subject to lateral shades of tower, was created to estimate the resulting power losses on the PV modules. In details, the tower is 25-m higher than the roofs, where these PV modules are placed. The tilt of the roof is 6° , whereas the azimuths are -17° (southeastern) and $+163^\circ$ (northwestern). The decrease of productivity is different for each individual string and depends on the position in which it is installed. To carry out daily simulations representative of the yearly behavior, spring, summer and autumn days are chosen: the winter impact is negligible. The Sun-beam evolution is analyzed with respect to the projected shades on the PV modules: 109 strings in different colors in Fig. 3 at right and left sides of the tower. The irradiance profiles, only for 10 strings with SE (left side) and NW (right side) orientations, are shown in Fig. 4, in which the steep increments and decrements represent the end of shadows in the morning and their beginning in the afternoon on the involved strings. PVGIS [12] provides data on global irradiance and diffuse contribution in monthly mean conditions. The diffuse irradiance is considered, if the shadow of the tower covers at least one of the string modules, neglecting the action of the bypass diodes inside the modules with a pessimistic estimation. As main findings of the simulation on a 272-kWp portion of *BIPV* system, the energy losses are $\approx 6\%$ in spring, $\approx 9\%$ in summer and $\approx 3\%$ in autumn (negligible in winter) with respect to the calculation without the shade effect. However, these losses have an impact $< 1\%$ on yearly basis (0.7%, 1.1% and 0.3% in the three seasons, respectively), taking into account the relative weight (12% of 2.3 MWp) of the PV system portion in the energy production. In addition, other obstacles, as e.g. balustrades and chimneys, provide losses concentrated in winter (it accounts for 9% of the yearly production) with noticeable deviations with respect to energy calculated without shades. Even if the shades have an impact month by month, the energy reduction per year can be estimated within 1—2%.
