DIAMOND WIRE – STONE INTERACTION DURING THE CUTTING PROCESS: MECHANICAL,  
PHYSICAL AND CHEMICAL INVESTIGATIONS

DIAMOND WIRE – STONE INTERACTION DURING THE CUTTING PROCESS: MECHANICAL, PHYSICAL AND CHEMICAL INVESTIGATIONS / Spriano, Silvia Maria; Ferraris, Sara; Bellopede, Rossana; Marini, Paola; Zichella, Lorena; Tori, Alice. - STAMPA. - 1:(2015), pp. 125-132. ( International Conference on Stone and Concrete Machining Bochum 02-11-2015).

# DIAMOND WIRE – STONE INTERACTION DURING CUTTING PROCESS: MECHANICAL, PHYSICAL AND CHEMICAL INVESTIGATIONS

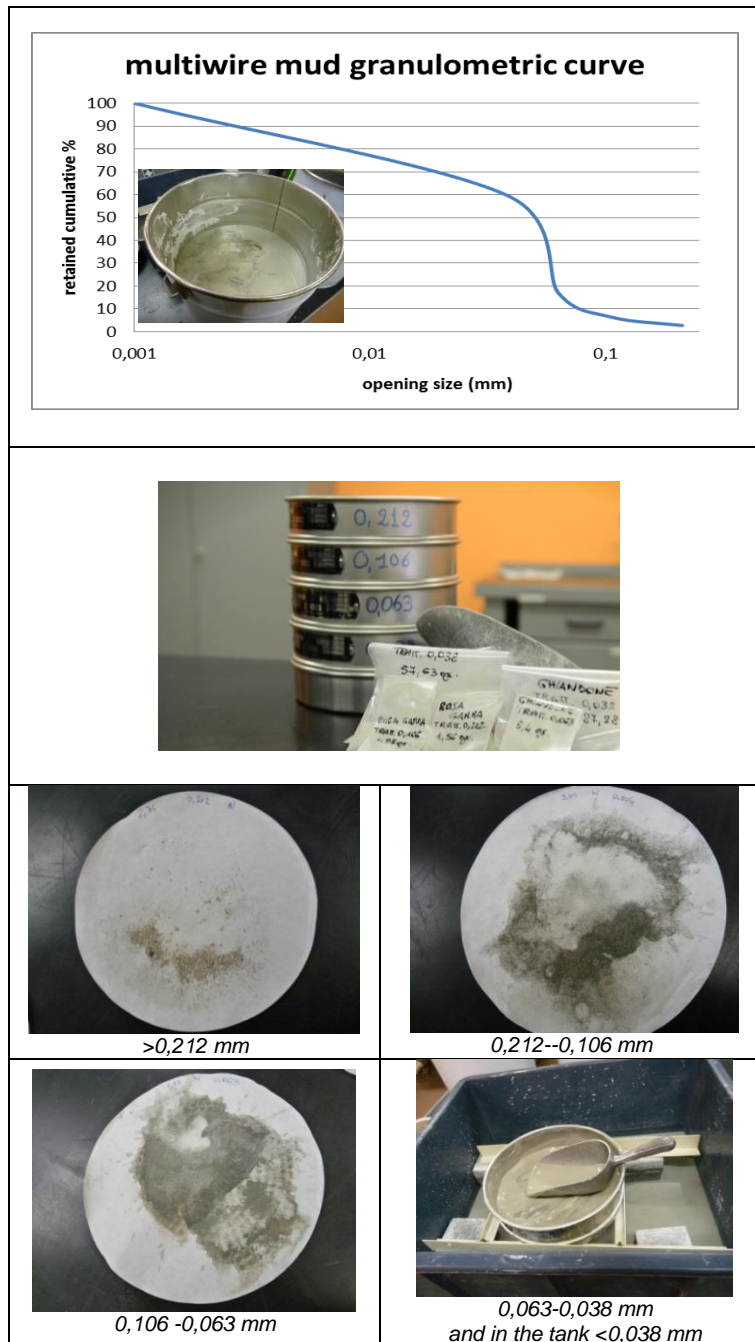
The granulometric curve of multiwire muds is shown in Figure 2; it is characterized by a high percentage (40.2%) of particles minor than 0,038mm.

Figure 2: size distribution process and characterization of multiwire muds

Each one of the classes obtained through the granulometric separation has been processed with a wet magnetic separation (Co-Al – Ni magnet). On the size classes minor than 0,063mm a further analysis by means of X – Ray Diffraction (XRD) have been performed.

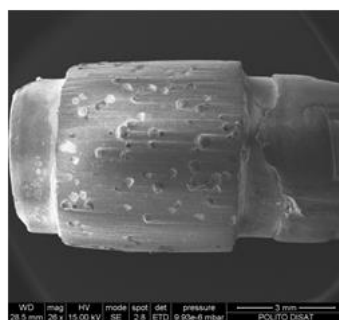
As first, we observed at low magnification that the beads almost maintain their shape after stone cutting and they are almost uniformly worn (see Figure 4) on all their length. The direction of cutting and rotation of the diamond wire can be derived by observing the presence of “comet tails” behind the diamond grits and the slight lower diameter of the bead on the left of the image: the first impact of the bead with the stone during cutting was on the left side, in this case.

*Figure 4: SEM image at low magnification of a worn diamond bead*

In the case of diamond wires used in cutting of Fe containing stones, we observed by SEM that the junction between the diamond beads and the steel rope is good and no wear was observed in this area (Figure 3). The steel rope is well covered by a thin or thick polymeric coating (polyurethane) at the junction between the rope and the diamond bead, without any erosion, detachment or wear of the coating (Figure 4).
