DIAMOND WIRE – STONE INTERACTION DURING THE CUTTING PROCESS: MECHANICAL,
PHYSICAL AND CHEMICAL INVESTIGATIONS

DIAMOND WIRE – STONE INTERACTION DURING THE CUTTING PROCESS: MECHANICAL, PHYSICAL AND CHEMICAL INVESTIGATIONS / Spriano, Silvia Maria; Ferraris, Sara; Bellopede, Rossana; Marini, Paola; Zichella, Lorena; Tori, Alice. - STAMPA. - 1:(2015), pp. 125-132. ((Intervento presentato al convegno International Conference on Stone and Concrete Machining tenutosi a Bochum nel 02-11-2015.

DIAMOND WIRE – STONE INTERACTION DURING CUTTING PROCESS: MECHANICAL, PHYSICAL AND CHEMICAL INVESTIGATIONS

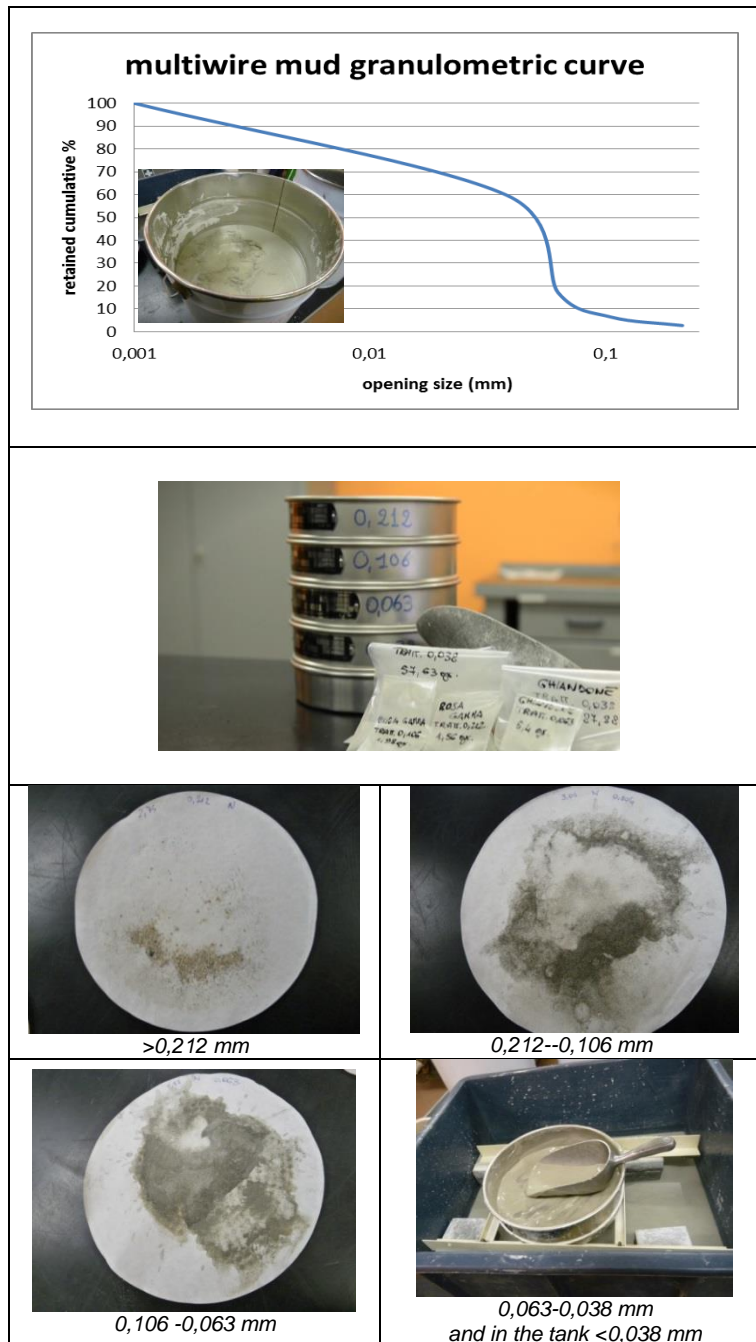
The granulometric curve of multiwire muds is shown in Figure 2; it is characterized by an high percentage (40.2%) of particles minor than 0,038mm.

Figure 2: size distribution process and characterization of multiwire muds

Each one of the classes obtained through the granulometric separation has been processed with a wet magnetic separation (Co-Al – Ni magnet). On the size classes minor than 0,063mm a further analysis by means of X – Ray Diffraction (XRD) have been performed.

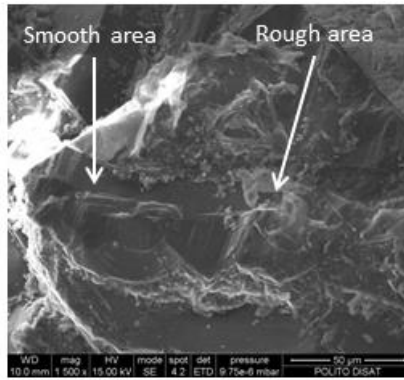
The most interesting diamonds grits are the macro fractured and etched ones. These diamonds are no longer able to cut stones and they do not show any “comet tail” behind them. Macro fractured diamonds do not highly protrude from the surface level and they still show a good interface with the metal matrix, showing that in some cases the retention ability of the metal matrix is too high: un-efficient diamonds without cutting ability are still maintained on the surface by the strong interface with the metal matrix. [10] The surface of the macro fractured diamonds shows both some smooth cleavage planes, deriving from a brittle fracture mechanism, and some rough areas probably deriving from etching (Figure 6). On the rough areas of the etched diamonds, EDS analysis shows the presence of an adherent layer of stone containing Fe, Ca Na, K, Mg and Si, suggesting that Fe containing stones are able to react with the diamonds causing a high degree of damage and macro fractures follow this etching.

Figure 6: Macro fractured and etched diamond

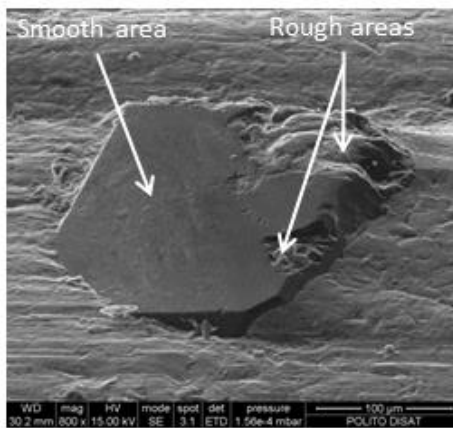
On one diamond grain, arising from the surface with an almost un-damaged and smooth surface, it was interesting to see the damage, probably due to etching and reaction with iron, in a first stage (Figure 7), limited to small areas: in this case macro fractures did not occur because of the limited etching.

Figure 7: An almost un-damaged diamond bit showing etching in a first stage

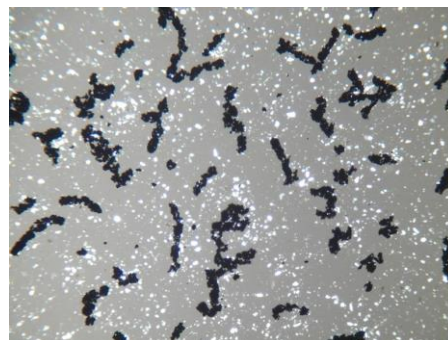
Figure 8: On the left micro-photo (6.9x5,19mm) with crossed nicols of mud particles >0.212mm and on the right micro photo (10.6 x 8mm)with parallel nicols of mud particles between 0.038-0.063mm.

Muds generated by stone cutting are mainly composed by stones debris and fraction of heavy metals (e.g. Co, Ni, Cu, Zn, Cr, W and their alloys) deriving from metal matrix. In particular, the magnetic separation shows, in the 0,038mm-0,063mm class, a higher amount of ferromagnetic particles coming from the metal matrix erosion, while, in the fine class (<0,038mm) the rock minerals (quartz in particular) are predominant: this is confirmed from the diffractometric analysis too (Figure 8). The sawmill mud contains heavy metals coming from the sawing tools: an example of 4 different muds sample (M1-M2-M3-M4) is in
