DIAMOND WIRE – STONE INTERACTION DURING THE CUTTING PROCESS: MECHANICAL, PHYSICAL AND CHEMICAL INVESTIGATIONS / Spriano, Silvia Maria; Ferraris, Sara; Bellopede, Rossana; Marini, Paola; Zichella, Lorena; Tori, Alice. - STAMPA. - 1:(2015), pp. 125-132. (Intervento presentato al convegno International Conference on Stone and Concrete Machining tenutosi a Bochum nel 02-11-2015).

# DIAMOND WIRE – STONE INTERACTION DURING CUTTING PROCESS: MECHANICAL, PHYSICAL AND CHEMICAL INVESTIGATIONS

S. Spriano<sup>1</sup>, S. Ferraris<sup>1</sup>, R. Bellopede<sup>2</sup>, P. Marini<sup>2</sup>, L. Zichella<sup>2</sup>, A. Tori<sup>3</sup>

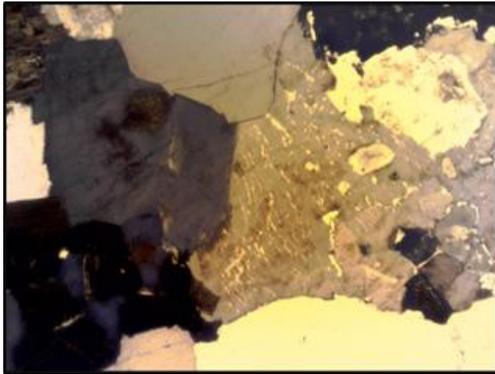
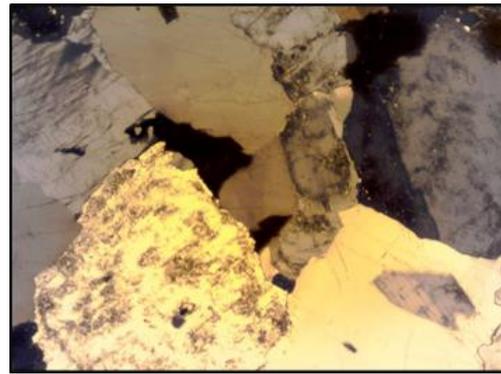
*Petrographic analysis and mineralogical investigation have been performed on the stones and on the muds derived from their cutting. Both have been analyzed by means of the optical microscope Leitz Wetzlar. Image analyzer software IMAGE J (an open source image processing program designed for scientific multidimensional image), in order to define size, dimension and ratio between quartz and feldspar. In*

Figure 1 the thin sections of two different kind of Sardinian granite (RG and GP) are reported.

A. RG granite

B. GP granite

*Figure 1: Thin sections of RG and GP granite (long side 4.3mm): microscopy crossed nicols, in black the ferrous components (biotite).*

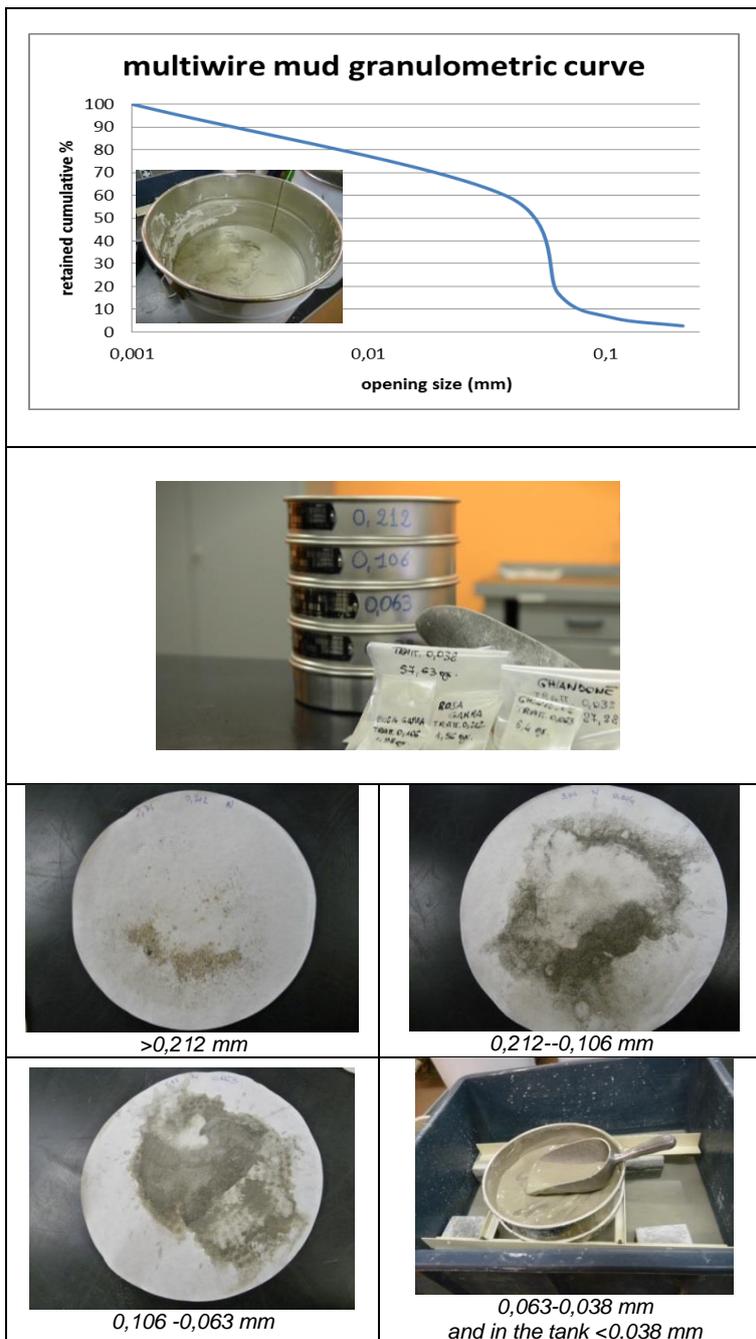
The granulometric curve of multiwire muds is shown in Figure 2; it is characterized by a high percentage (40.2%) of particles minor than 0,038mm.

Figure 2: size distribution process and characterization of multiwire muds

Each one of the classes obtained through the granulometric separation has been processed with a wet magnetic separation (Co-Al – Ni magnet). On the size classes minor than 0,063mm a further analysis by means of X – Ray Diffraction (XRD) have been performed.

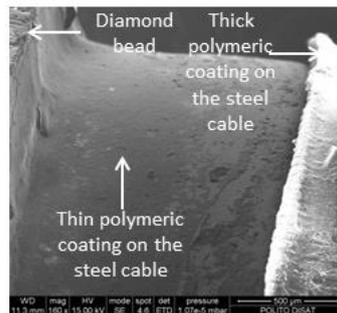
In the case of diamond wires used in cutting of Fe containing stones, we observed by SEM that the junction between the diamond beads and the steel rope is good and no wear was observed in this area (Figure 3). The steel rope is well covered by a thin or thick polymeric coating (polyurethane) at the junction between the rope and the diamond bead, without any erosion, detachment or wear of the coating (Figure 4).

*Figure 3: SEM image at low magnification of the junction between the diamond beads and the steel rope*

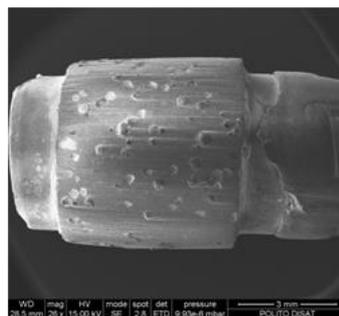
As first, we observed at low magnification that the beads almost maintain their shape after stone cutting and they are almost uniformly worn (see Figure 4) on all their length. The direction of cutting and rotation of the diamond wire can be derived by observing the presence of “comet tails” behind the diamond grits and the slight lower diameter of the bead on the left of the image: the first impact of the bead with the stone during cutting was on the left side, in this case.

*Figure 4: SEM image at low magnification of a worn diamond bead*

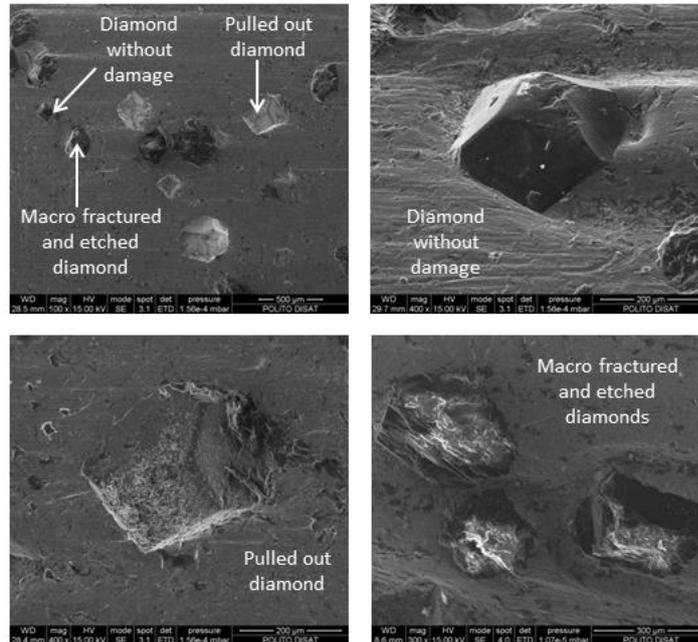
In this case, we observed diamonds arising from the surface without any damage, macro fractured, pulled out and etched (Figure 5).

Figure 5: Image of the surface of a worn diamond bead with diamond bits differently damaged

Diamonds without any damage are diamonds still able to cut stones and a “comet tail” is clearly visible behind them, because their presence prevent erosion of the metal matrix behind them by stone debris, during cutting. [8] The interface between the un-damaged diamond bits and the metal matrix is continuous and without any cracks, showing a high retention ability of the metal matrix and good sintering of the beads. [9] EDS analysis performed on the smooth surface of the un-damaged diamonds only shows the presence of carbon.

Some diamonds were pulled out during cutting and some voids are observable on the surface; the voids are often quite deep, showing that in these cases diamonds were pulled out before they were highly worn. The EDS analysis performed inside the voids deriving from pulled out diamonds shows the presence of Co and WC, which are the main components of the matrix. No porosity can be seen inside the voids of the pulled out diamonds, confirming a good sintering of the metal matrix.

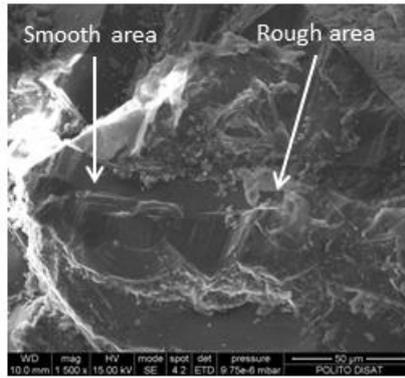
The most interesting diamonds grits are the macro fractured and etched ones. These diamonds are no longer able to cut stones and they do not show any “comet tail” behind them. Macro fractured diamonds do not highly protrude from the surface level and they still show a good interface with the metal matrix, showing that in some cases the retention ability of the metal matrix is too high: un-efficient diamonds without cutting ability are still maintained on the surface by the strong interface with the metal matrix. [10] The surface of the macro fractured diamonds shows both some smooth cleavage planes, deriving from a brittle fracture mechanism, and some rough areas probably deriving from etching (Figure 6). On the rough areas of the etched diamonds, EDS analysis shows the presence of an adherent layer of stone containing Fe, Ca Na, K, Mg and Si, suggesting that Fe containing stones are able to react with the diamonds causing a high degree of damage and macro fractures follow this etching.

Figure 6: Macro fractured and etched diamond

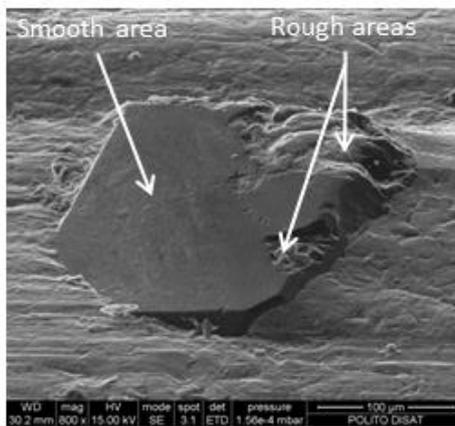
On one diamond grain, arising from the surface with an almost un-damaged and smooth surface, it was interesting to see the damage, probably due to etching and reaction with iron, in a first stage (Figure 7), limited to small areas: in this case macro fractures did not occur because of the limited etching.

Figure 7: An almost un-damaged diamond bit showing etching in a first stage

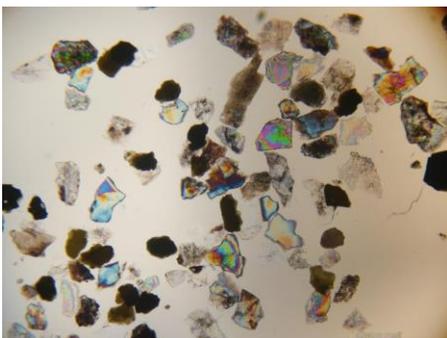
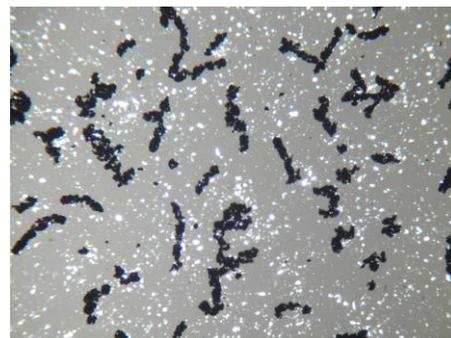
Figure 8: On the left micro-photo (6.9x5,19mm) with crossed nicols of mud particles >0.212mm and on the right micro photo (10.6 x 8mm)with parallel nicols of mud particles between 0.038-0.063mm.

Muds generated by stone cutting are mainly composed by stones debris and fraction of heavy metals (e.g. Co, Ni, Cu, Zn, Cr, W and their alloys) deriving from metal matrix. In particular, the magnetic separation shows, in the 0,038mm-0,063mm class, a higher amount of ferromagnetic particles coming from the metal matrix erosion, while, in the fine class (<0,038mm) the rock minerals (quartz in particular) are predominant: this is confirmed from the diffractometric analysis too (Figure 8). The sawmill mud contains heavy metals coming from the sawing tools: an example of 4 different muds sample (M1-M2-M3-M4) is in

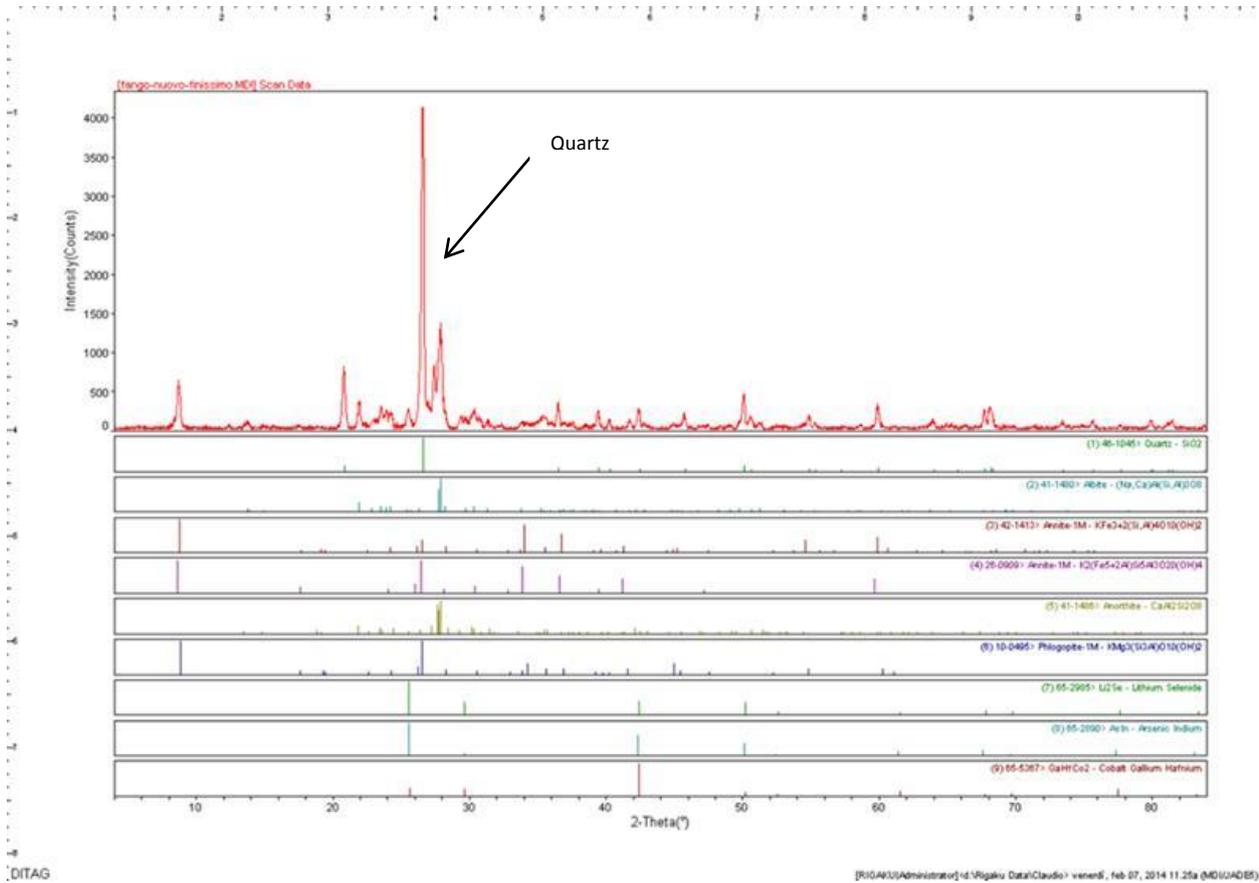
Figure 9: X- Ray Diffraction of muds <0,038 mm
