DIAMOND WIRE – STONE INTERACTION DURING THE CUTTING PROCESS: MECHANICAL, PHYSICAL AND CHEMICAL INVESTIGATIONS / Spriano, Silvia Maria; Ferraris, Sara; Bellopede, Rossana; Marini, Paola; Zichella, Lorena; Tori, Alice. - STAMPA. - 1:(2015), pp. 125-132. ((Intervento presentato al convegno International Conference on Stone and Concrete Machining tenutosi a Bochum nel 02-11-2015.

DIAMOND WIRE – STONE INTERACTION DURING CUTTING PROCESS: MECHANICAL, PHYSICAL AND CHEMICAL INVESTIGATIONS

S. Spriano¹, S. Ferraris¹, R. Bellopede², P. Marini², L. Zichella², A. Tori³

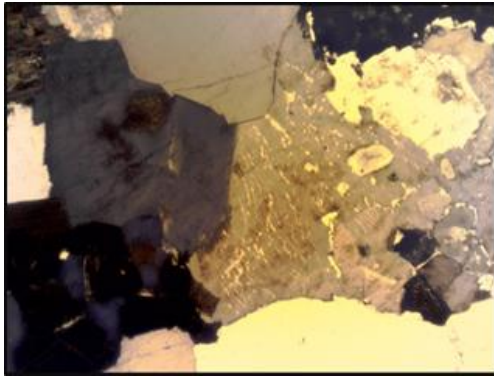
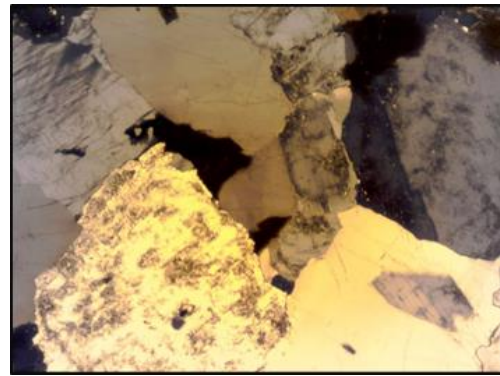
A. RG granite

B. GP granite

Figure 1: Thin sections of RG and GP granite (long side 4.3mm): microscopy crossed nicols, in black the ferrous components (biotite).

Figure 1 the thin sections of two different kind of Sardinian granite (RG and GP) are reported.

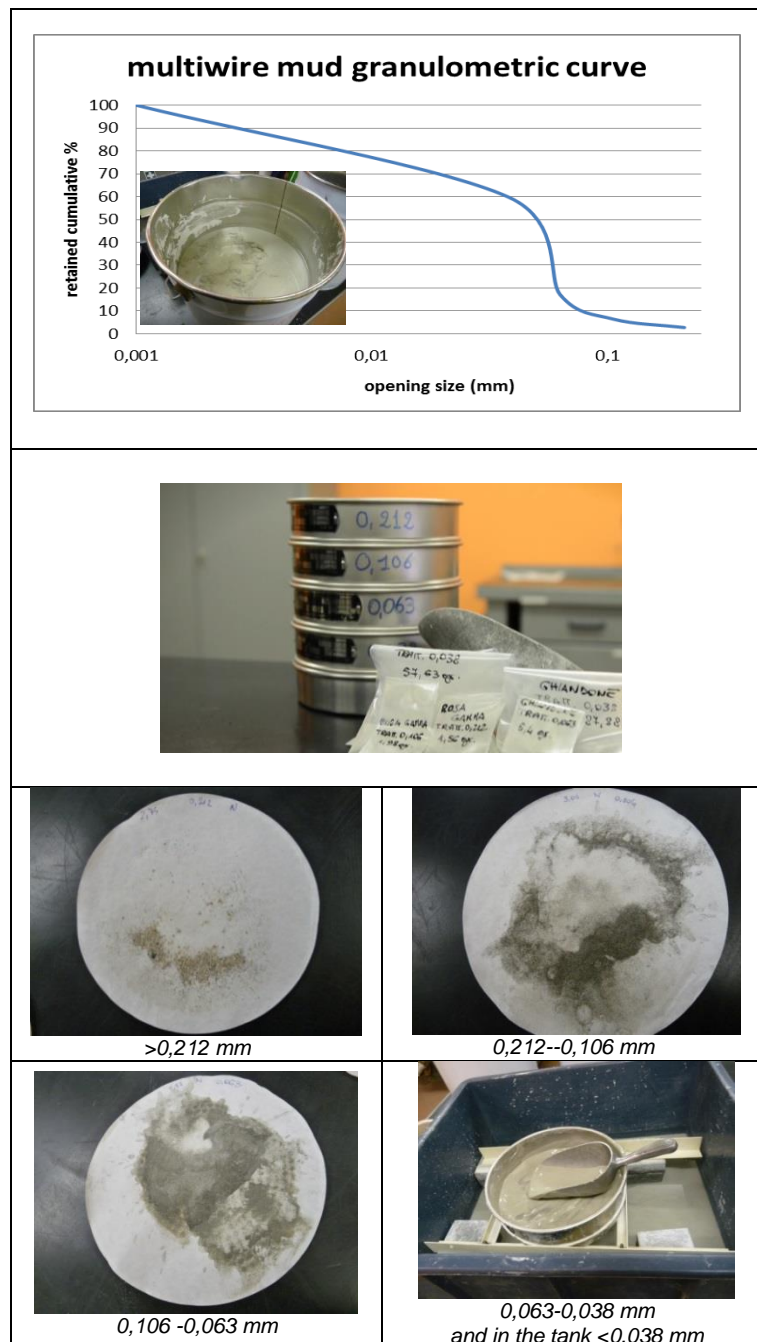
The granulometric curve of multiwire muds is shown in Figure 2; it is characterized by a high percentage (40.2%) of particles minor than 0,038mm.

Figure 2: size distribution process and characterization of multiwire muds

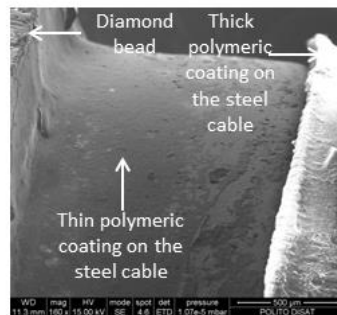
In the case of diamond wires used in cutting of Fe containing stones, we observed by SEM that the junction between the diamond beads and the steel rope is good and no wear was observed in this area (Figure 3). The steel rope is well covered by a thin or thick polymeric coating (polyurethane) at the junction between the rope and the diamond bead, without any erosion, detachment or wear of the coating (Figure 4).

Figure 3: SEM image at low magnification of the junction between the diamond beads and the steel rope

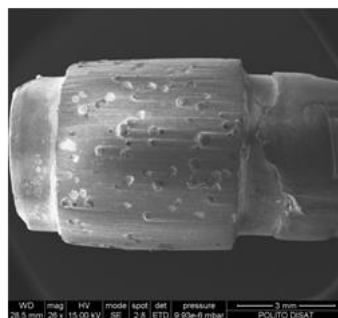
As first, we observed at low magnification that the beads almost maintain their shape after stone cutting and they are almost uniformly worn (see Figure 4) on all their length. The direction of cutting and rotation of the diamond wire can be derived by observing the presence of “comet tails” behind the diamond grits and the slight lower diameter of the bead on the left of the image: the first impact of the bead with the stone during cutting was on the left side, in this case.

Figure 4: SEM image at low magnification of a worn diamond bead

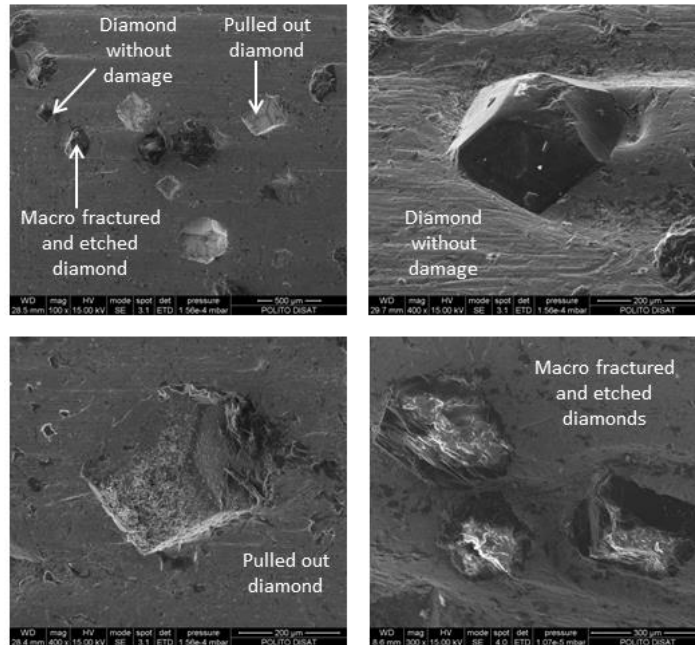
In this case, we observed diamonds arising from the surface without any damage, macro fractured, pulled out and etched (Figure 5).

Figure 5: Image of the surface of a worn diamond bead with diamond bits differently damaged

Diamonds without any damage are diamonds still able to cut stones and a “comet tail” is clearly visible behind them, because their presence prevent erosion of the metal matrix behind them by stone debris, during cutting. [8] The interface between the un-damaged diamond bits and the metal matrix is continuous and without any cracks, showing a high retention ability of the metal matrix and good sintering of the beads. [9] EDS analysis performed on the smooth surface of the un-damaged diamonds only shows the presence of carbon.

Some diamonds were pulled out during cutting and some voids are observable on the surface; the voids are often quite deep, showing that in these cases diamonds were pulled out before they were highly worn. The EDS analysis performed inside the voids deriving from pulled out diamonds shows the presence of Co and WC, which are the main components of the matrix. No porosity can be seen inside the voids of the pulled out diamonds, confirming a good sintering of the metal matrix.

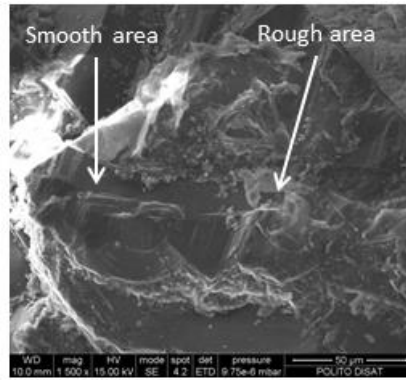
The most interesting diamonds grits are the macro fractured and etched ones. These diamonds are no longer able to cut stones and they do not show any “comet tail” behind them. Macro fractured diamonds do not highly protrude from the surface level and they still show a good interface with the metal matrix, showing that in some cases the retention ability of the metal matrix is too high: un-efficient diamonds without cutting ability are still maintained on the surface by the strong interface with the metal matrix. [10] The surface of the macro fractured diamonds shows both some smooth cleavage planes, deriving from a brittle fracture mechanism, and some rough areas probably deriving from etching (Figure 6). On the rough areas of the etched diamonds, EDS analysis shows the presence of an adherent layer of stone containing Fe, Ca Na, K, Mg and Si, suggesting that Fe containing stones are able to react with the diamonds causing a high degree of damage and macro fractures follow this etching.

Figure 6: Macro fractured and etched diamond

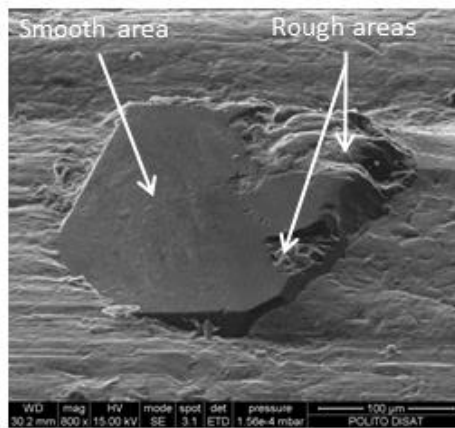
On one diamond grain, arising from the surface with an almost un-damaged and smooth surface, it was interesting to see the damage, probably due to etching and reaction with iron, in a first stage (Figure 7), limited to small areas: in this case macro fractures did not occur because of the limited etching.

Figure 7: An almost un-damaged diamond bit showing etching in a first stage

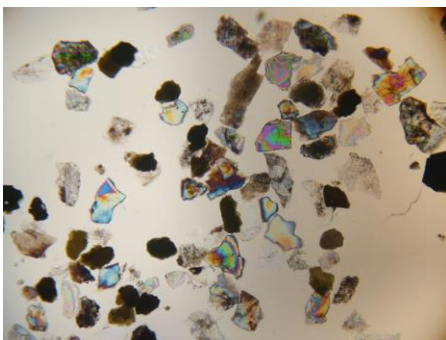
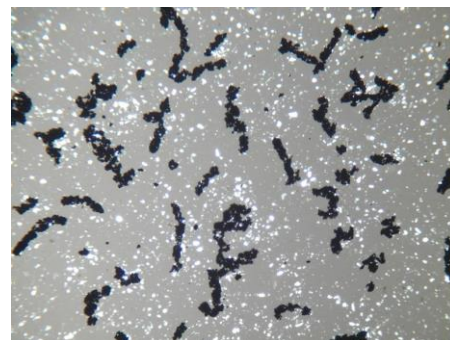
Figure 8: On the left micro-photo (6.9x5,19mm) with crossed nicols of mud particles >0.212mm and on the right micro photo (10.6 x 8mm)with parallel nicols of mud particles between 0.038-0.063mm.

Muds generated by stone cutting are mainly composed by stones debris and fraction of heavy metals (e.g. Co, Ni, Cu, Zn, Cr, W and their alloys) deriving from metal matrix. In particular, the magnetic separation shows, in the 0,038mm-0,063mm class, a higher amount of ferromagnetic particles coming from the metal matrix erosion, while, in the fine class (<0,038mm) the rock minerals (quartz in particular) are predominant: this is confirmed from the diffractometric analysis too (Figure 8). The sawmill mud contains heavy metals coming from the sawing tools: an example of 4 different muds sample (M1-M2-M3-M4) is in

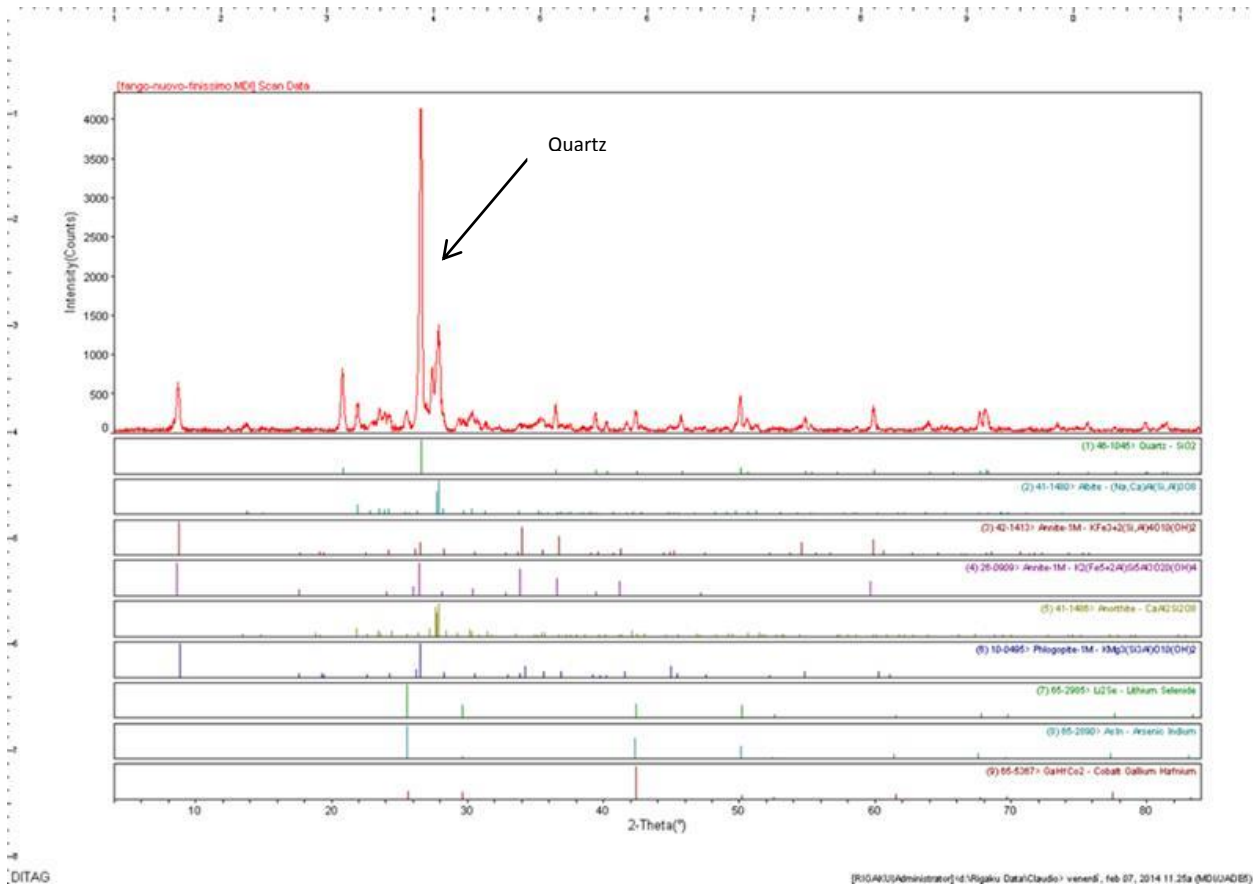
Figure 9: X- Ray Diffraction of muds <0,038 mm

Each one of the classes obtained through the granulometric separation has been processed with a wet magnetic separation (Co-Al – Ni magnet). On the size classes minor than 0,063mm a further analysis by means of X – Ray Diffraction (XRD) have been performed.
