DIAMOND WIRE – STONE INTERACTION DURING CUTTING PROCESS: MECHANICAL, PHYSICAL AND CHEMICAL INVESTIGATIONS

S. Spriano¹, S. Ferraris¹, R. Bellopede², P. Marini², L. Zichella², A. Tori³

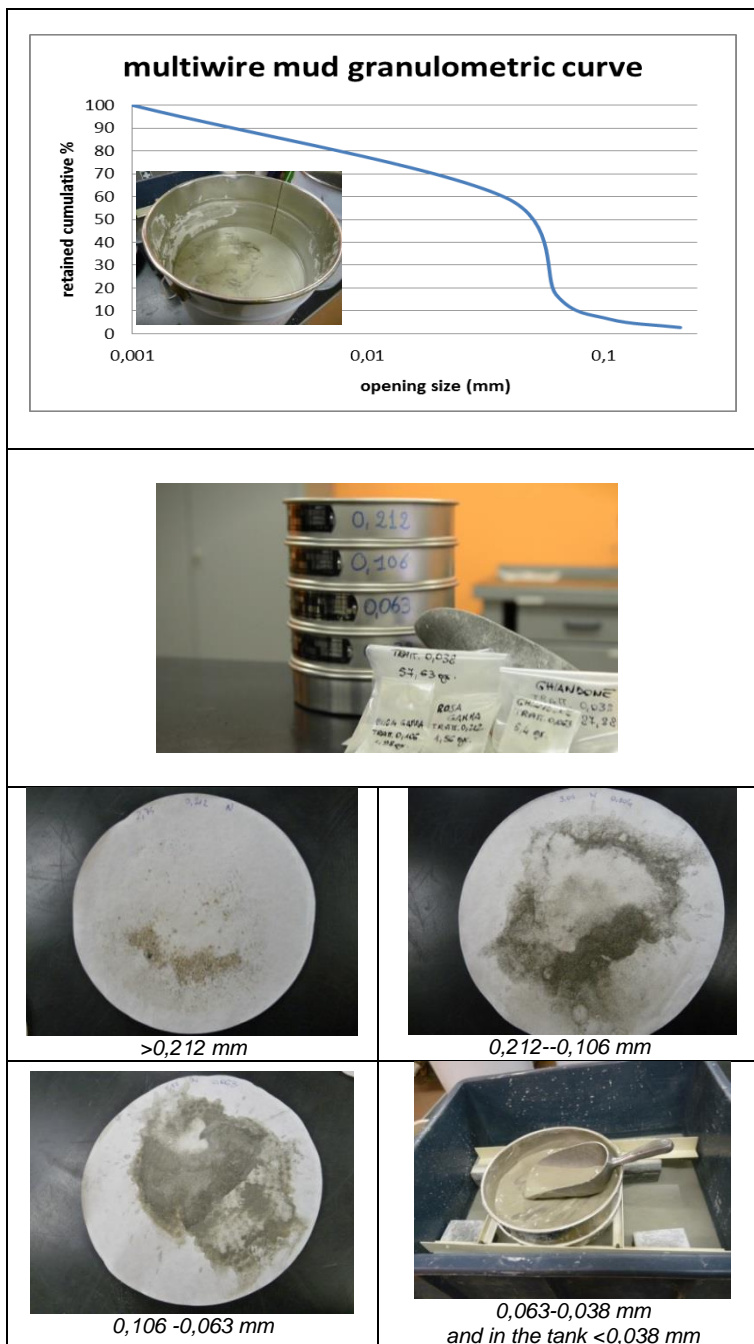
Figure 2: size distribution process and characterization of multiwire muds

The granulometric curve of multiwire muds is shown in Figure 2; it is characterized by a high percentage (40.2%) of particles minor than 0,038mm.
