Stabilization of earthen plasters: Exchange of knowledge and experiences between Italy and Morocco

Stabilization of earthen plasters: Exchange of knowledge and experiences between Italy and Morocco / Mattone, Manuela; Ibnoussina, M.; Rescic, S.; Fratini, F.; Magrini, D.; Mecchi, A. M.; Nocairi, M.. - In: JOURNAL OF MATERIALS & ENVIRONMENTAL SCIENCE. - ISSN 2028-2508. - ELETTRONICO. - J. Mater. Environ. Sci.:7(10)(2016), pp. 3647-3655.

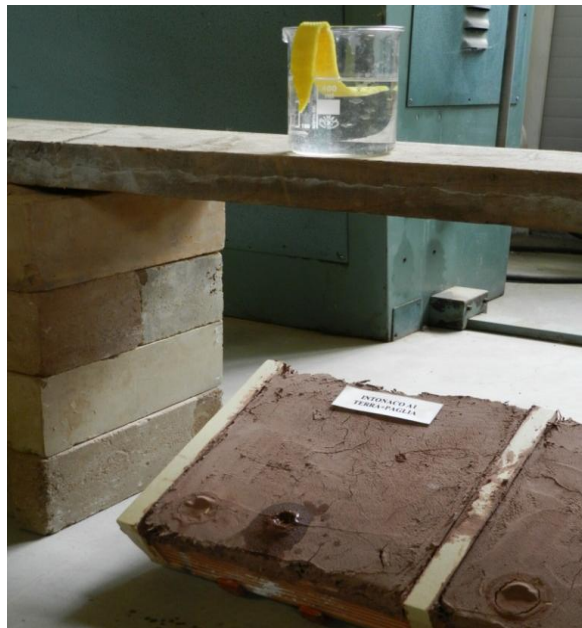
The Geelong test is based on the measurement of the samples' erosion caused by the repeated impact of a water drop (from an height of 400 mm and for a total of 100 ml) on the tested surface which is placed at an angle of nearly 30° to the horizontal (Figure 1). The evaluation is done by measuring the cavity depth due to the impact of the water drop on the surface.

Figure 1: The Geelong test (Manuela Mattone).

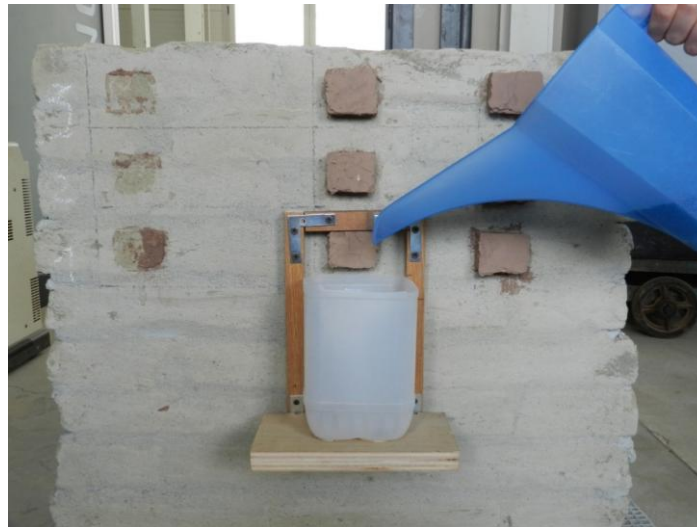
In order to evaluate the bond of the plasters to the wall, shear tests were conducted according to what suggested in recent researches (Hamard et al., 2013). Three specimens (size 40x50x20 mm) of each kind of plaster were prepared. The shear test measures the load necessary to make the specimen fail. Each specimen was loaded with little lead balls until fail, using a special device (Figure 2). The load at which the sample fails was recorded. It was possible to evaluate the average shear stress (τ , N/mm²) of each plaster considering the failure load (m_f , Kg) and the surface (S , mm²) of the samples since $\tau = m_f \times g / S$, where $g = 9.81 \text{ m/s}^2$.

Figure 2: The shear test device (Manuela Mattone).

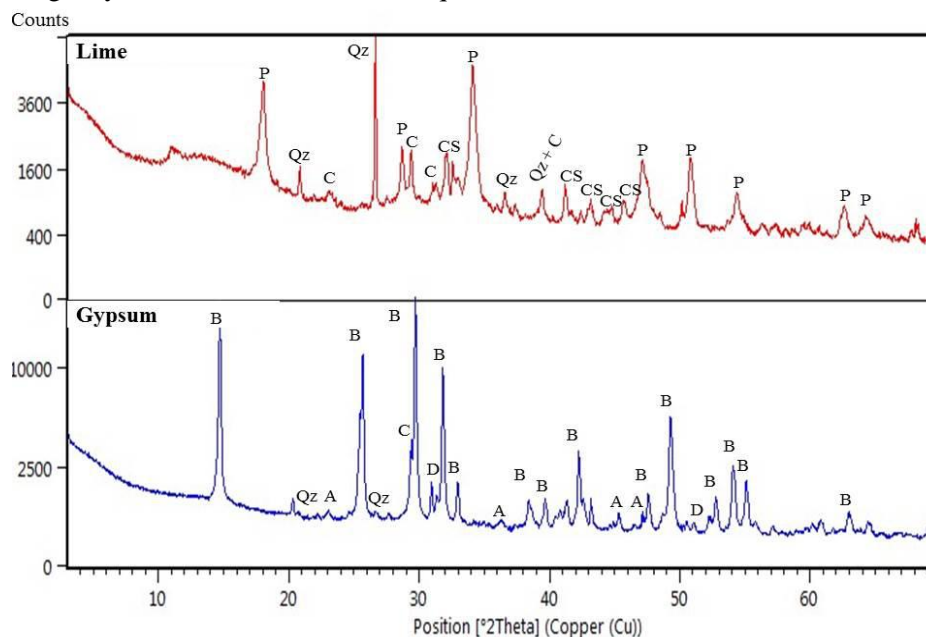
Figure 3: XRD spectra of Moroccan lime and gypsum. Calcium silicate (larnite) is a typical compound of hydraulic lime (P=portlandite; CS=calcium silicate; B= bassanite; A= anhydrite; Q=quartz, C=calcite, D=dolomite).

The composition of the Moroccan starting materials carried out by XRD analysis is described in Table 3 and Figure 3.

The mineralogical investigation made it possible to verify that the gypsum can be ascribed to a “soluble anidrite” while the lime is a natural hydraulic lime due to the presence of β -calcium silicate (larnite). After 28 days of curing, as new mineralogical phases, we have evidenced the presence of calcite in earthen plaster stabilized with lime and presence of calcite in earthen plaster stabilized with gypsum (Fig.4). Hydraulic phases due to hydration of larnite (CS) or pozzolanic reaction between calcium hydroxide (portlandite) with clay minerals have not been identified (may be due to amorphous state or low crystallinity).

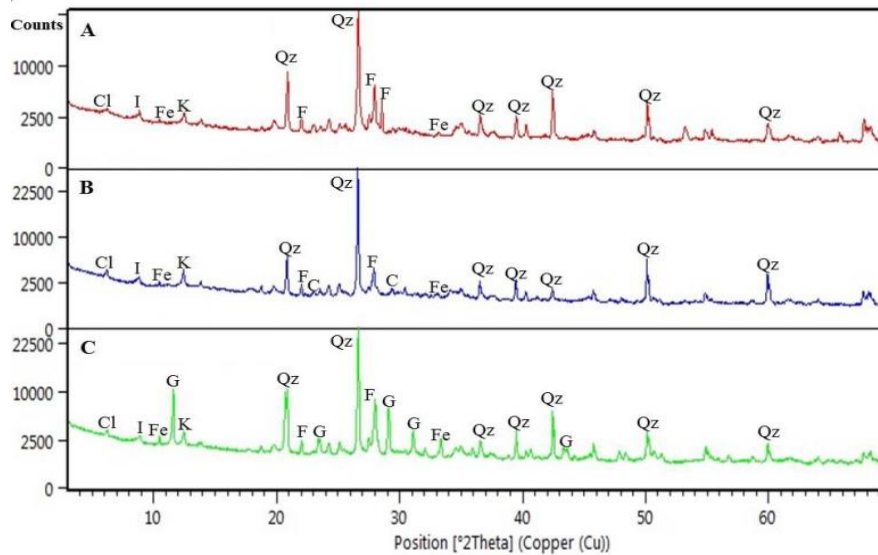
Figure 4: Comparison among XRD spectra of earthen plaster made with only earth (A) earth + lime (B) and earth + gypsum (C). Qz=quartz, F=feldspars, C=calcite, D=dolomite, P=portlandite, I=illite, K=kaolinite, Cl=chlorite; G= gypsum, Fe= iron oxides.

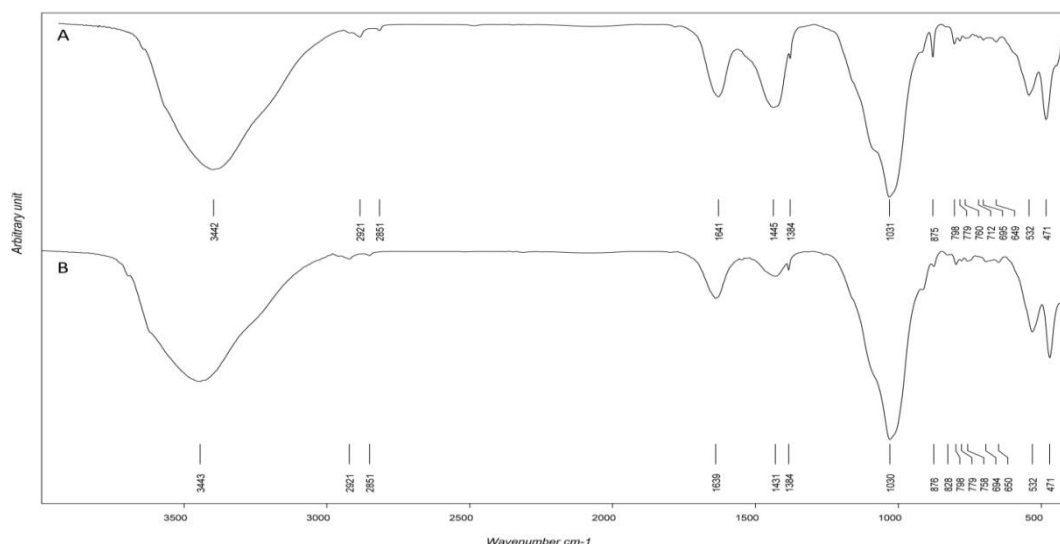
In Figure 5 the results of mid -IR investigation carried out on earth - lime samples (graph A) compared to those obtained from the earth ones (graph B), are shown.

Figure 5: Mid -IR spectra: comparison between sample of earth with lime (graph A) and sample of only earth (graph B).

The spectra are very similar and IR bands are comparable. In particular, in both spectra, the following peaks are present: symmetric and asymmetric stretching of Si-O ($800-1000\text{cm}^{-1}$, silicates) and, specifically, a high peak at 1030cm^{-1} attributable to stretching of Si-Al-O (aluminosilicates); deformation of SiO_4 tetrahedron ($400-500\text{cm}^{-1}$, silicates) (Hanke, 1986); asymmetric stretching of CO_3^{2-} ($1400-1500\text{cm}^{-1}$, carbonates) and a shoulder

of bending out-of-plane of CO_3^{2-} ion (875cm^{-1} , carbonates) (Hunt 1971); bending H-O-H of molecular H_2O (1640cm^{-1}) and $-\text{OH}$ stretching vibration of H_2O ($2800\text{--}3700\text{cm}^{-1}$) (Williams, 1966). It should be noted that, the main vibrations characteristics of C-S-H compounds (peak at $\sim 970\text{cm}^{-1}$ and two shoulders at $\sim 1060\text{cm}^{-1}$ and 900cm^{-1}), related to Si-O stretching vibrations of the Q2 tetrahedra (Trezza, 2007, Yu, 1999), are not visible (probably they are hidden by the broad band of silicates at $800\text{--}1000\text{cm}^{-1}$).

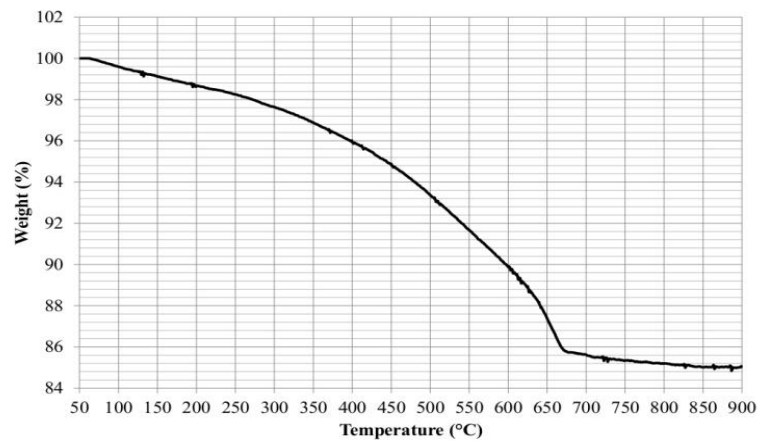
The result of the thermal analysis carried out on the sample of earth - lime plaster (B) is shown in Figure 6.

Figure 6: Thermogravimetric curve of sample of earth with lime (plaster B).

The thermogravimetric curve (Figure 6) indicates that the dehydration of the earth + lime sample occurs in more stages: $60\text{--}110^\circ\text{C}$ loss of absorbed water; $130\text{--}190^\circ\text{C}$ loss of water from calcium silicate hydrates (CSH) (Eskander et al, 2012); $250\text{--}450^\circ\text{C}$ loss of water from different stages of dehydration of C-S-H and calcium aluminate hydrates, and loss of water from dehydration of interlayer water of clay minerals (Eskander et al, 2012; ěč et al, 2013; Plante et al., 2009); $450\text{--}600^\circ\text{C}$ expulsion of OH-ion from the clay mineral lattice (dehydroxylation) (Plante et al., 2009); $600\text{--}680^\circ\text{C}$ dehydroxylation of clay mineral and initial stage of decomposition of carbonates ion associated with calcite (Eskander et al, 2012); $680\text{--}900^\circ\text{C}$ decomposition of carbonate ions of calcite (Eskander et al, 2012). It should be noted that this analysis is the only one that allows to evidence the presence, as expected, of products of larnite's hydration.

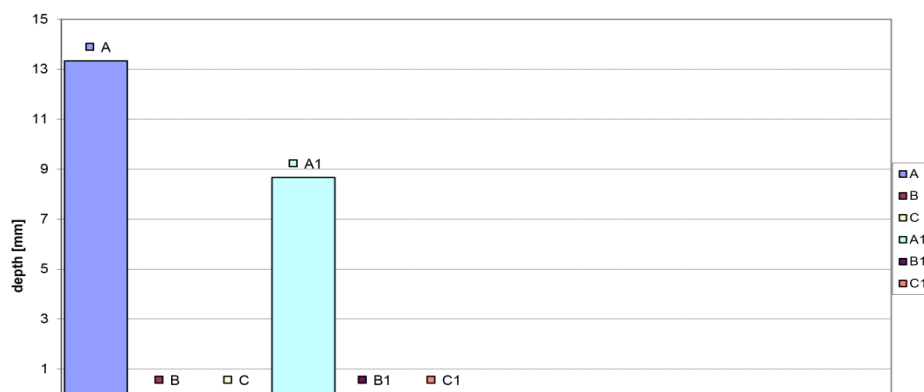
The Geelong test shows that, except for the earthen plasters (A and A1) which failed, all the other tested samples were not eroded at all (Figure 7). Concerning the Spray test as well (Figure 8) higher erosion resistance is evidenced for the stabilized earths. In particular, the erosion is none for the plasters stabilized with lime (B and B1).

Figure 7: Diagram showing Geelong test results (in ordinates is the depth of erosion)

The performance tests carried out in laboratory show that, with regard to water resistance (determined with the Geelong test and spray test), the addition of lime gives the best results. To be noted however that the plaster with no additives has not withstood the test.

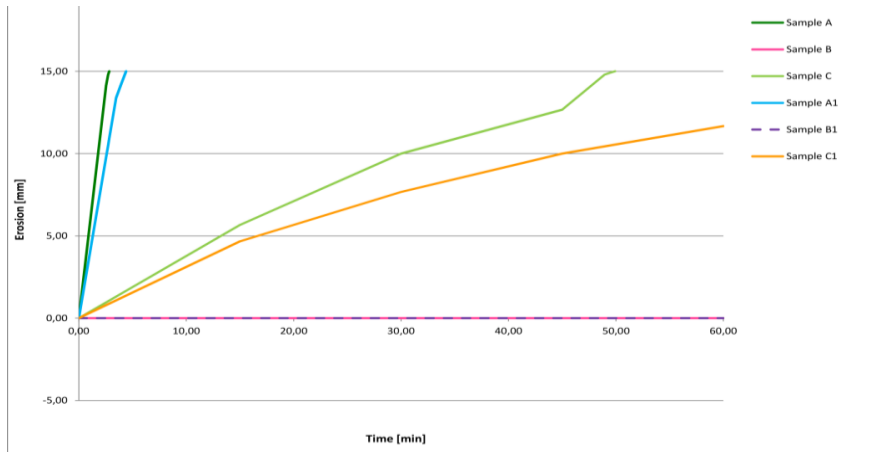
Figure 8: Diagram showing the erosion spray test results

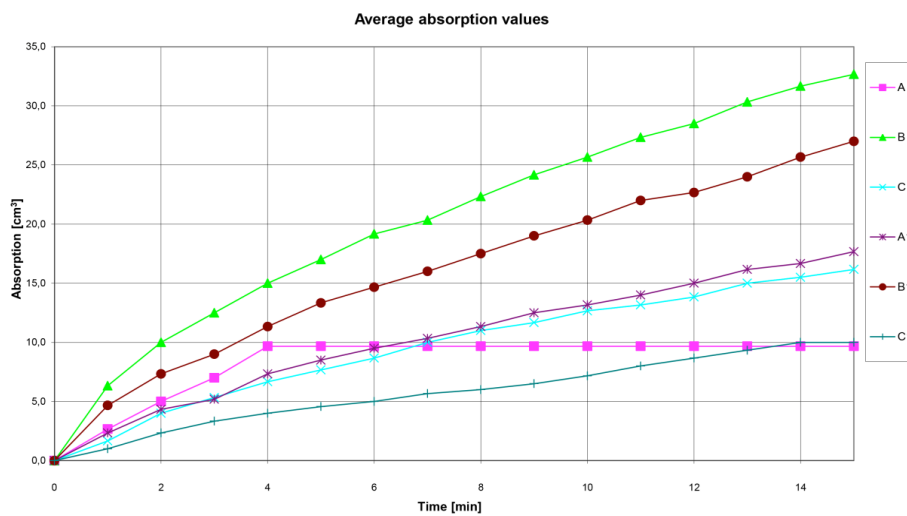
The water absorption test shows that, while gypsum (C and C1) reduces the rate of water absorption, the lime (B and B1) determines an increase of absorption with respect to the earth plaster (A) and the earth + straw (A1) (Figure 9).

Figure 9: Diagram showing the water absorption test results.

With regard to the capillary absorption capacity, the values obtained show that gypsum has reduced it while the addition of lime has made the plaster more absorbent. With regard to shear tests, the presence of straw generally worsens the behaviour, while for gypsum and lime, the best performance has been obtained by the first one. Regarding the permeability to water vapour, it keeps almost unchanged in all the plasters.

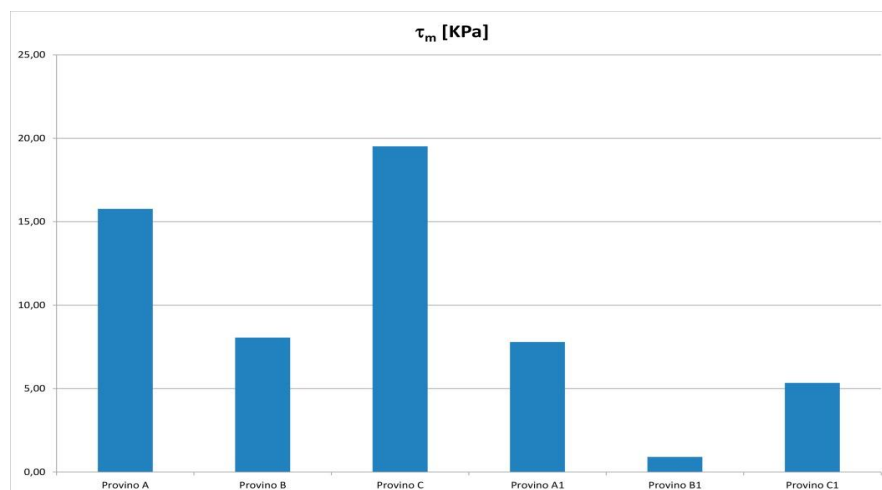
The shear test point out that all the plasters made with straw (A1, B1, C1) are characterized by a lower shear strength compared to the others (Figure 10). The higher shear strength was obtained for the plaster stabilized with gypsum (C). However the results are quite scattered, which could be due both to heterogeneities of the wall and to the dimensions of the samples that makes it difficult to guarantee a good application of the coating. Therefore, the shear strength should be evaluated preparing more samples and increasing their size.

Figure 10: Shear test to evaluate the bond of the plasters to the wall (τ_m [KPa]).
