Optimization of Three-Dimensional (3D) Multi-Sensor Models For Damage Assessment in Emergency Context: Rapid Mapping Experiences in the 2016 Italian Earthquake

Giulia Sammartano

Politecnico di Torino, Department of Architecture and Design, Torino, Italy;
giulia.sammartano@polito.it

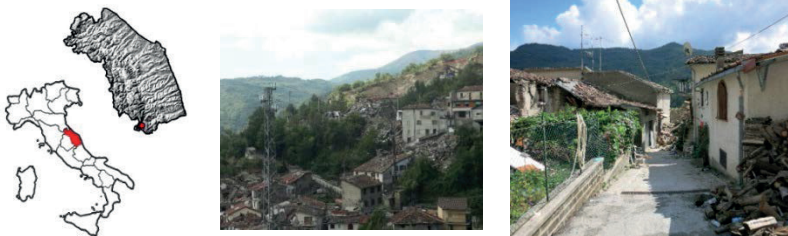
Figure 3. Pescara del Tronto in Arquata del Tronto municipality (Ascoli Piceno), is one of the perched villages allocated across the Apennines mountain in Marche region (left, center), center Italy, on the border with regions Abruzzo, Lazio, Umbria. It was destroyed by the reiterated seismic shocks from

The present contribution is focused on the ancient perched village of Pescara del Tronto (Figure 3), in Arquata del Tronto municipality. The techniques that were deployed by the teams have been focused on the documentation post-disaster of the whole village with multi-scale approach and resulting assorted multi-sensor acquisitions. Groups of differently damaged buildings were examined, with the combined use of terrestrial and aerial sensors.

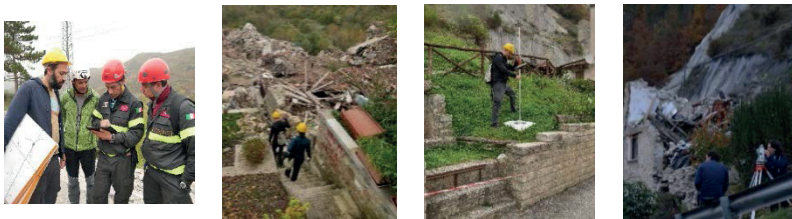
Figure 4. Survey operation during the setting up of the topographic measurements. A moment of the aerial markers planning and placing on ground with fire fighters (left). Global Navigation Satellite System (GNSS) measurements on target disseminated in more or less accessible areas in the neighborhood of the damaged building, with the Leica System 1200 GNSS receiver (center left and right), Leica TS06 total station topographic survey (right).

The whole area in Pescara del Tronto involved in the metric survey was covered by almost 40 GCP materialized on ground by targets as Figure 4. Three of these targets were positioned in the neighborhood of the damaged building. Moreover, for each building that was measured and imaged by multi-sensor acquisitions, a set of natural points were detected on buildings. For the buildings blocks points have been measured on the main elements, as the roof edges, the façade, the windows and the door, and the stone elements are useful for both the aerial and the close-range blocks.

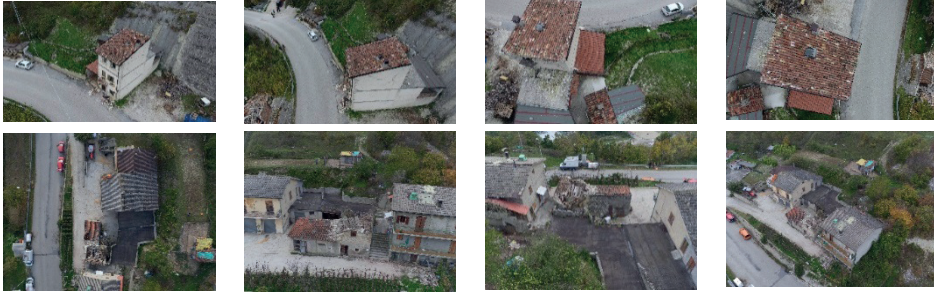
Figure 7. Samples datasets of acquired images by flights. North area, Phantom4 (first row) and South area, Inspire1 (second row).

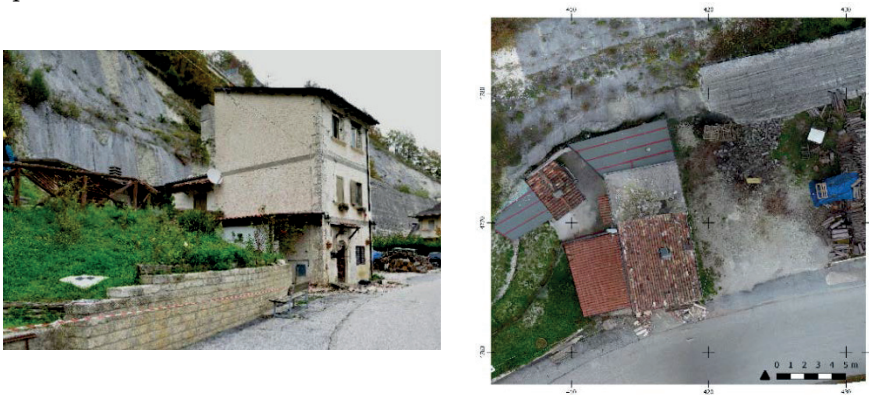
Figure 14. An images of the building n°5 in October 2016 and relative orthoimage by multi-rotor drone (aerial images of both shooting and frames extraction from 4k video with DJI drone).

A pertinence area around the test building have been chosen too (Figure 14). A large amount of information have been extracted from aerial and terrestrial acquisition and classified from images and 2D/3D production, as in following examples.

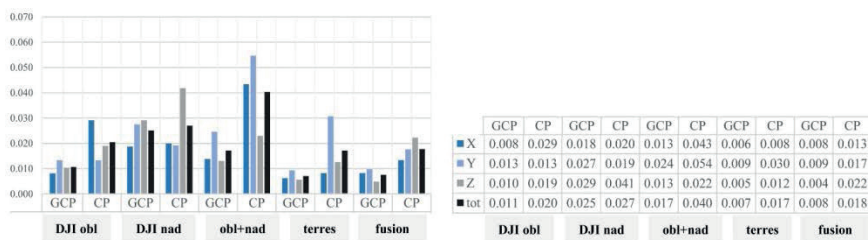
Figure 15. Accuracy on ground control points (GCPs) and Check Points (CPs) RMSE (m): DJI flights, fusion of aerial data, close-range acquisition, and global integration of photogrammetric datasets. We can consider this last one as the best verified result so that it can be used as ground-truth.

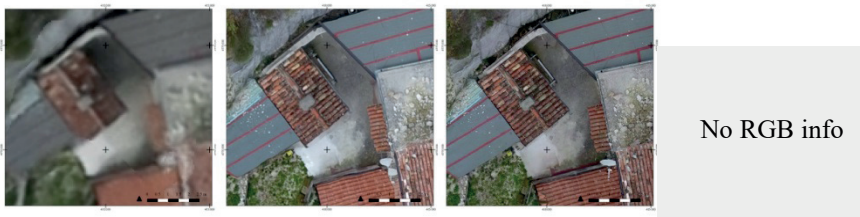
Figure 16a. Comparison, on a small area, between used platforms and sensors: eBee, average GSD of 5 cm/pixel (left); DJI Phantom, average GSD of 2.18 cm/pixel (center left); fusion model, average GSD of 0.92 cm/pixel (center right); no RGB data from Zeb1.

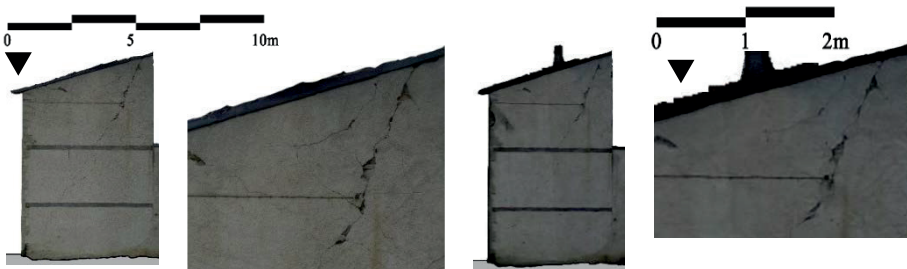
Figure 17. Orthoimage of the East side. The aerial model by integrated oblique and nadir cameras (right), can be comparable in terms of available detail and the accessible information to the terrestrial photogrammetric one (left).

A photogrammetric model by commercial DJI drone, as in Orthoimage, is highly competitive in terms of quality of RGB information. The standard of comparison is a well-known terrestrial close-range photogrammetry, a solution that is less viable in these contexts of timing and accessibility to spaces. Most damages and creeps on all of the façades are clearly visible even in the aerial model (as in example in Figure 17), better than in the fusion one. More reflections
