Optimization of Three-Dimensional (3D) Multi-Sensor Models For Damage Assessment in Emergency Context: Rapid Mapping Experiences in the 2016 Italian Earthquake

Giulia Sammartano

Politecnico di Torino, Department of Architecture and Design, Torino, Italy;
giulia.sammartano@polito.it

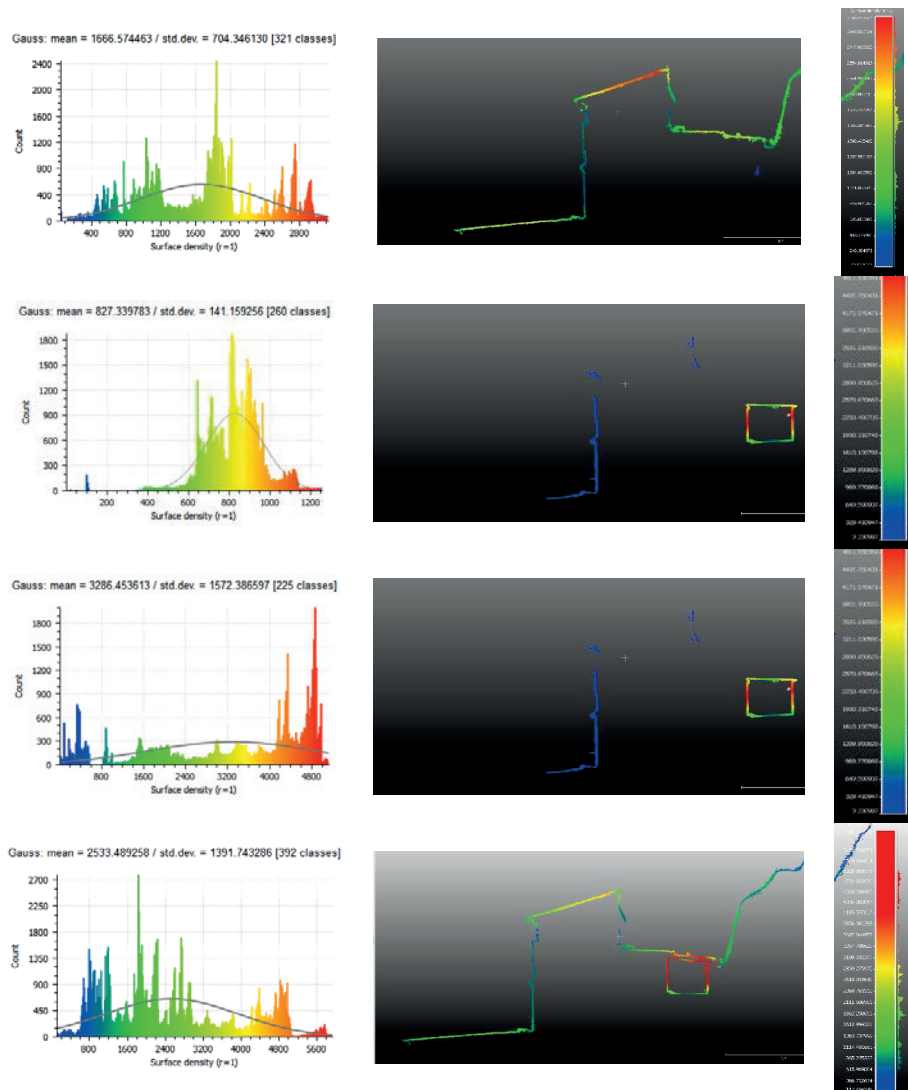
Figure 19. Density for aerial point cloud (1), data fusion point cloud (2), ZEB point cloud (3), and integrated Light Detection and Ranging (LiDAR) and aerial point cloud (4).

We can affirm that the extensiveness data from fusion of terrestrial and aerial images can be integrated with a union of the LiDAR ZEB1 data (Figure 19) that have been georeferenced, in order to produce a complete profile of the building with hits geometry in relationship with the rear rock face.
