Energy in cultural heritage: the case study of Monasterio de Santa Maria de Monfero in Galicia

ENERGY IN CULTURAL HERITAGE: THE CASE STUDY OF MONASTERIO DE SANTA MARIA DE MONFERO IN GALICIA

Lisitano, Ivana Mattea¹; Laggiard, Deborah¹; Fantucci, Stefano²; Serra, Valentina^{2*}; Bartolozzi, Carla³; Blanco Lorenzo, Enrique Manuel⁴; Sabín Díaz, Patricia⁴;

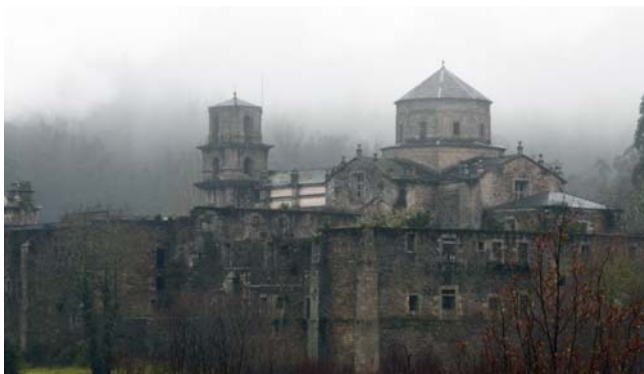
Fig.1 Monastery of Santa Maria de Monfero, view of the complex

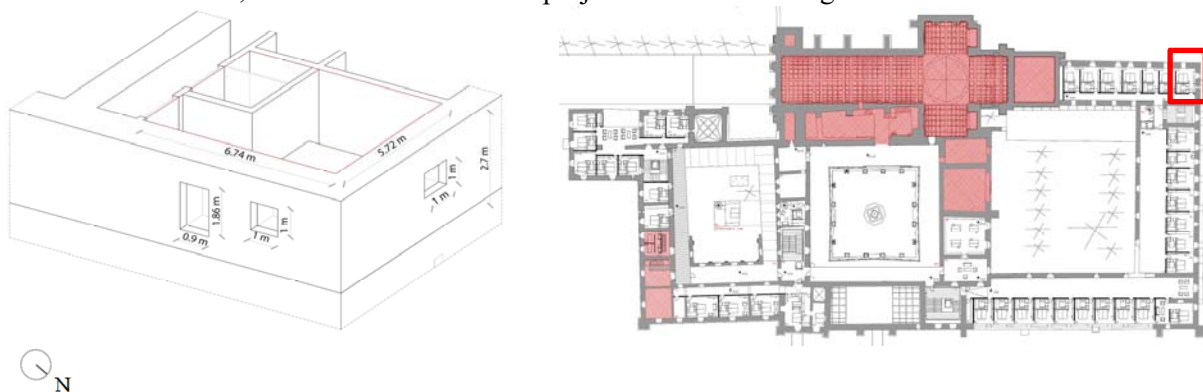
Following extensive hygrothermal simulations on a building component, the dynamic energy simulations were then extended to an indoor environment. The indoor environment examined was a standard hotel room, as defined in the winner project and shown in Fig. 4.

Fig. 4 Axonometric view of the room and floor plan

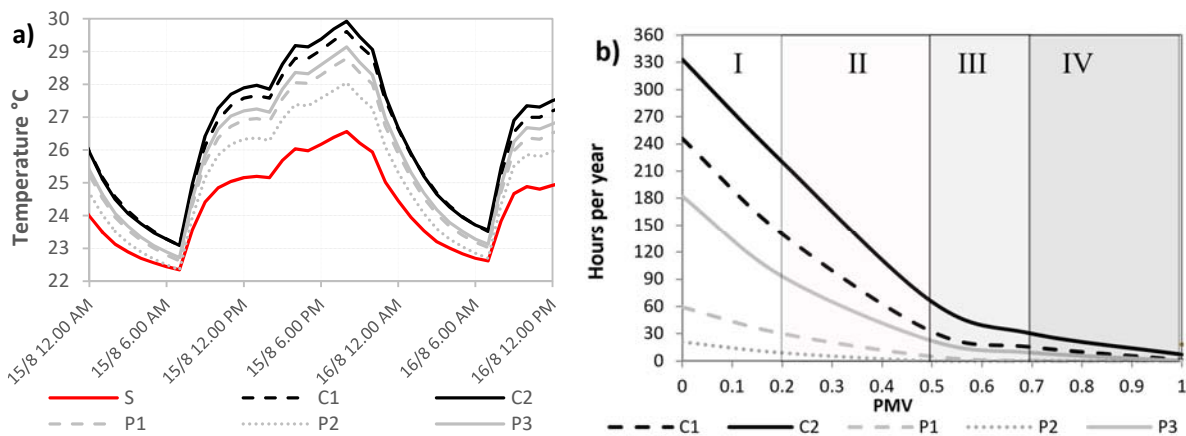
Fig. 6 a) Indoor temperature on August 15th b) Number of hours per year within a certain thermal comfort category.

Analysing the operative temperature, the chart in fig. 5 shows that plasters solutions for most of the hours of the summer period achieve the class I and II, which correspond respectively at $0 < PMV < +0.2$ and $+0.2 < PMV < +0.5$, meaning high level and normal level of comfort expectation. The number of hours in which plaster achieves these classes is significantly lower if compared to counter-walls, since the indoor environment presents mainly negative PMV values (cold thermal sensation), but this drawback could be easily overtaken with higher clothes resistances. The other classes III and IV are reached for a limited number of hours which means that by adopting these plasters solutions during the summer period it is possible to obtain acceptable levels of indoor temperature avoiding the use of cooling systems. The counter-walls achieve the class I and II for a longer period of hours but contemporarily the number of hours with temperatures providing a $PMV > 0.5$ is 3 times greater than the plasters solutions.
