Energy in cultural heritage: the case study of Monasterio de Santa Maria de Monfero in Galicia

ENERGY IN CULTURAL HERITAGE: THE CASE STUDY OF MONASTERIO DE SANTA MARIA DE MONFERO IN GALICIA

KEYWORDS: historical building retrofit; internal wall insulation; heat and moisture simulations; cultural heritage; indoor thermal comfort;

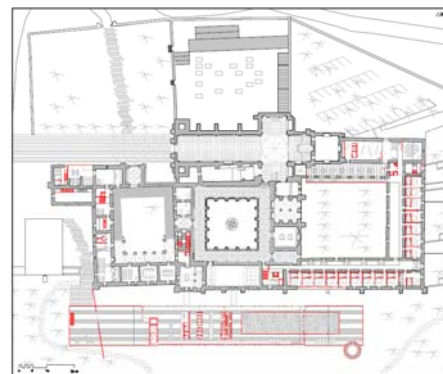
Fig.2 Hotel Spa proposal project - Ground Floor plan

On July 2004 the “Consellería de Cultura, Comunicación Social e Turismo” announced the contest of ideas for the rehabilitation of the monastery in hotel-spa. Enrique Blanco and Patricia Sabin Diaz were the winner of the first prize. Among others, competitors were Labics from Rome, Francisco Mangado from Navarra or Estudio Cano Lasso from Madrid [13]. The main ideas of the designers was to maintain the original aesthetics of the Monastery, without altering the perception and feeling that the building provided to the visitors. The first actions were cleaning and securing the unstable parts of the building. The project provide minimum interventions respecting as much as possible the existing masonry: new holes for the windows and doors were open only where essential, covering were provided where missing.

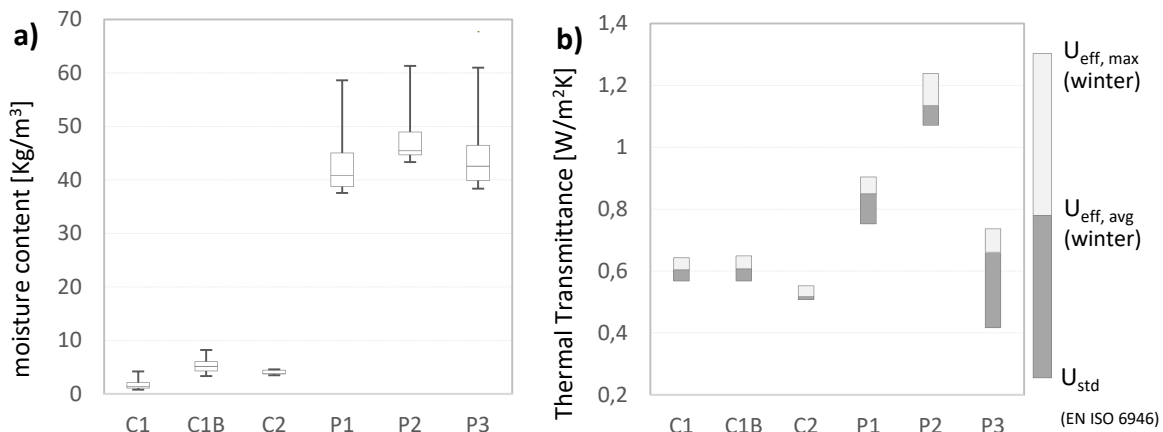
Fig.3a shows the moisture content mc (kg/m^3) of the insulating layers: mineral wool and PUR (counter wall) and thermal plasters. Simulations were performed for 3 years, but the results refer to the last year of simulations since it is not influenced by the initial conditions. The box-plots summarise all the hourly moisture content results, and the maximum and minimum value are indicated for all the design

alternatives. The bottom and top of the box represent the first and the third quartile, and the band inside the box is the median of the data (second quartile).

The results shows higher water content on the thermal plaster configuration due to the higher capability of plasters to absorb and store moisture if compared to mineral wool and PUR. The results show mc values of plaster (P1, P2, P3) from 5 to 10 times higher if compared to the counter wall configuration. The data concerning the thermo-hygrometric behaviour of the various solutions allow to make further discussion on the use of vapour barriers. The result reveals that in C1 the addition of a vapour barrier (C1_B) between the gypsum board and the mineral wool layer determine an increase of the moisture content. Although the current practice suggests to add the vapour barrier on the warm side of the insulation, in this particular case (unprotected external walls exposed to driving rain) the presence of water vapour does not allow the re-evaporation of moisture on the interior side resulting in a non-negligible moisture storage inside the insulation layer. For this specific case the result is not effective and should be avoided, the values of mc for C1 reach a maximum of about 4 kg/m³ compared to 8 kg/m³ with a vapour barrier (C1_B).

Fig.3 a) Box-plot analysis: moisture content in the insulation layer mc [kg/m³],
 b) Wall thermal transmittance U [W/m²K] calculated for winter period (October – April)

The variation of the thermal transmittance (first-third quartile and median value) during the winter period are illustrated in Fig.3b. Results demonstrate how much the environmental conditions affect the performance of the insulation layer, even if it is placed on the inner side. Indeed an important factor that affects the thermal performance is represented by the water content in the insulating layer.

A clear difference between the value of U_{std} (thermal transmittance) calculated according to EN ISO 6946:2007 (considering dry materials) and the U_{eff} calculated taking into account the moisture dependency of the thermal conductivity was observed, in particular:

- A higher difference between U_{std} and $U_{eff, avg}$ was observed in plasters due to the presence of high moisture content;
- All the retrofit configurations show a reduction of the U_{std} from the initial value of the bare wall (~ 2.8 W/m²K), between 62% (P2) and 83% (P3);

- Counter wall configurations presents lower $U_{eff,avg}$ (between 0.52 and 0.61 W/m^2K). Nevertheless, plaster P3 (aerogel based) shows slighter higher $U_{eff,avg}$ results, even though in line with the counter wall systems (0.66 W/m^2K).

As the bar graph shows, always result in $U_{eff,max} > U_{dry}$, due to the presence of moisture on the configuration. In general, it appears how this phenomenon is more impacting on thermal plaster than on the counter wall. Actually the $U_{eff,avg}$ value for the plaster configurations results almost 17% higher than U_{std} , while the $U_{eff,avg}$ value of the counter wall grow from 12% to 33%.

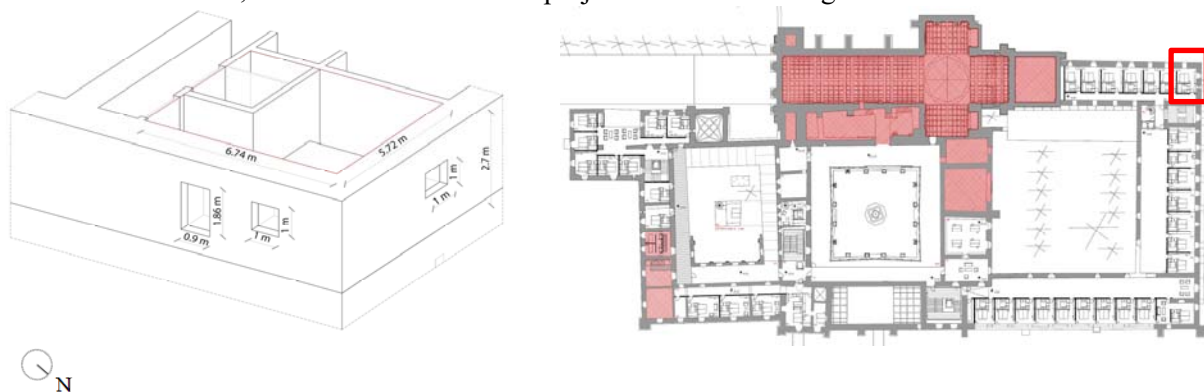
Following extensive hygrothermal simulations on a building component, the dynamic energy simulations were then extended to an indoor environment. The indoor environment examined was a standard hotel room, as defined in the winner project and shown in Fig. 4.

Fig. 4 Axonometric view of the room and floor plan

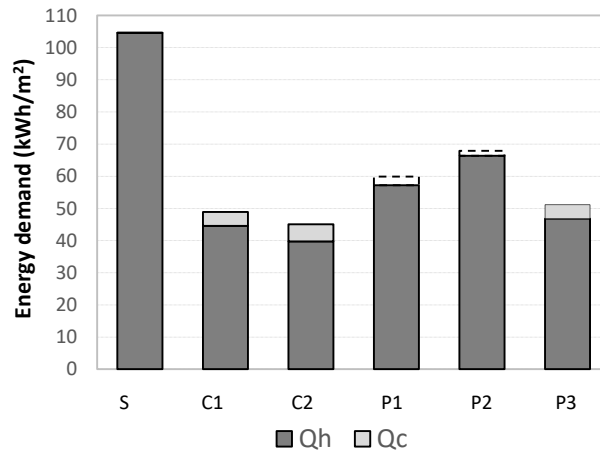
Fig. 5 Annual net energy demand for heating (Q_h) and cooling (Q_c).

For the evaluation of the right strategy to be adopted, another crucial aspect is related to the energy saving potential of the intervention in term of heating and cooling energy demand reduction. The bar chart in fig.6, shows that counter-walls have lower consumption than the thermal plaster, but is also clear that the energy consumption for cooling, using thermal plaster, is near to zero. Moreover considering that, from the comfort point of view, only few hours per year presents a PMV higher than +0.7, evidence the possibility to avoid the installation of cooling systems with some advantages in particular for historic buildings in term of space saving issues, HVAC elements integration and as far as economic aspects are concerned.

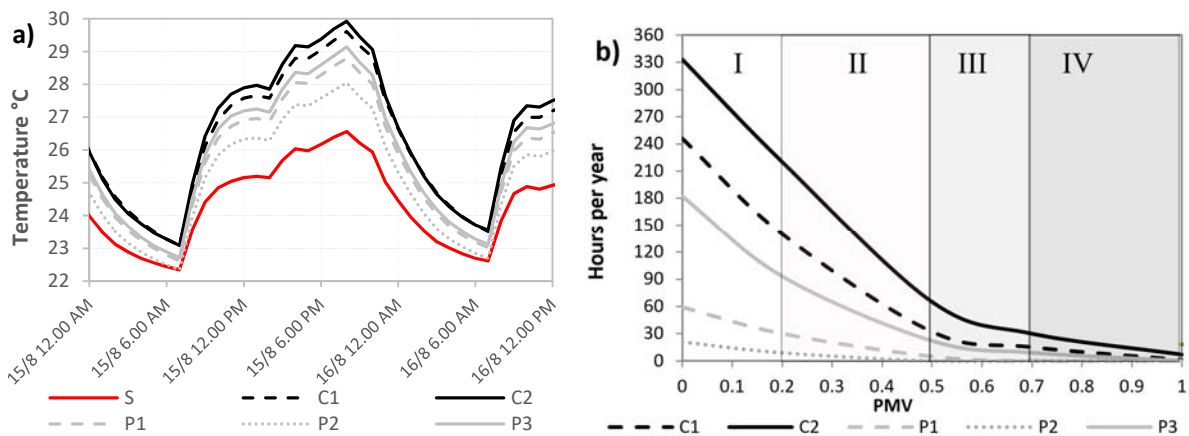
Fig. 6 a) Indoor temperature on August 15th b) Number of hours per year within a certain thermal comfort category.

Analysing the operative temperature, the chart in fig. 5 shows that plasters solutions for most of the hours of the summer period achieve the class I and II, which correspond respectively at $0 < PMV < +0.2$ and $+0.2 < PMV < +0.5$, meaning high level and normal level of comfort expectation. The number of hours in which plaster achieves these classes is significantly lower if compared to counter-walls, since the indoor environment presents mainly negative PMV values (cold thermal sensation), but this drawback could be easily overtaken with higher clothes resistances. The other classes III and IV are reached for a limited number of hours which means that by adopting these plasters solutions during the summer period it is possible to obtain acceptable levels of indoor temperature avoiding the use of cooling systems. The counter-walls achieve the class I and II for a longer period of hours but contemporarily the number of hours with temperatures providing a $PMV > 0.5$ is 3 times greater than the plasters solutions.
