Energy in cultural heritage: the case study of Monasterio de Santa Maria de Monfero in Galicia

Energy in cultural heritage: the case study of Monasterio de Santa Maria de Monfero in Galicia / Lisitano, I.M., Laggiard, D., Fantucci, S., Serra, V., Bartolozzi, C., Blanco Lorenzo, E.M., Sabín Díaz, P.. - ELETTRONICO. - (2018), pp. 1591-1599. (7th REHABEND Congress Caçeres (ES) 15-18 May,, 2018).

ENERGY IN CULTURAL HERITAGE: THE CASE STUDY OF MONASTERIO DE SANTA MARIA DE MONFERO IN GALICIA

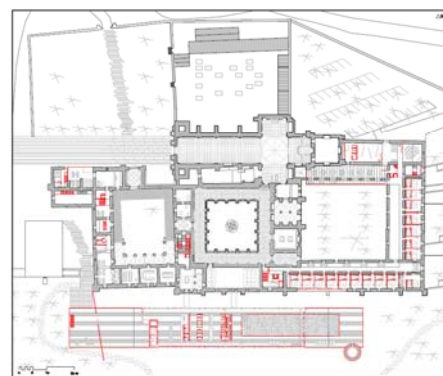
Fig.2 Hotel Spa proposal project - Ground Floor plan

On July 2004 the “Consellería de Cultura, Comunicación Social e Turismo” announced the contest of ideas for the rehabilitation of the monastery in hotel-spa. Enrique Blanco and Patricia Sabin Diaz were the winner of the first prize. Among others, competitors were Labics from Rome, Francisco Mangado from Navarra or Estudio Cano Lasso from Madrid [13]. The main ideas of the designers was to maintain the original aesthetics of the Monastery, without altering the perception and feeling that the building provided to the visitors. The first actions were cleaning and securing the unstable parts of the building. The project provide minimum interventions respecting as much as possible the existing masonry: new holes for the windows and doors were open only where essential, covering were provided where missing.

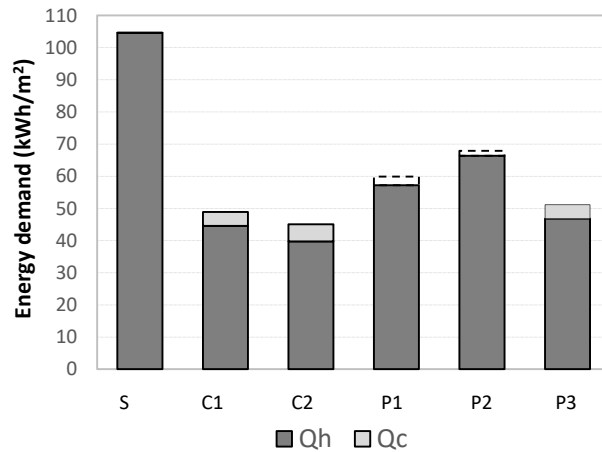
Fig. 5 Annual net energy demand for heating (Q_h) and cooling (Q_c).

For the evaluation of the right strategy to be adopted, another crucial aspect is related to the energy saving potential of the intervention in term of heating and cooling energy demand reduction. The bar chart in fig.6, shows that counter-walls have lower consumption than the thermal plaster, but is also clear that the energy consumption for cooling, using thermal plaster, is near to zero. Moreover considering that, from the comfort point of view, only few hours per year presents a PMV higher than +0.7, evidence the possibility to avoid the installation of cooling systems with some advantages in particular for historic buildings in term of space saving issues, HVAC elements integration and as far as economic aspects are concerned.
