A quick-assessment procedure to evaluate the degree of conservation of rockfall drapery meshes

A quick-assessment procedure to evaluate the degree of conservation of rockfall drapery meshes / Marchelli, Maddalena; De Biagi, Valerio; Peila, Daniele. - In: FRATTURA E INTEGRITÀ STRUTTURALE. - ISSN 1971-8993. - 47:(2019), pp. 437-450. [10.3221/IGF-ESIS.47.34]

M. Marchelli, V. De Biagi, D. Peila

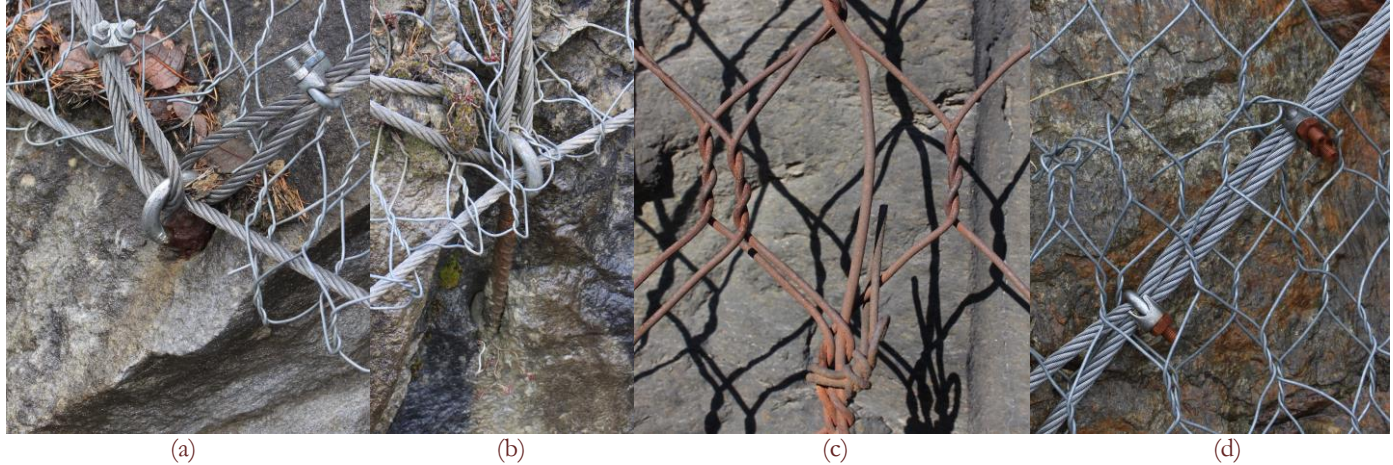
Figure 4: Examples of different damage levels attributed to various components. Different anchors types and connection with the ropes and the mesh: (a) Damage on the plate and/or on the head of the anchors – D1, (b) Unthreading of the anchors – D2, (c) Presence of corrosion and/or removal of the corrosion protections of the mesh – D2, (d) Presence of corroded zones and/or significant damage of the rope – D1.

From a technical point of view, it is expected that an expert (say an engineer or a geologist) is called for a periodic survey of the structure, assessing the damage, deterioration, or even to mark the fact that the component is missing. Three increasing damage levels were introduced, as described in Tab. 5. Due to the inherent subjectivity of the approach, which is operator-based, the choice of three levels seems to be a profitable solution. Fig. 4 shows examples of damage states according to the authors.

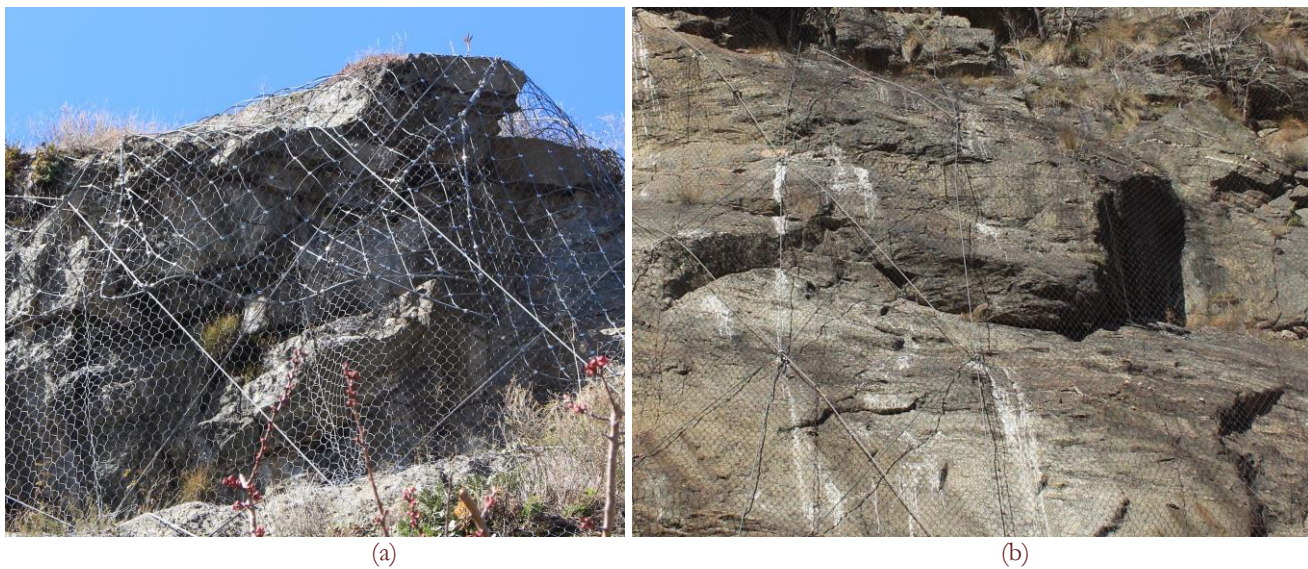
Figure 6: In (a) two mesh types are adopted; in (b) the simple and the reinforced drapery systems are adjacent in the same site.

As an overall comment, the driving idea of classifying the components into main categories helps in dealing with the heterogeneity of techniques within the same site. For example, different mesh types (wire mesh and cable net) are sometimes combined, see Fig. 6.a, or different anchoring devices are used. More frequently, the two investigated different drapery net systems occur in sequence, i.e. a simple and a reinforced drapery nets, as shown in Fig. 6.b. In this case, since the check list is system-dependent, two different analyses must be considered, as the influence of the local damages on the global efficiency varies.
