Experimental Characterization of Piezoelectric Transducers for Automotive Composite Structural Health Monitoring

Massimiliana Carello, Alessandro Ferraris, Andrea Giancarlo Airale, Alessandro Messina, Lorenzo Sisca,
Henrique de Carvalho Pinheiro, and Simone Reitano

Politecnico di Torino

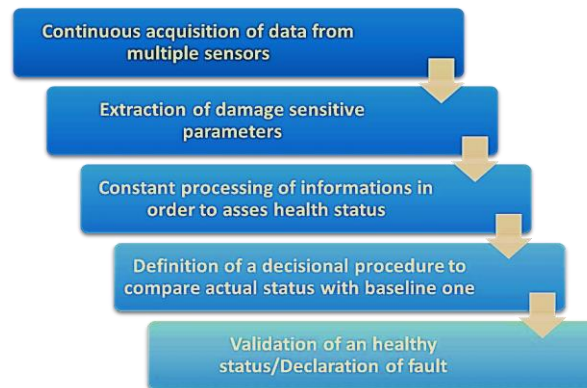
Figure 1: Schematic steps for a Structural Health Monitoring system.

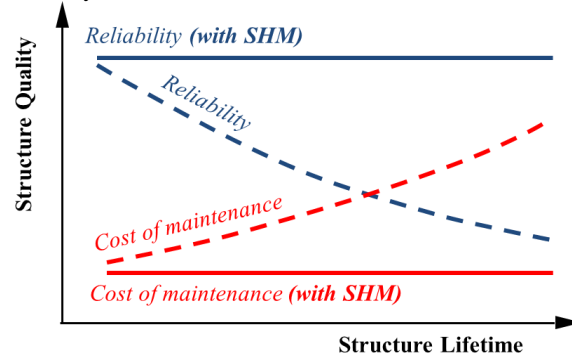
Figure 2: SHM advantages in terms of reliability and cost of maintenance on the host structure [10].

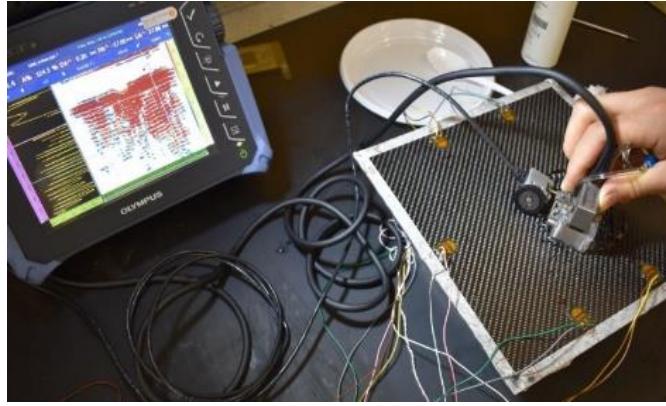
Figure 12: Experimental setup for the C-Scan investigation with Olympus OmniScan SX device.

To evaluate the entity of the damage generated with the drop-dart impact machine, a C-Scan Analysis has been conducted on composite plate using an Olympus OmniScan SX, a device based on phased array technique and equipped with a near-wall probe of 64 piezo elements. The experimental setup is shown in Figure 12.

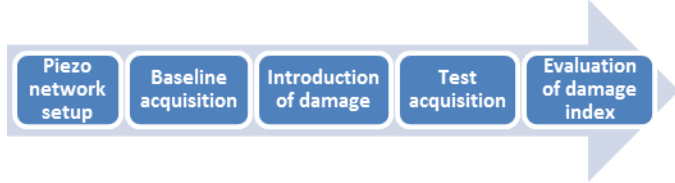
Figure 31: Schematic representation of the experimental procedure.

Firstly, a baseline acquisition for the healthy structure without any damage has been effectuated either for beam or for plate. After that, an external defect has been generated on the sample surface and a second data acquisition has been recorded. The defect presence that induces a distortion in the guided waves propagation, has been demonstrated, through the comparison between the two data sets. Figure 31 shows a schematic representation of the steps required for experimental investigation for beam and plate.
