# Experimental Characterization of Piezoelectric Transducers for Automotive Composite Structural Health Monitoring

Massimiliana Carello, Alessandro Ferraris, Andrea Giancarlo Airale, Alessandro Messina, Lorenzo Sisca, Henrique de Carvalho Pinheiro, and Simone Reitano

Politecnico di Torino

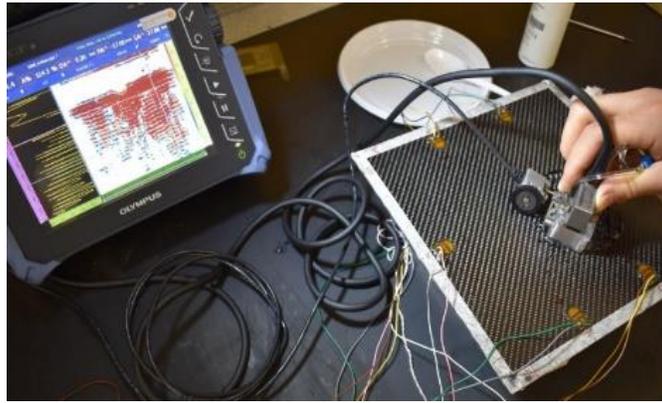
Figure 12: Experimental setup for the C-Scan investigation with Olympus OmniScan SX device.

To evaluate the entity of the damage generated with the drop-dart impact machine, a C-Scan Analysis has been conducted on composite plate using an Olympus OmniScan SX, a device based on phased array technique and equipped with a near-wall probe of 64 piezo elements. The experimental setup is shown in Figure 12.

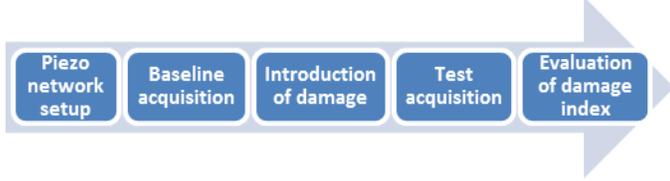
Firstly, a baseline acquisition for the healthy structure without any damage has been effectuated either for beam or for plate. After that, an external defect has been generated on the sample surface and a second data acquisition has been recorded. The defect presence that induces a distortion in the guided waves propagation, has been demonstrated, through the comparison between the two data sets. Figure 31 shows a schematic representation of the steps required for experimental investigation for beam and plate.

Figure 31: Schematic representation of the experimental procedure.

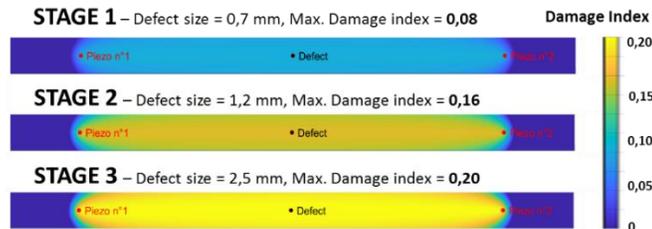
In Figure 35 is reported the comparison between recorded signals, with a defect increasing size while in Figure 36 the damage maps shows the good evaluation of the defect size by the SHM system.

Figure 36: Maximum Damage index and Damage map for the three stages.
