UAV data acquisition and analysis for a Cultural Landscape Heritage: the emergency area of the Vallone d'Elva.

Keywords:
Cultural Landscape Heritage, UAV, photogrammetry, integrated 3D metric survey, environmental 3D model.

UAV DATA ACQUISITION AND ANALYSIS FOR A CULTURAL LANDSCAPE HERITAGE: THE EMERGENCY AREA OF THE VALLONE D'ELVA

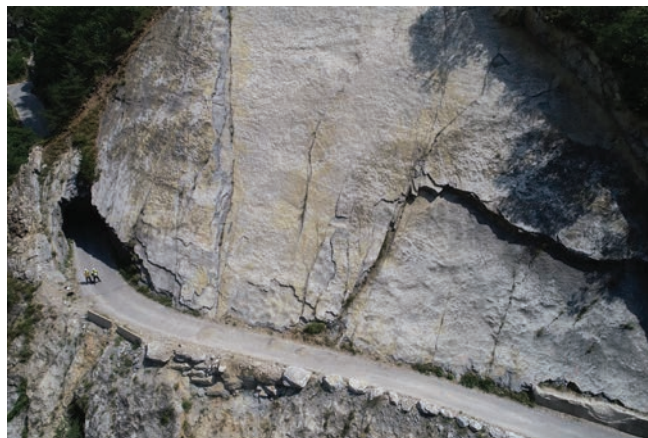
Figure 1. 2014 landslide's event which closed the SP 104.

Nadiral and oblique images (Lingua 2017) have been acquired, in order to obtain a more exhaustive and correct 3D model (complete, accurate, precise) for the greater landslide hazard as witnessed by the event occurred in 2014 which led to the definitive closure of the route. As performed in a similar case (Bassani 2019), a specific Mobile Mapping System (MMS) with LiDAR, GNSS and other synchronized sensors mounted on a car could allow the extraction of detailed 3D model of the sub-vertical rock walls. Here, this investigation could not be carried out due the poor GNSS satellite visibility for kinematic applications caused by complex orography. To overcome this, high resolution terrestrial photogrammetric survey of the whole road has been performed, obtaining dense point clouds and vertical orthophotos, useful for geostructural analysis and tourism landscape purposes. High-resolution images by UAV and terrestrial photogrammetry were analysed using photogrammetric software (Agisoft Metashape Professional), generating surface data at different survey scales with a multiscale approach (Bemis 2014), obtaining 3D models at different levels of detail along the road axis, or focusing on the landslide event. The models obtained enabled the generation of the DSM (Digital Surface Model) and orthophotos (Li 2004); further analyses were carried out to classify the vegetation on rocky slopes, generating a high-resolution DTM (Digital Terrain Model) useful for the planning and landslide risk analysis. Data obtained through the SfM (Structure for Motion) computation of UAV images, allows also to calculate the rock volume possibly subject to collapse, in continuity with field analysis (Tucci 2019).
