UAV data acquisition and analysis for a Cultural Landscape Heritage: the emergency area of the Vallone d'Elva.

E. PONTOGGIO¹, I. AICARDI¹, A. CALANTROPIO², E. COLUCCI¹, V. DI PIETRA¹,
N. GRASSO¹, A. LINGUA¹, P.F. MASCHIO¹

Keywords:
Cultural Landscape Heritage, UAV, photogrammetry, integrated 3D metric survey, environmental 3D model.

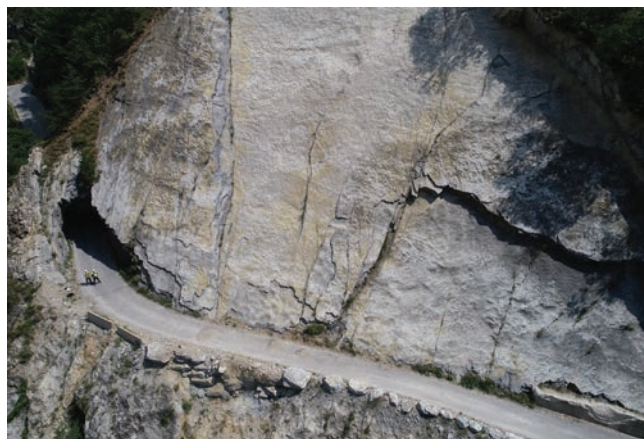
Figure 1. 2014 landslide's event which closed the SP 104.

Nadiral and oblique images (Lingua 2017) have been acquired, in order to obtain a more exhaustive and correct 3D model (complete, accurate, precise) for the greater landslide hazard as witnessed by the event occurred in 2014 which led to the definitive closure of the route. As performed in a similar case (Bassani 2019), a specific Mobile Mapping System (MMS) with LiDAR, GNSS and other synchronized sensors mounted on a car could allow the extraction of detailed 3D model of the sub-vertical rock walls. Here, this investigation could not be carried out due the poor GNSS satellite visibility for kinematic applications caused by complex orography. To overcome this, high resolution terrestrial photogrammetric survey of the whole road has been performed, obtaining dense point clouds and vertical orthophotos, useful for geostructural analysis and tourism landscape purposes. High-resolution images by UAV and terrestrial photogrammetry were analysed using photogrammetric software (Agisoft Metashape Professional), generating surface data at different survey scales with a multiscale approach (Bemis 2014), obtaining 3D models at different levels of detail along the road axis, or focusing on the landslide event. The models obtained enabled the generation of the DSM (Digital Surface Model) and orthophotos (Li 2004); further analyses were carried out to classify the vegetation on rocky slopes, generating a high-resolution DTM (Digital Terrain Model) useful for the planning and landslide risk analysis. Data obtained through the SfM (Structure for Motion) computation of UAV images, allows also to calculate the rock volume possibly subject to collapse, in continuity with field analysis (Tucci 2019).
