# A novel characterization method for hard coatings: preliminary results with TiN

**Abstract.** Pin-on-disc method is increasingly used to evaluate the tribological behavior of thin hard coatings. At present, ISO 18535 is the only standard applying to hard coatings tribology and it prescribes that investigations do not extend past the coating failure. This approach followed by many researchers is inadequate though for a complete characterization of a coated system. A novel approach is proposed in this paper, at a preliminary stage, to characterize coated systems thoroughly. Friction curves with a suitable shape are resorted to, so that two representative friction coefficients can be extracted, one before and the other after coating failure. Results with a PVD TiN coating are presented showing that it is possible with this coating to get friction curves with the desired shape in specific testing conditions.

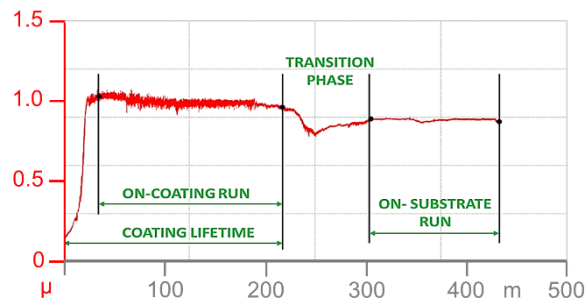
Fig. 7. Wear process stages with representation of the relevant portions of the friction curve

Fig 6a-b presents the curves corresponding to those in fig 5a-b where a 20-points moving averaging filter was applied. Fig 7 sketches out the wear process stages and provides a representation of corresponding relevant portions of the friction curve:

- I. A wear-in phase takes up the first 50m of test. The coefficient of friction evolves reaching 1-1.1 from an initial value of about 0.2. At the very beginning, the test run smoothly and the value of the coefficient of friction increases slowly. The trend changes then after 10 to 30 meters and the value peaks with a steep ramp; white debris ( $\text{TiO}_2$  [5]) starts also appearing around the wear track. The predominate tribological mechanism is probably changing and severe abrasion takes over as the strong increase in CoF suggests [10].

- II. A first steady-state period corresponding to the on-coating run. The CoF mean value is stable but scattering may be higher than elsewhere. During the first steady state (*on-coating run* in Fig.7), the uniform wearing out of the ceramic coating takes place. Its duration is variable as it correlates to the unavoidable variability from sample to sample of the ceramic layer properties, thickness firstly. The interaction between the ball and the surface is still smooth and quiet, just a low-intensity whistle may arise. Stages I and II merge in the so-called *coating lifetime*.

- III. A *transition phase* of variable length which lessens the coefficient of friction towards a new stable mean value. The behavior of the system is often characterized

by a transitory increase of the curve noise, i.e. a larger scattering of CoF. This stage is inhomogeneous; its duration varies from sample to sample, as well as the tribological behavior. Black debris appears on the sample surface (Fe-O and Fe-Ti-O compounds, maybe [5]), proof that steel substrate wearing out has started.

- IV. A second steady-state period (*on-substrate run* in Fig.7). It persists until the end of the test. The curve is, on average, thinner besides unregular (raw data). The trend is nearly horizontal, and a new quiet running condition settles in all the repetitions. The sphere is here partly in contact with the substrate and partly with the ceramic film. The presence of a black area in the middle of the track means that oxidation effects took place.
