Finite Element Modeling Application in Forensic Practice: A Periprosthetic Femoral Fracture Case Study

Finite Element Modeling Application in Forensic Practice: A Periprosthetic Femoral Fracture Case Study / Terzini, M., Aldieri, A., Nurisso, S., De Nisco, G., Bignardi, C.. - In: FRONTIERS IN BIOENGINEERING AND BIOTECHNOLOGY. - ISSN 2296-4185. - 8:(2020), pp. 1-11. [10.3389/fbioe.2020.00619]

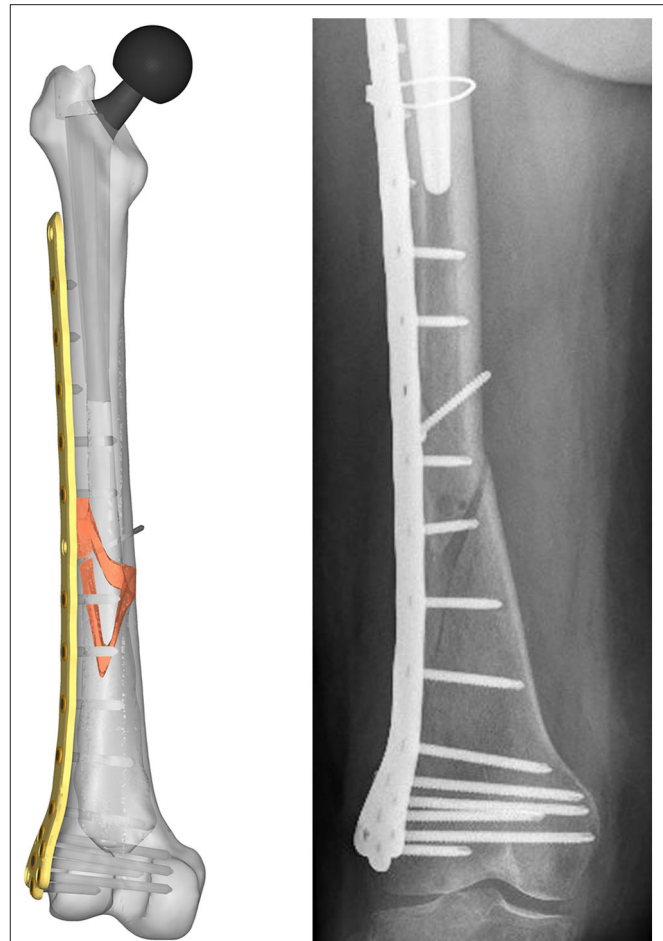
**FIGURE 4 |** Resulting assembled geometrical model (**Left**) compared with the corresponding x-ray image (**Right**).

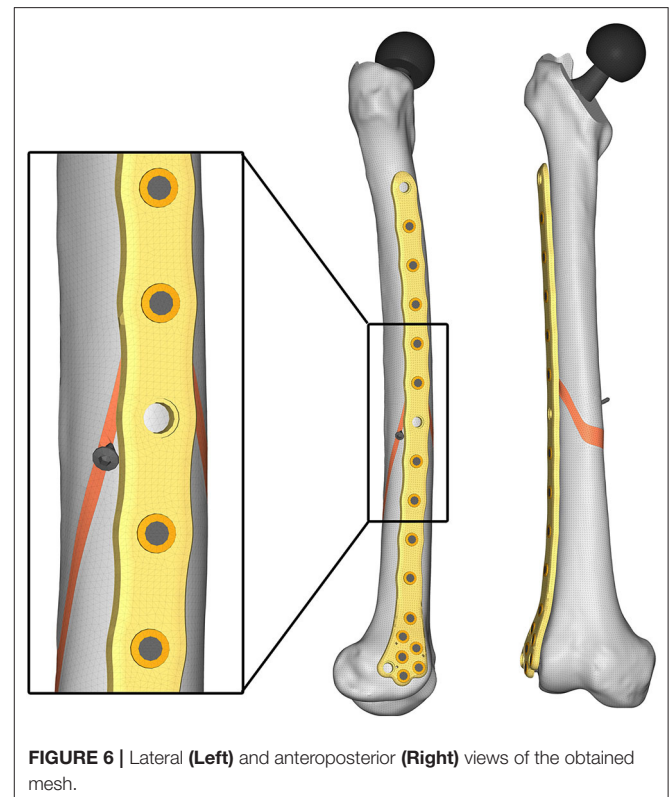
**FIGURE 6 |** Lateral (Left) and anteroposterior (Right) views of the obtained mesh.

According to Viceconti et al. (1998), Polgar et al. (2001), and Ramos and Simões (2006), a tetrahedral mesh of 388652 elements with a 2 mm average edge length was created (Figure 6).
