Finite Element Modeling Application in Forensic Practice: A Periprosthetic Femoral Fracture Case Study

Finite Element Modeling Application in Forensic Practice: A Periprosthetic Femoral Fracture Case Study / Terzini, M.; Aldieri, A.; Nurisso, S.; De Nisco, G.; Bignardi, C.. - In: FRONTIERS IN BIOENGINEERING AND BIOTECHNOLOGY. - ISSN 2296-4185. - 8:(2020), pp. 1-11. [10.3389/fbioe.2020.00619]

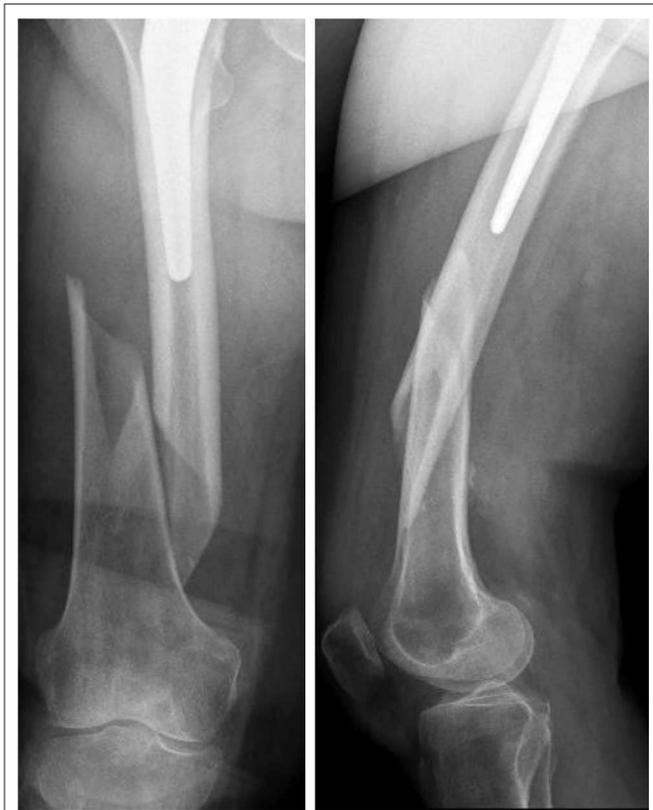
**FIGURE 1** | Anteroposterior (**Left**) and lateral (**Right**) x-ray images of the periprosthetic fracture.

The x-ray images of the femoral fracture are shown in **Figure 1**, while **Figure 2** shows the x-ray images after the plate implant. After 3 months the plate suffered of catastrophic break in the area where the healing bone was present, accompanied by a further femoral fracture characterized by a profile similar to the previous one (**Figure 3**). The context and reason of the break are unknown.

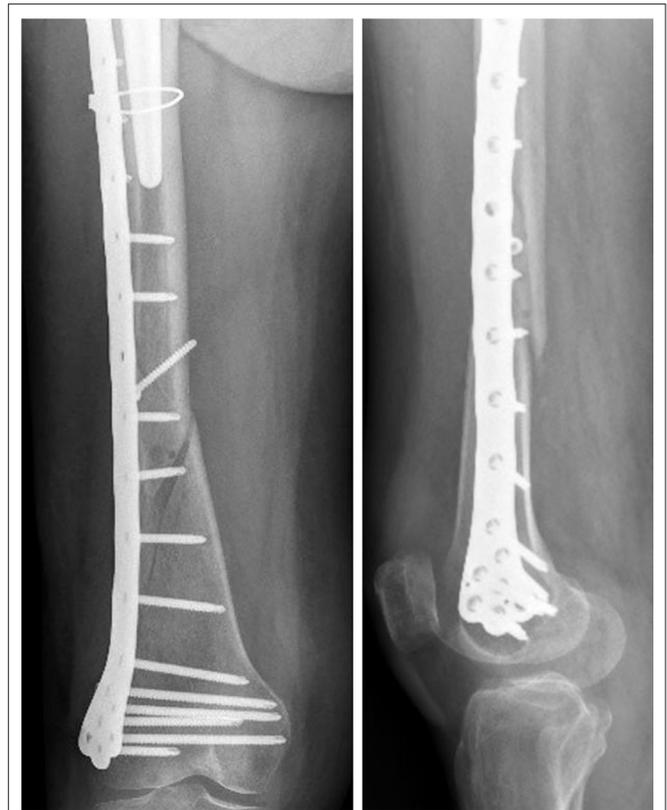
**FIGURE 2** | Anteroposterior (**Left**) and lateral (**Right**) x-ray images of the reduced periprosthetic fracture after the plate implant.

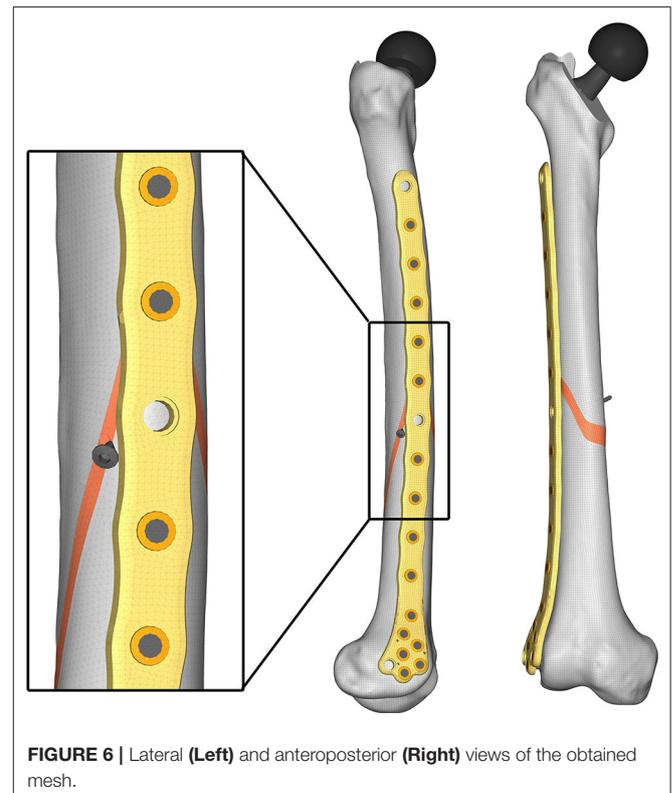
According to Viceconti et al. (1998), Polgar et al. (2001), and Ramos and Simões (2006), a tetrahedral mesh of 388652 elements with a 2 mm average edge length was created (Figure 6).

**FIGURE 6 |** Lateral (Left) and anteroposterior (Right) views of the obtained mesh.

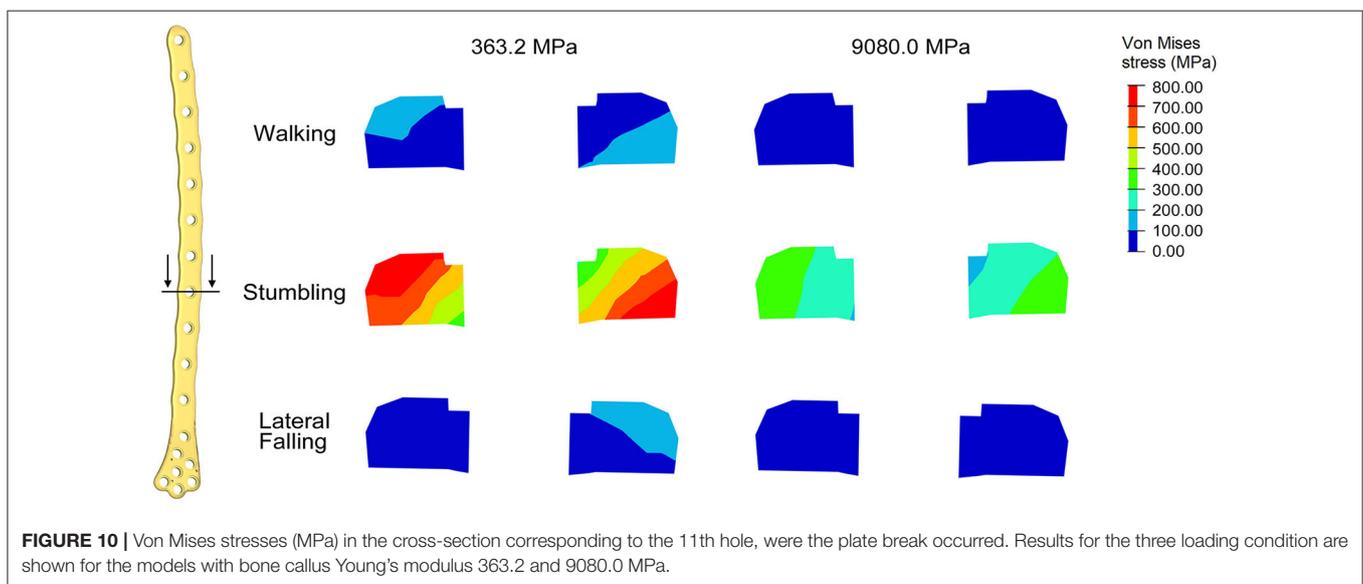
The force acting on the femur during stumbling from standing position have the same direction as that during walking, but its module is amplified. In this case the zones where Von Mises stress is higher are S2 and S3, and in these zones the femur plate yield point is exceeded for lower values of the fracture bone callus Young's modulus (Figures 8B, 9B). This is interesting because, as previously stated, the real plate break occurred at the 11th hole between S2 and S3 zones. For this reason, an additional model was considered to better understand which level of bone healing would correspond to the plate break. Here, the bone callus Young's modulus was set equal to 726.4 MPa after few trials, corresponding to a bone reduction factor of 4%, and Von Mises stress results are represented in red in Figure 9B. The two stress distributions around the hole section where the actual break occurred show how the fracture bone callus Young's modulus influences the femur plate stress state (Figure 8B): indeed, as the fracture bone callus Young's modulus decreases, the higher stress

zone moves closer to the 11th hole. The consequent yield causes the reduction of the plate section and the subsequent break. Being the most representative or the real break event, for the stumbling load condition a further model was considered in which a body mass equal to 75 kg, representative with high probability of the real situation, was addressed and the applied load was reduced accordingly. The obtained Von Mises stresses distribution was similar to the previous one, but as expected the stress peaks were lower and reached the yield stress value for a fracture bone callus Young's modulus equal to 300.0 MPa.
