Finite Element Modeling Application in Forensic Practice: A Periprosthetic Femoral Fracture Case Study

Finite Element Modeling Application in Forensic Practice: A Periprosthetic Femoral Fracture Case Study / Terzini, M.; Aldieri, A.; Nurisso, S.; De Nisco, G.; Bignardi, C.. - In: FRONTIERS IN BIOENGINEERING AND BIOTECHNOLOGY. - ISSN 2296-4185. - 8:(2020), pp. 1-11. [10.3389/fbioe.2020.00619]

This study aims to quantitatively analyse, by means of a FE analysis, the possible causes of a real case of femoral plate break, implanted following a PFF. Different load conditions acting on the femur during daily and incidental activities were simulated, in order to validate the correct behavior of the plate, according to the intended use recommended by the manufacturer.

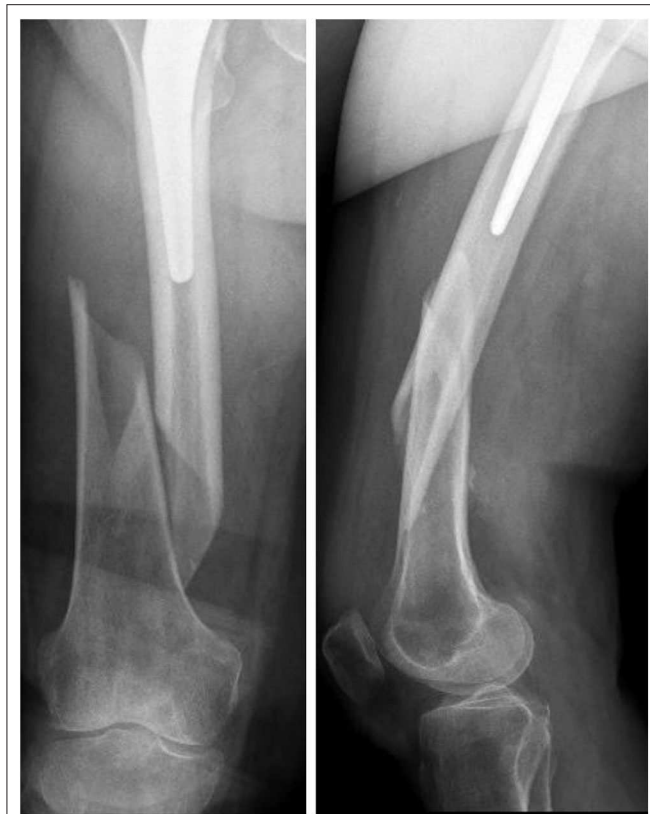
FIGURE 1 | Anteroposterior (Left) and lateral (Right) x-ray images of the periprosthetic fracture.

The x-ray images of the femoral fracture are shown in **Figure 1**, while **Figure 2** shows the x-ray images after the plate implant. After 3 months the plate suffered of catastrophic break in the area where the healing bone was present, accompanied by a further femoral fracture characterized by a profile similar to the previous one (**Figure 3**). The context and reason of the break are unknown.

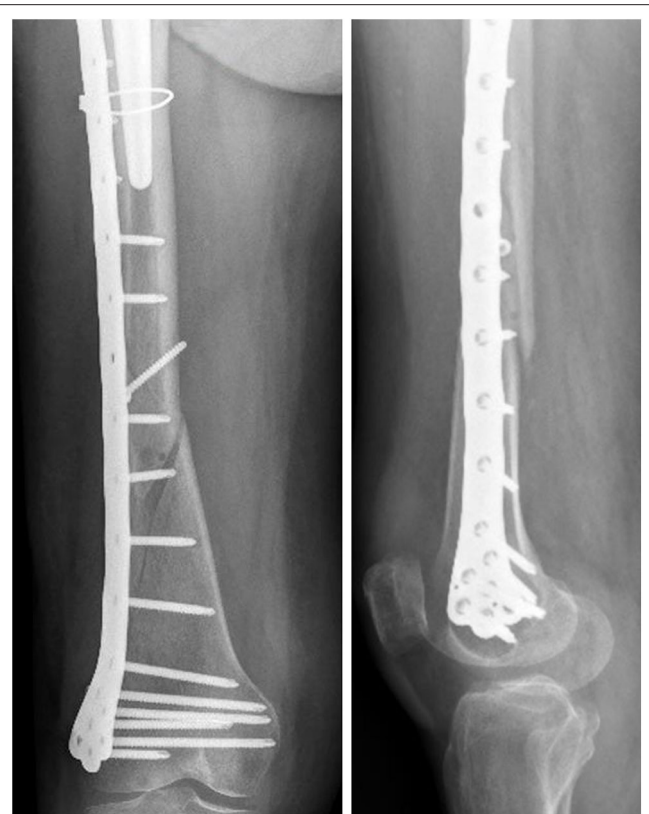
FIGURE 2 | Anteroposterior (Left) and lateral (Right) x-ray images of the reduced periprosthetic fracture after the plate implant.

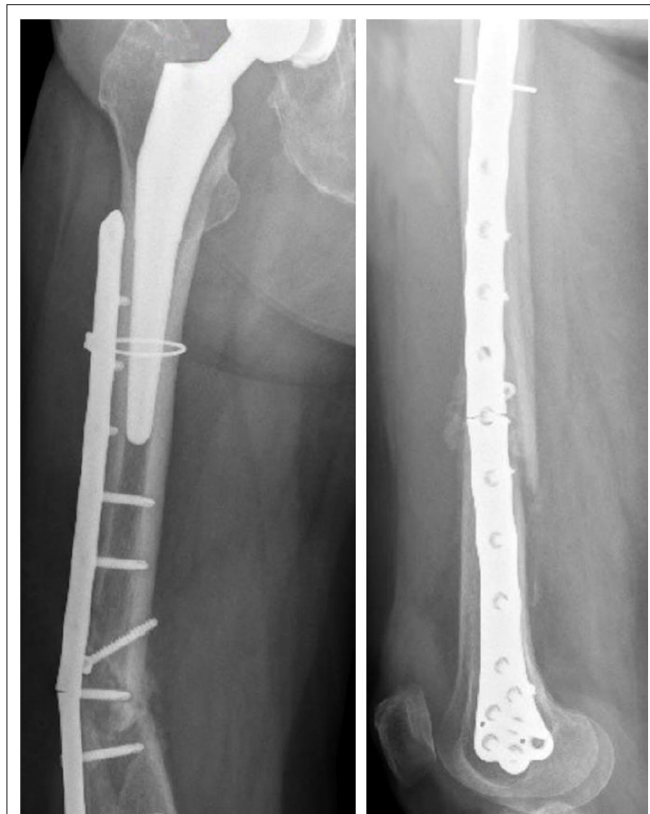
FIGURE 3 | Anteroposterior (**Left**) and lateral (**Right**) x-ray images of the plate break.

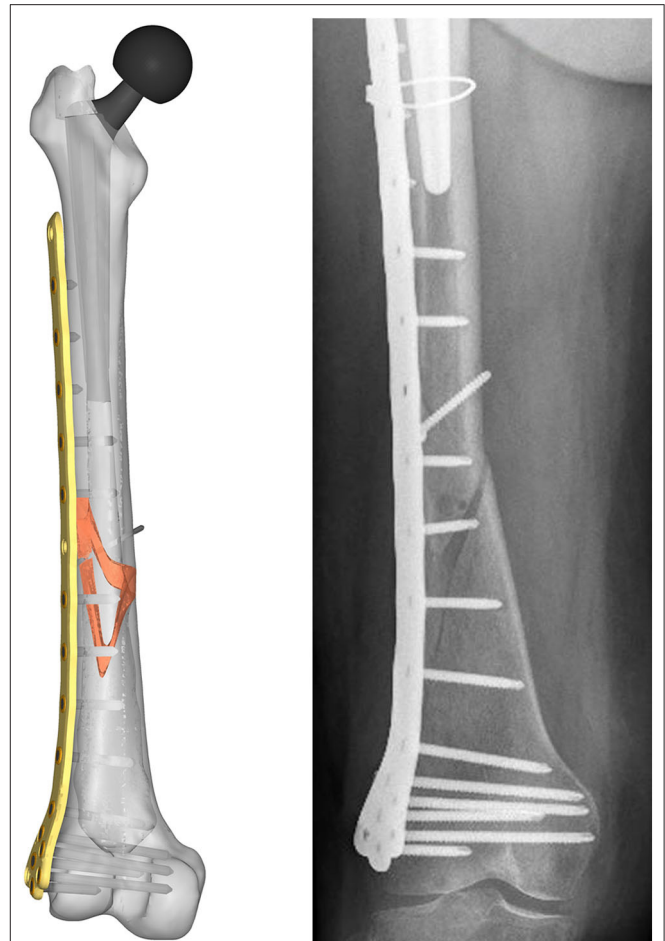
FIGURE 4 | Resulting assembled geometrical model (**Left**) compared with the corresponding x-ray image (**Right**).

The so assembled model, composed of the fractured femur, the prosthetic stem and head, the bushings, the plate screws, the interfragmentary screw, and the femur plate, was imported into the FE pre-processor software Hypermesh (Altair, USA). **Table 1** lists the material properties assigned to each volume. A linear elastic behavior was assumed for each component, and cortical bone mechanical characteristics, considered homogeneous and isotropic, were chosen according to Morgan et al. (2018). Regarding the fracture bone callus, the mechanical properties are dependent on the specific situation. Bone tissue, in fact, has a remarkable ability for self-repair and regeneration after an injury, and is able to completely restore its mechanical

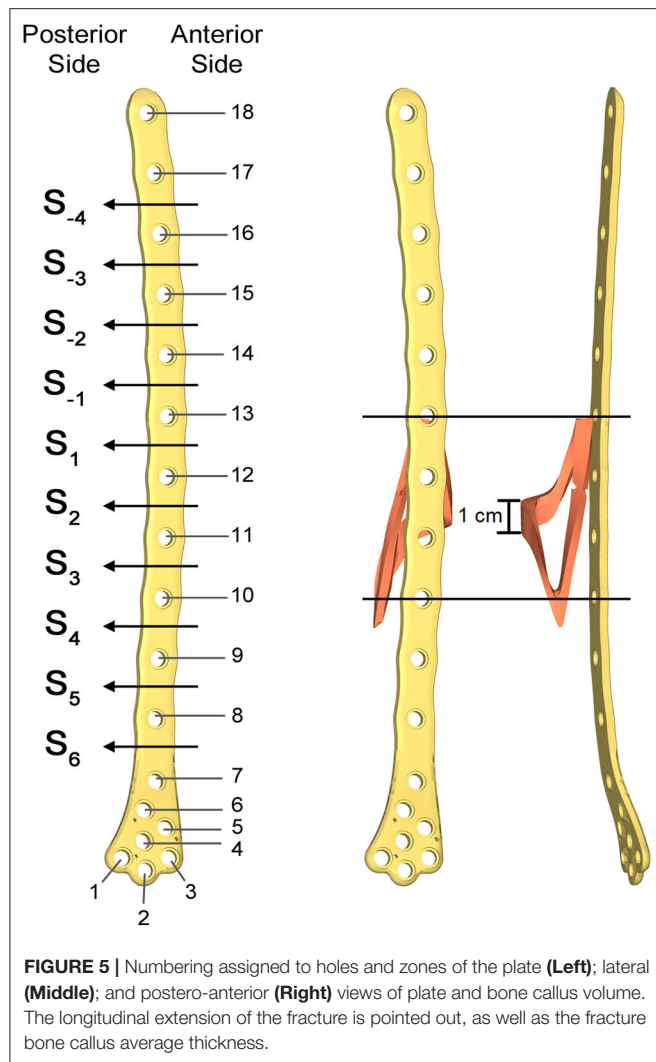
FIGURE 5 | Numbering assigned to holes and zones of the plate (Left); lateral (Middle); and postero-anterior (Right) views of plate and bone callus volume. The longitudinal extension of the fracture is pointed out, as well as the fracture bone callus average thickness.

the main object of investigation of the present study (Papini et al., 2007). Using the software ImageJ (National Institutes of Health, USA) some reference measures were taken on the x-ray images in order to scale the standard femur model and adapt it to the real anatomical case. To recreate the fracture profile, reference points were identified on the x-ray images and reported on the bone surface, so that the fracture shape could be reproduced. The result is a fracture volume characterized by an average thickness of 1 cm (**Figure 5**).

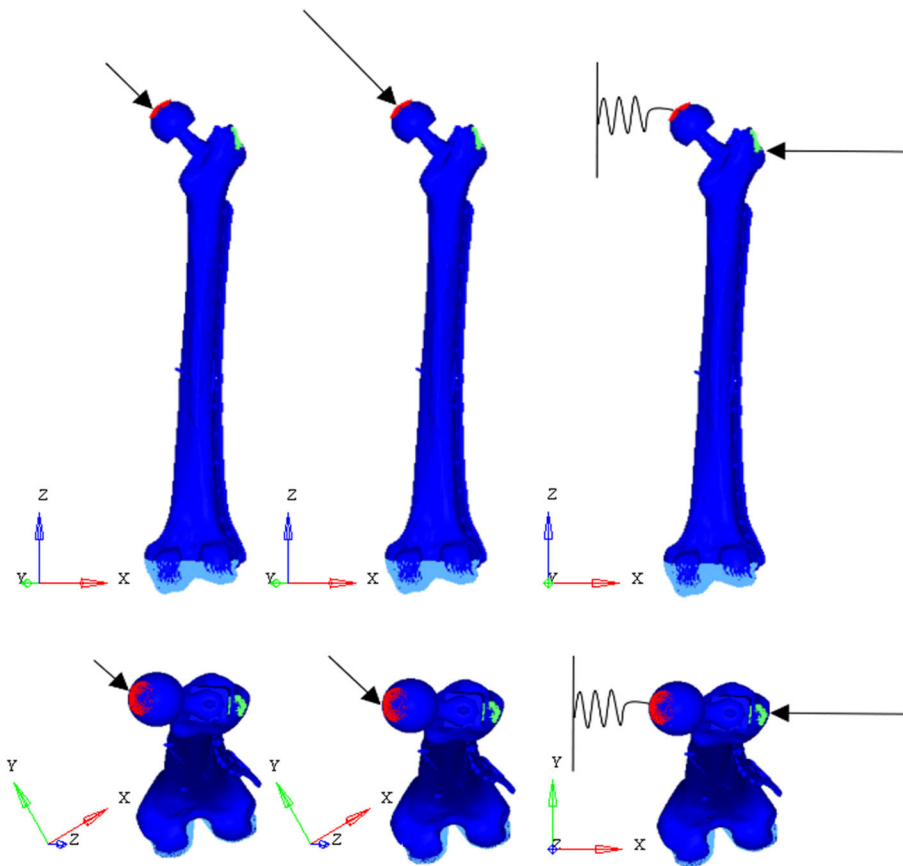
FIGURE 7 | Applied load conditions: walking (Left) (Bergmann et al., 2001), stumbling (Middle) (Bergmann et al., 2004), and falling (Right) (Aldieri et al., 2018b).

Loads applied in the three simulated conditions are listed in Table 3. It should be noted that loads directions were implanted according with the examined literature, and the used coordinate systems are shown in Figure 7.

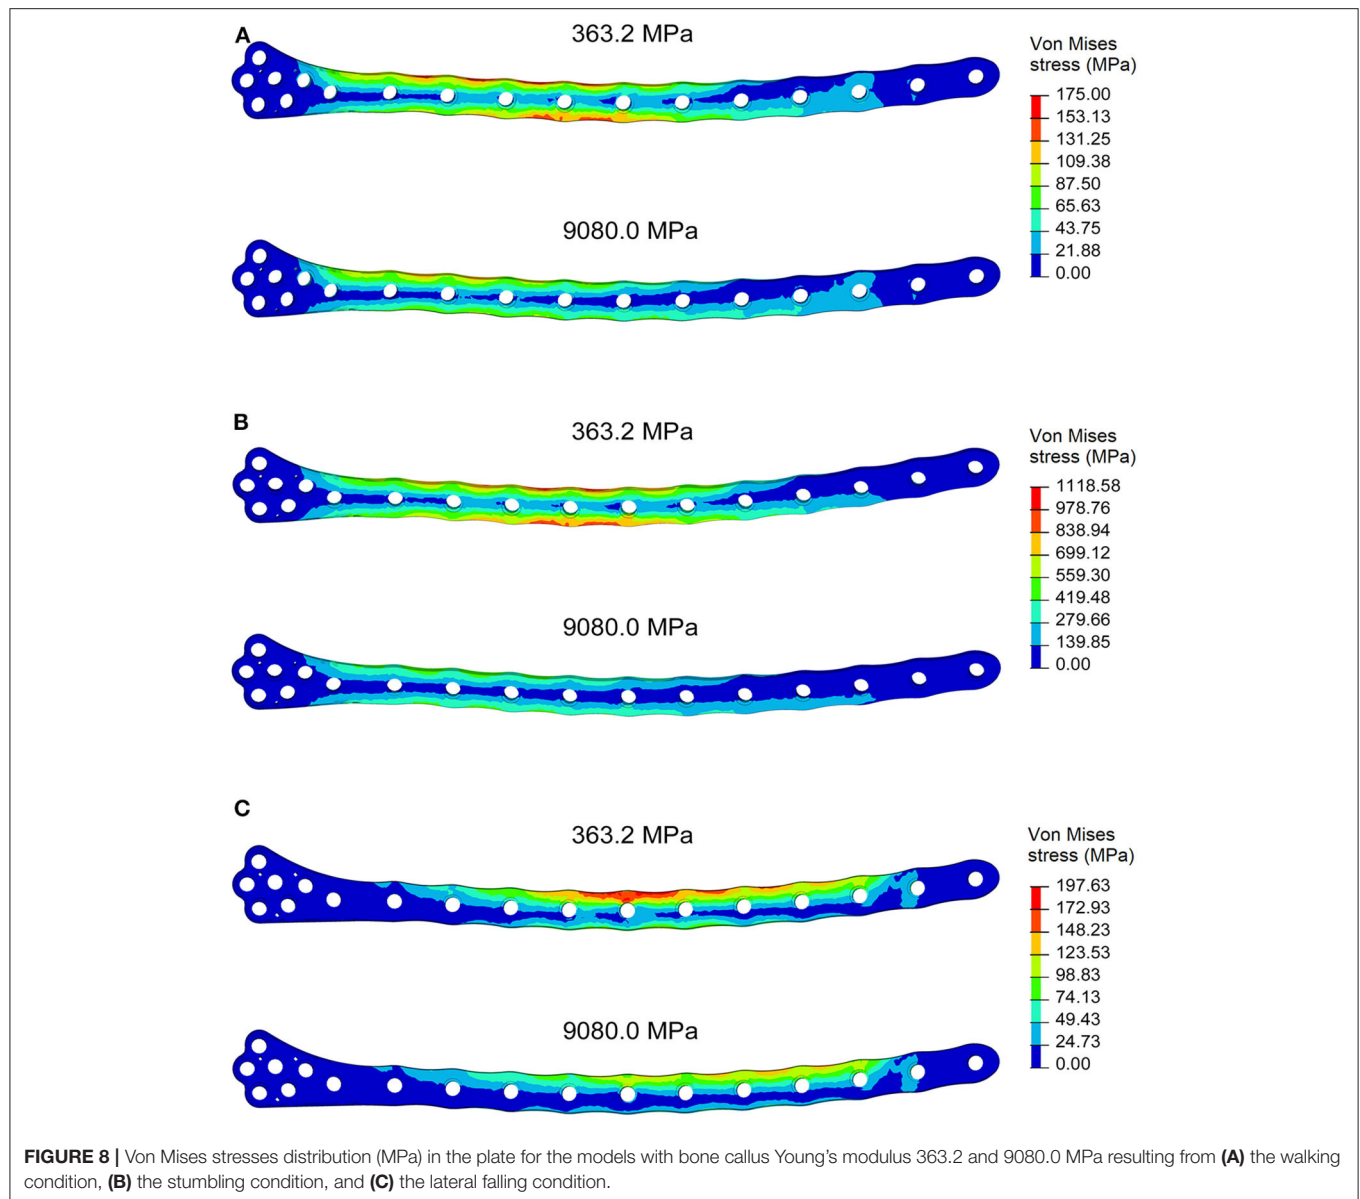
For each of the load configurations considered, Von Mises stress in the femur plate and its peak value were analyzed. As regards the walking load configuration Von Mises stresses distribution within the plate varies according to the level of

healing achieved. For lower Young's modulus values of the fracture bone callus, the lateral surfaces belonging to the S2 zone are more stressed. As the bone callus stiffness increases, the highest stresses move downwards, affecting the lateral surfaces of the S4 and S5 zones (Figure 8A), while the Von Mises stress values on the femur plate surface in the S2 zone reduce, with initially precipitous progression as visible in Figure 9A. In the S2 zone, the plate stress is distributed evenly between the anterior and the posterior portions, with a slight prevalence of the posterior area in the presence of lowest bone callus stiffness. Conversely, the S5 zone is characterized by a slightly decreasing trend both posteriorly and anteriorly, but with a clear predominance of the posterior values compared to the anterior ones.

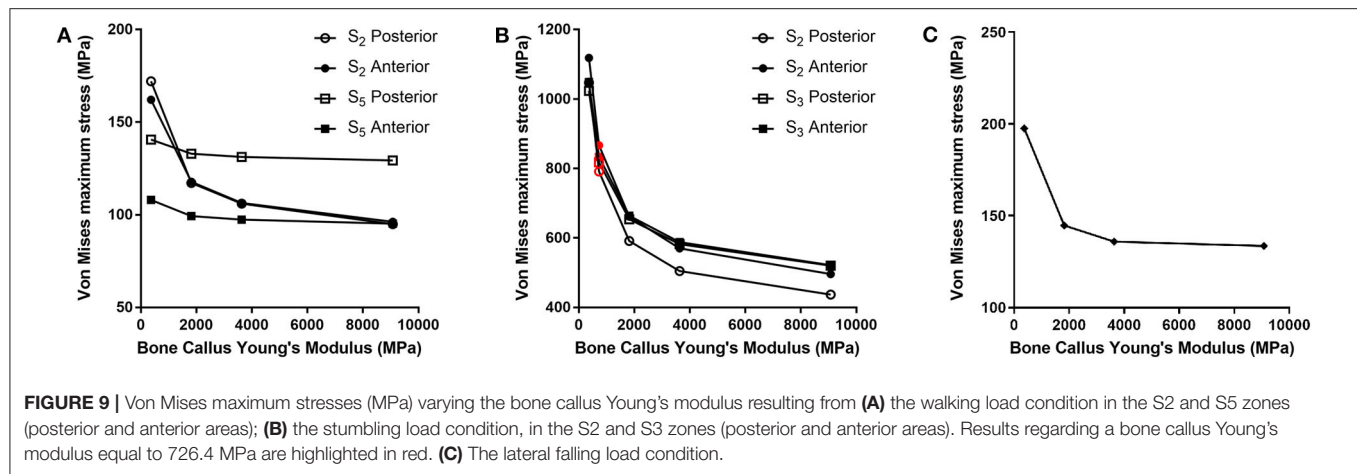
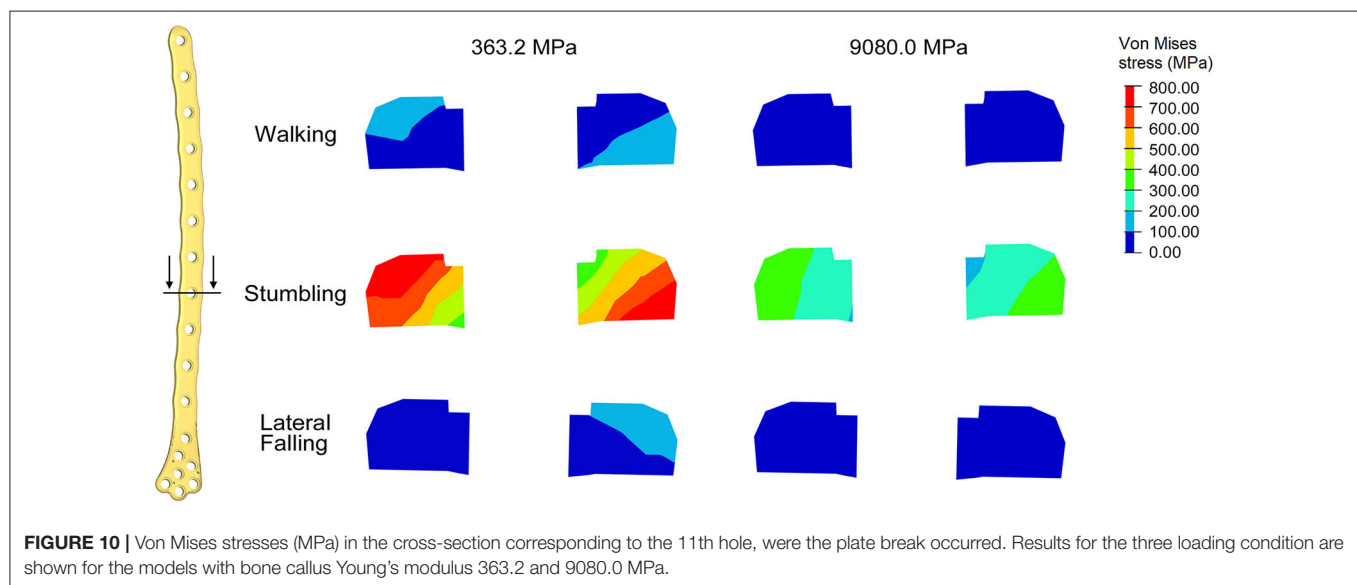
The force acting on the femur during stumbling from standing position have the same direction as that during walking, but its module is amplified. In this case the zones where Von Mises stress is higher are S2 and S3, and in these zones the femur plate yield point is exceeded for lower values of the fracture bone callus Young's modulus (**Figures 8B, 9B**). This is interesting because, as previously stated, the real plate break occurred at the 11th hole between S2 and S3 zones. For this reason, an additional model was considered to better understand which level of bone healing would correspond to the plate break. Here, the bone callus Young's modulus was set equal to 726.4 MPa after few trials, corresponding to a bone reduction factor of 4%, and Von Mises stress results are represented in red in **Figure 9B**. The two stress distributions around the hole section where the actual break occurred show how the fracture bone callus Young's modulus influences the femur plate stress state (**Figure 8B**): indeed, as the fracture bone callus Young's modulus decreases, the higher stress

zone moves closer to the 11th hole. The consequent yield causes the reduction of the plate section and the subsequent break. Being the most representative or the real break event, for the stumbling load condition a further model was considered in which a body mass equal to 75 kg, representative with high probability of the real situation, was addressed and the applied load was reduced accordingly. The obtained Von Mises stresses distribution was similar to the previous one, but as expected the stress peaks were lower and reached the yield stress value for a fracture bone callus Young's modulus equal to 300.0 MPa.

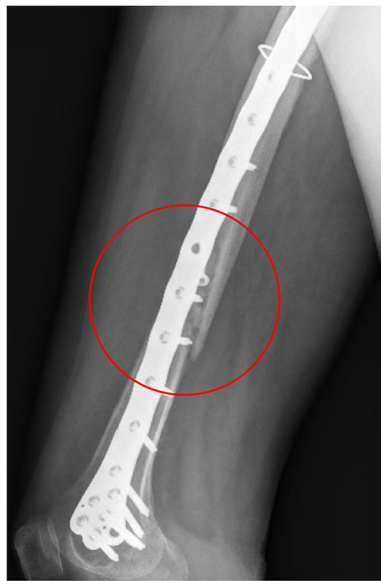
FIGURE 11 | X-ray image taken after 2 months from the surgery. The non-consolidation of the bone fracture is pointed out.

it was deduced that a combination of insufficient bone healing and unexpected high load applied to the prosthesis head with a predominant vertical component is the most probable cause of the plate break occurrence. In particular, the research highlighted how the femur plate implanted during surgery is able to support the loads deriving from daily activities, such as walking, even considering high body masses, as long as an adequate bone healing is granted.
