AIAS 2019 International Conference on Stress Analysis

Monitoring of railway freight vehicles using onboard systems

Nicola Bosso*, Antonio Gugliotta, Matteo Magelli, Nicolò Zampieri

Politecnico di Torino, Torino 10029, Italy

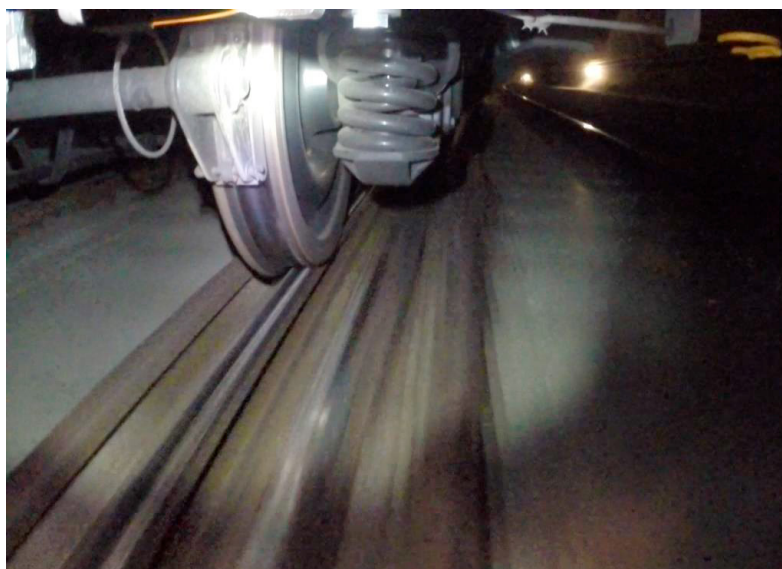
During the test, a camera was fixed on the coach and synchronized with the acquisition system, in order to relate the results with the track defects and singularities. The camera has been oriented to record the track and one wheel of the coach. From the analysis of the video at about the km 37, where the acceleration peak was detected, it is possible to notice the presence of a series of railway switches that is the cause of the acceleration increment. Fig. 11 shows the first railway switch located at the km 37.

Fig. 11. Detail of one vehicle wheel while running on the switch located at km 37 of the Gotthard Base tunnel.
