Monitoring of railway freight vehicles using onboard systems

AIAS 2019 International Conference on Stress Analysis

Nicola Bosso*, Antonio Gugliotta, Matteo Magelli, Nicolò Zampieri

Politecnico di Torino, Torino 10029, Italy

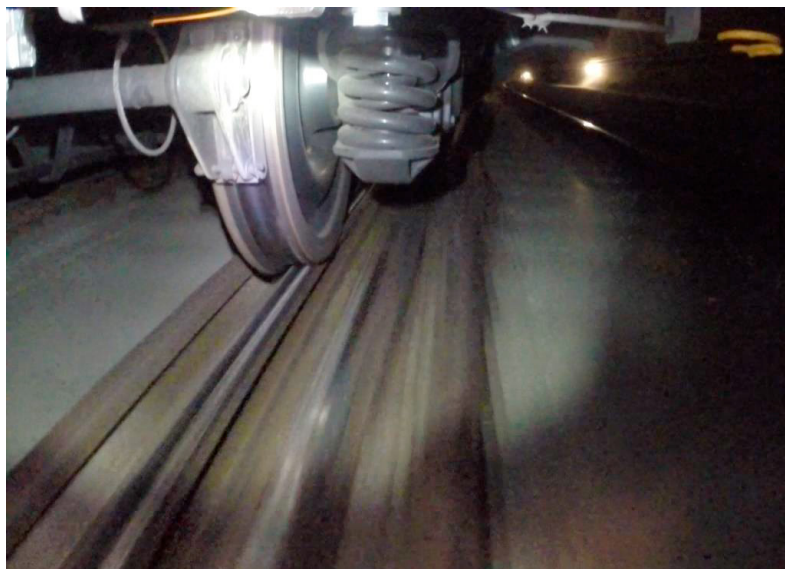
During the test, a camera was fixed on the coach and synchronized with the acquisition system, in order to relate the results with the track defects and singularities. The camera has been oriented to record the track and one wheel of the coach. From the analysis of the video at about the km 37, where the acceleration peak was detected, it is possible to notice the presence of a series of railway switches that is the cause of the acceleration increment. Fig. 11 shows the first railway switch located at the km 37.

Fig. 11. Detail of one vehicle wheel while running on the switch located at km 37 of the Gotthard Base tunnel.
