AIAS 2019 International Conference on Stress Analysis

Monitoring of railway freight vehicles using onboard systems

Nicola Bosso*, Antonio Gugliotta, Matteo Magelli, Nicolò Zampieri

Politecnico di Torino, Torino 10029, Italy

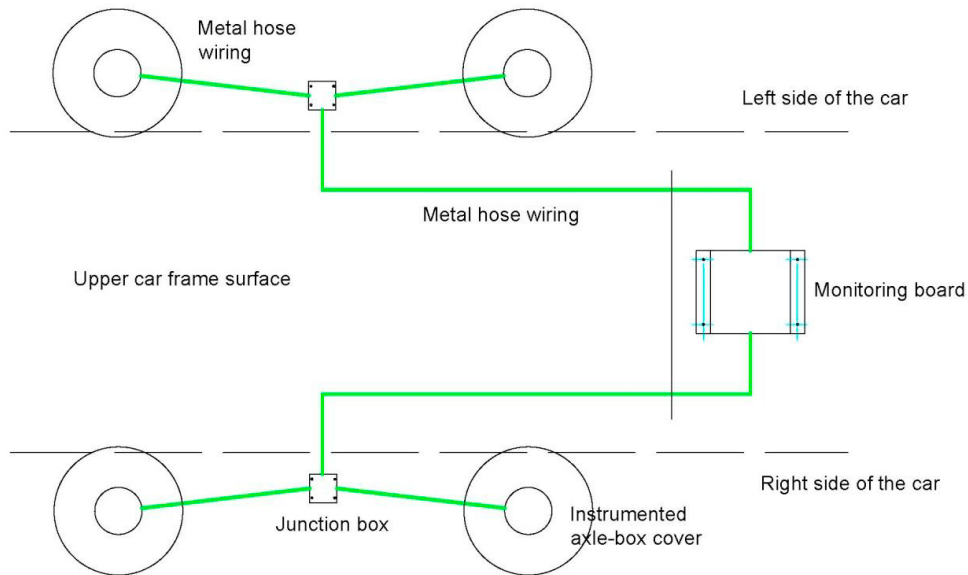
The wiring of the system is carried out according to the diagram in Fig. 3, using two intermediate junction boxes mounted on the side of the vehicle frame and connected to the two axle-box covers of the same side.

Fig. 3. Layout of system installation on the vehicle

The wiring is made using shielded multipolar cables, contained in a folded steel braided hose. The length of the wiring depends on the positioning of the control unit on the wagon. As regards the wiring made between the axle-boxes and the junction boxes located on the side of the wagon, a cable longer than necessary was created to take into account the relative rotation between the vehicle frame and the bogie.

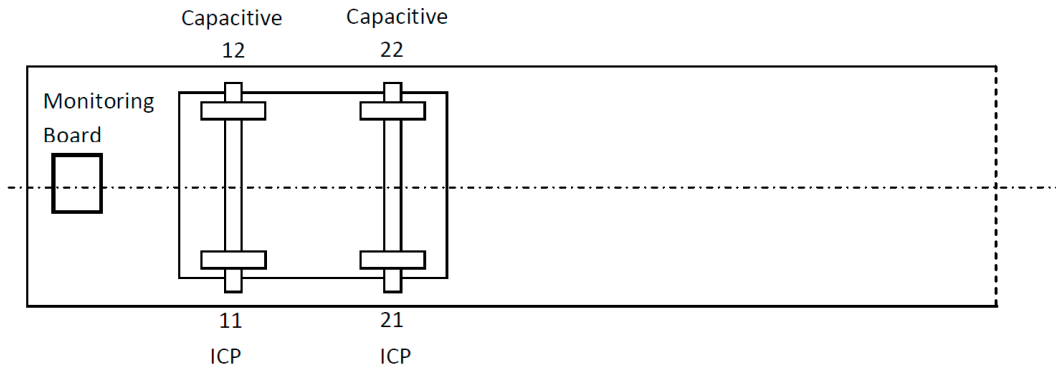
The installation of the monitoring system on the two types of wagon was carried out differently due to the different arrangement of the load on the vehicle. On the CT Light chassis, the control unit was installed on the floor of the wagon in the front portion not occupied by the load as shown in Fig. 4. The axle-box covers fitted with ICP sensors were mounted on the right side, the ones fitted with capacitive sensors on the left side.

Fig. 4. Installation diagram on the CT-Light wagon.

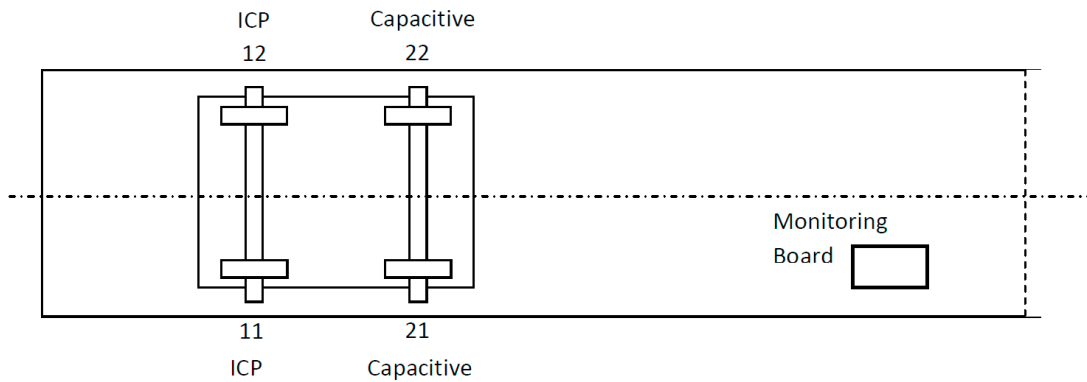
On the Tasca type car, the control unit was installed under the vehicle frame on the right side, in the central portion. The axle-box covers fitted with ICP sensors were mounted on the first axle, the covers fitted with capacitive sensors on the second, as shown in Fig. 5.

Fig. 5. Installation diagram on the Tasca wagon.

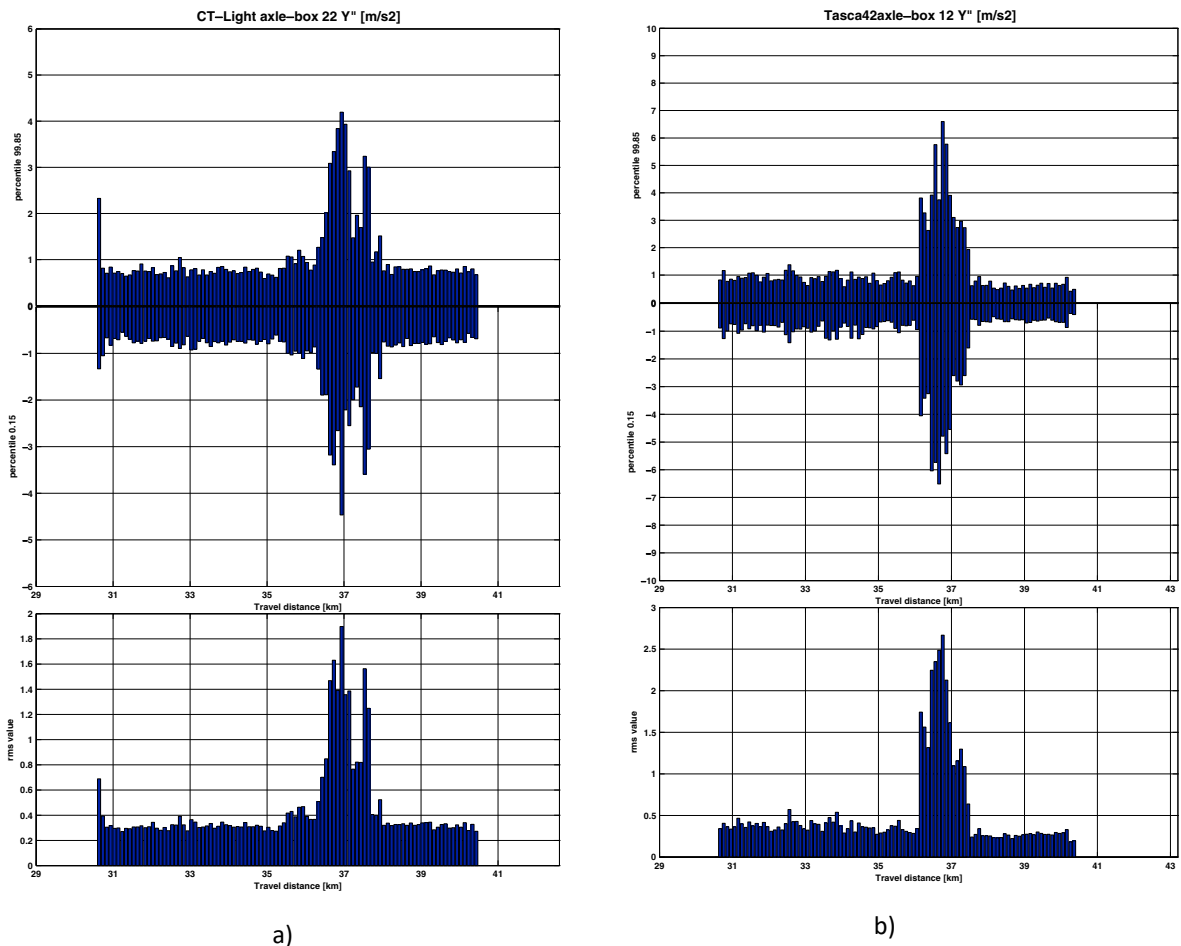
Fig. 9.a and 9.b respectively show the percentiles and the r.m.s values of the coach lateral acceleration for the CT-LIGHT and the TASCA vehicles. The vertical accelerations for the same axle-box are instead shown in Fig. 10.a and 10.b. The r.m.s. and the percentile values allow to clearly identify the increment of acceleration starting from km 36. Furthermore, the lateral accelerations on the TASCA vehicle are slightly higher than the accelerations on the CTLIGHT vehicle, while considering the vertical accelerations the situation is reversed and the accelerations measured on the CTLIGHT vehicle are about twice the ones measured on the TASCA vehicle. This difference in the vertical direction is due to the different axle load and the different position of the freight cars with respect to the train composition. The TASCA vehicle was tested in tare conditions, while the CTLIGHT vehicle was loaded with a 25 tons load placed on the side of the monitored bogie.

Fig. 9. Percentiles (0.15% and 99.85%) and r.m.s. values of the axle-box lateral accelerations measured on the Gotthard base tunnel on the CTLIGHT (axle-box 22) an TASCA (axle-box 12) vehicles, passing on the switch section on the diverging route (km 37).

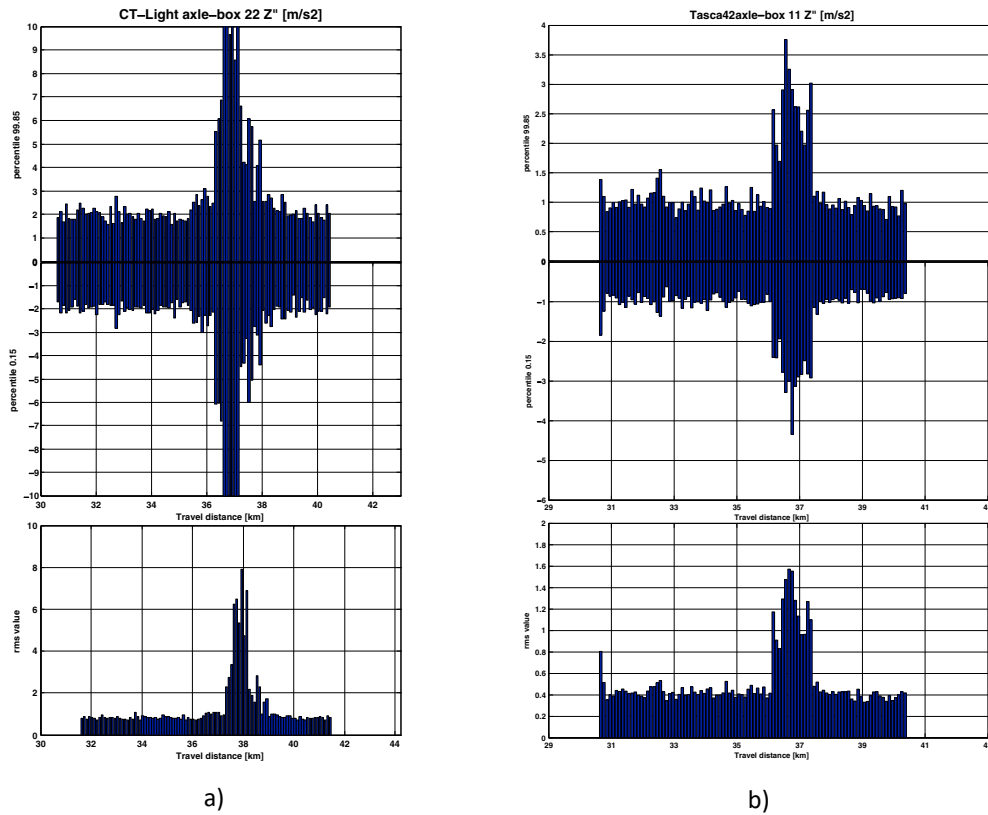
Fig. 10. Percentiles (0.15% and 99.85%) and r.m.s. values of the coach vertical accelerations measured on the Gotthard base tunnel on the CTLIGHT (axle-box 22) and TASCA (axle-box 11) vehicles, passing on the switch section on the diverging route (km 37).

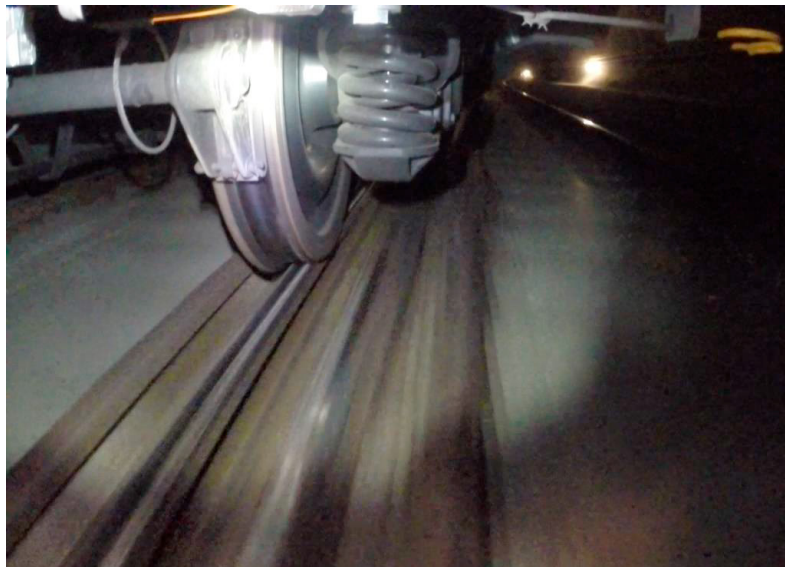
During the test, a camera was fixed on the coach and synchronized with the acquisition system, in order to relate the results with the track defects and singularities. The camera has been oriented to record the track and one wheel of the coach. From the analysis of the video at about the km 37, where the acceleration peak was detected, it is possible to notice the presence of a series of railway switches that is the cause of the acceleration increment. Fig. 11 shows the first railway switch located at the km 37.

Fig. 11. Detail of one vehicle wheel while running on the switch located at km 37 of the Gotthard Base tunnel.

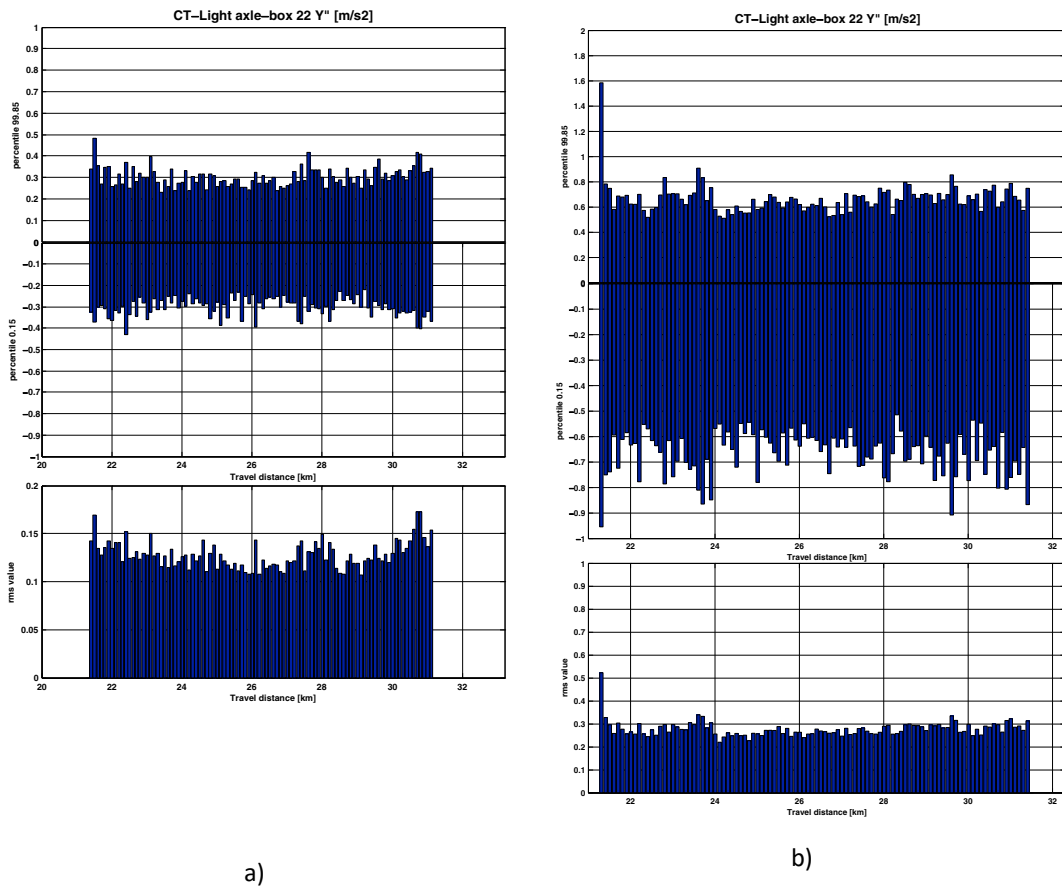
Fig. 12.a and 12.b respectively show the axle-box 22 lateral accelerations measured during the test at about 90 km/h and 115 km/h on the CTLIGHT vehicle.

Comparing the two cases, it is possible to notice that the lateral accelerations on the axle-box are approximately the double when increasing the vehicle speed of the 30%. Also comparing the vertical accelerations, shown in Fig. 13.a and 13.b, it is possible to observe that accelerations are about the double when the vehicle is running at 115 km/h. In any case, the axle-box acceleration values are very low also when the vehicle is running at quite the maximum speed (120 km/h). The maximum percentile values of the lateral and vertical accelerations are respectively equal to 0.9 m/s² and 2.6 m/s², which are very low and ensure very low track stresses. Considering the acceleration peaks due to the switches inside the tunnel, shown in Fig. 9 and 10, the maximum value in lateral direction is 6.5 m/s² on the TASCAs vehicle, while in vertical direction is 18.2 m/s² on the CTLIGHT vehicle. These higher values of accelerations have been measured only where are located the switches and the vehicle is running at the maximum speed, and so are not related with the track quality. In general, on the basis of the accelerations measured on the two vehicles running on the Gotthard Base tunnel it is possible to conclude that the new track has a very high-quality level.

Fig. 12: Percentiles (0.15% and 99.85%) and r.m.s. values of the axle-box 22 lateral accelerations measured on the Gotthard base tunnel on the CTLIGHT vehicle running at about 90 km/h (a) and 115 km/h (b).

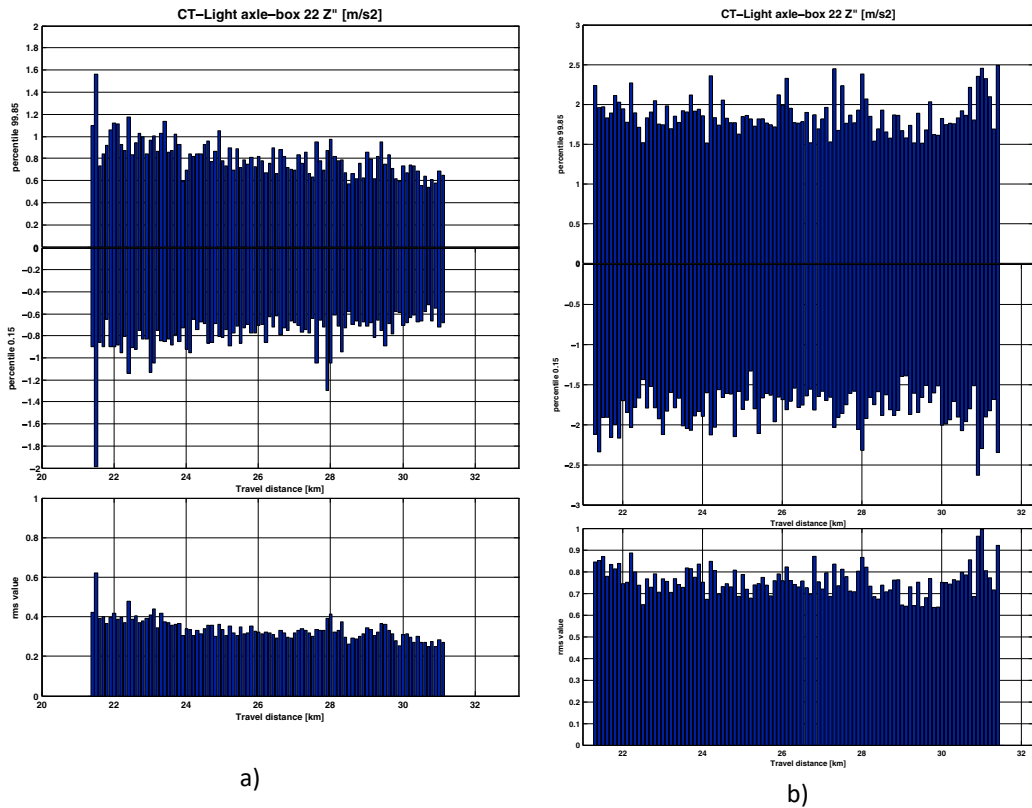
Fig. 13: Percentiles (0.15% and 99.85%) and r.m.s. values of the axle-box 22 vertical accelerations measured on the Gotthard Base tunnel on the CTLIGHT vehicle running at about 90 km/h (a) and 115 km/h (b).

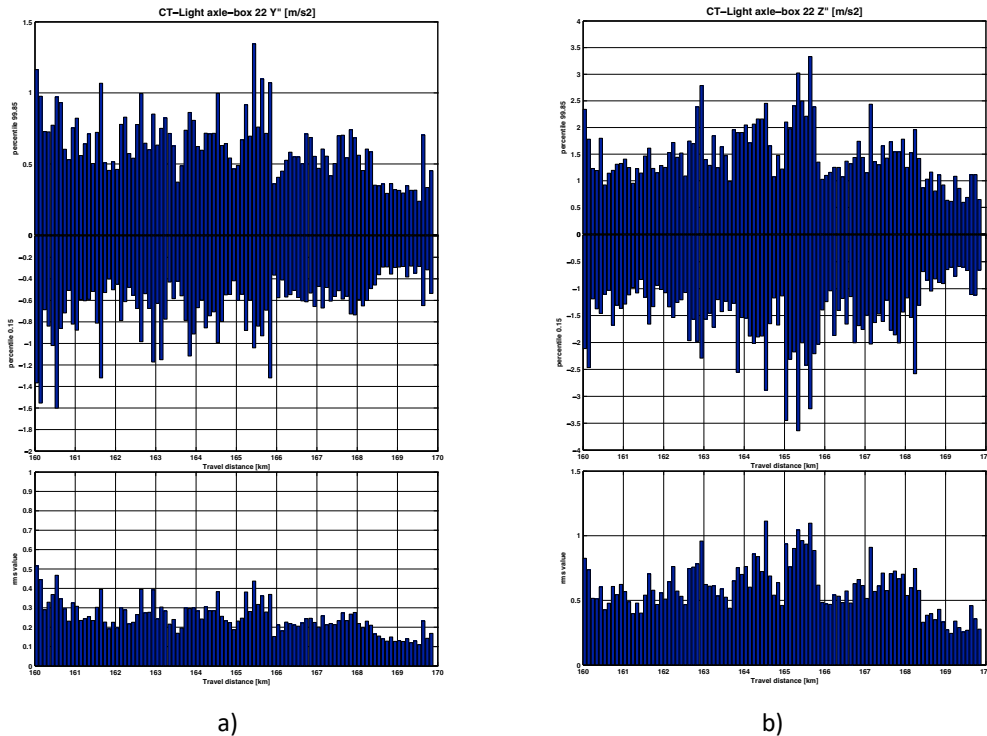
In order to highlight the quality of the new track a further comparison is carried on, comparing the axle-box lateral and vertical accelerations measured on the new Gotthard Base tunnel with the ones measured on the “traditional” Gotthard tunnel. Also in this case, the comparison is performed on the same vehicle with the same axle-load and considering a track section where the vehicle is running at 90 km/h. In Fig. 8.a is shown the axle-box 22 lateral acceleration measured on the “traditional” tunnel which can be compared with the one, measured on the Base tunnel, in Fig. 12.a. Comparing the acceleration percentiles it is evident that the “old” tunnel has higher accelerations than the “new” one, in fact the maximum acceleration in the first case is 1.3 m/s², while in the second case is 0.42 m/s². Also considering the maximum value of the r.m.s. diagram the acceleration value on the “old” tunnel is much higher (0.48 m/s² vs. 0.17 m/s²). In general, the lateral acceleration on the “traditional” Gotthard tunnel are three times higher than the ones measured on the Gotthard Base tunnel under the same conditions. The axle-box vertical accelerations on the “old tunnel”, see Fig. 14.b, have a percentile and r.m.s. peak values equal to -3.6 m/s² and 1.2 m/s², while considering the acceleration measured on the Base tunnel, see Fig. 13.a, the percentile and r.m.s. peak value are equal to -1.3 m/s² and 0.48 m/s². Therefore, the same considerations for the lateral accelerations can be extended to the vertical ones and also in this case the ratio between the accelerations measured on the “traditional” and Base tunnels is about three.

Fig. 14: Percentiles (0.15% and 99.85%) and r.m.s. values of the axle-box 22 lateral (a) and vertical (b) accelerations measured on the “traditional” Gotthard tunnel on the CTLIGHT vehicle running at about 90 km/h.

The last analysis allows to conclude that the accelerations measured on the vehicle axle-boxes, when the vehicle is running on the Gotthard Base tunnel with a speed of 120 km/h (see Fig. 12.b and 13.b), are in general lower than the accelerations that occur on the same vehicle running on the traditional tunnel with a speed of 90 km/h.
